Investigative analysis to determine safety priority levels for power distribution equipment using Infrared Thermography: The case study of related ancillary equipment located within selected substations in Kumasi Metropolis.

Asare K.¹, Quansah G.S.²

Abstract: The study focused on the identification of priority levels for power distribution equipment in selected substations in Kumasi, Ghana. So many times in the event of safety disasters in substations, engineers do not normally know which power distribution equipment to address and isolate. The determination of priority levels for the various equipment help mitigate such dilemma and prevent huge power losses. The selected substations included a 33kV Substation H at Edwenase, a 33kV Nsuta Substation and a Station A, 33kV Substation at Adum, all located in Kumasi Metropolis. The power equipment under study in the various substations included an 11kV busbar, a cable/overhead jumper on a transmission pylon, a 33kV cable end isolator, a 33kV jumper located in-between an overhead transmission line, a busbar and isolator joint, a series of busbar bushings, a terminated cable housed in a distribution panel, and a high voltage terminated

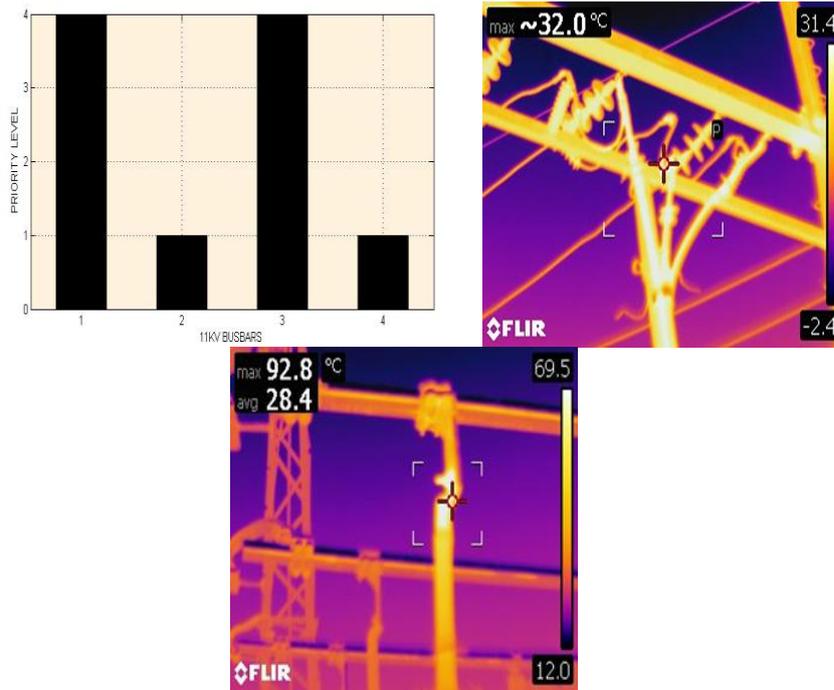
Fig.2. 11KV Busbar Assessment

Two of the 11kV busbars (1 and 3) were found to be in optimum health conditions while the other two were in need of repair and replacement (2 and 4).

Equipment	Amb. Temp (° C)	Max Temp (° C)	Msd Temp (° C)	Delta-T (Similar Cmpnts)	P.L.1	Delta-T (Cmpnt/Amb Temp)	P.L.2	Over all Priority Level	Remarks
11kV Busbar 1	25	31.4	32	0.6	4	7	4	4	Possible deficiency ; Warrants investigation
11kV Busbar 2	24	84	120	36	1	96	1	1	Major Discrepancy; Repair Immediately
11kV Busbar 3	25	84	69	-15	4	44	2	4	Possible deficiency ; Warrants investigation
11kV Busbar 4	25	69.5	92.8	23.3	1	67.8	1	1	Major Discrepancy; Repair Immediately

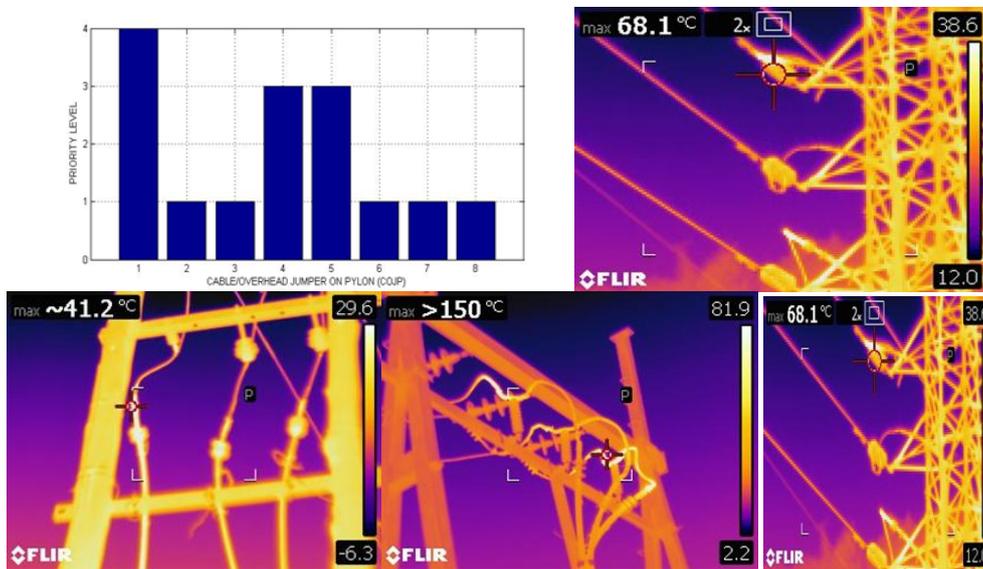
Fig.4. Cable/overhead jumper on pylon Assessment

The cable/overhead jumper (COJP) needs to be treated with urgency as almost all the components need some form of immediate attention. COJP 1 is in perfect condition while COJP 4 and 5 needs some time for repair. The rest needs immediate attention.

Equipment	Amb. Temp (° C)	Max Temp (° C)	Msd Temp (° C)	Delta-T (Similar Cmpnts)	P. L.1	Delta-T (Cmp nt/Amb Temp)	P.L 2	Overall Priority Level	Remarks
COJP 1	23	21.9	22.3	0.4	4	-0.7	4	4	Possible deficiency; Warrants investigation
COJP 2	25	38.6	68.1	29.5	1	43.1	1	1	Major Discrepancy; Repair Immediately

COJP 3	24	59.1	94.2	35.1	1	70.2	1	1	Major Discrepancy; Repair Immediately
COJP 4	23	51	63	12	3	40	2	3	Indicate probable deficiency; repair as time permits
COJP 5	21	29.6	41.2	11.6	3	20.2	3	3	Indicate probable deficiency; repair as time permits
COJP 6	20	81.9	155	73.1	1	135	1	1	Major Discrepancy; Repair Immediately
COJP 7	23	38.6	68.1	29.5	1	45.1	1	1	Major Discrepancy; Repair Immediately
COJP 8	24	51.2	112	60.8	1	88	1	1	Major Discrepancy; Repair Immediately

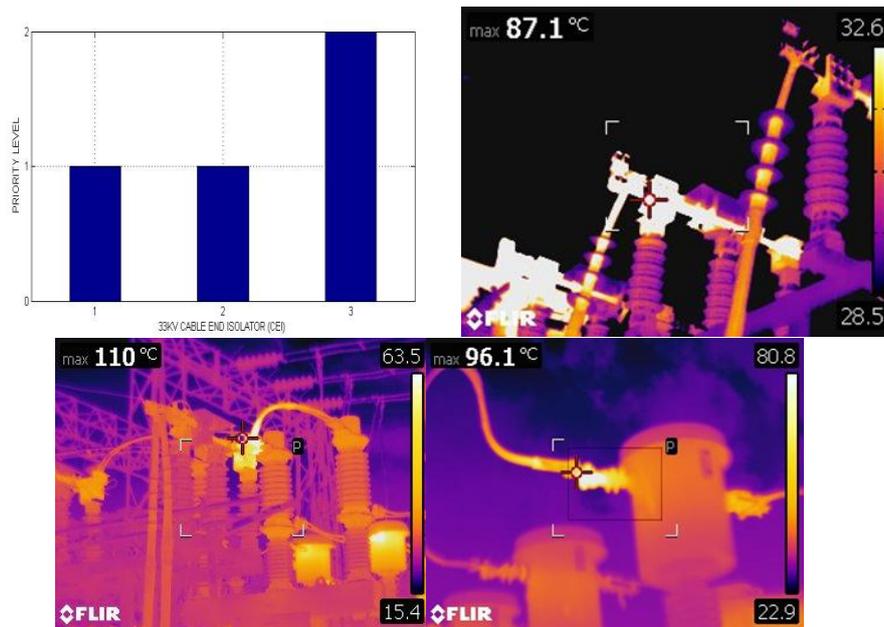
Fig.5. Cable end isolator Assessment

All the cable end isolators need immediate repair.

Equipment	Amb. Temp (° C)	Max Temp (° C)	Msd Temp (° C)	Delta-T (Similar Cmpnts)	P.L.1	Delta-T (Cmpnt /Amb Temp)	P.L. 2	Overall Priority Level	Remarks
CEI 1	24	32.6	87.1	54.5	1	63.1	1	1	Major Discrepancy; Repair Immediately
CEI 2	24	63.5	110	46.5	1	86	1	1	Major Discrepancy; Repair Immediately
CEI 3	24	80.8	96.1	15.3	2	72.1	1	2	Monitor continuously until corrective measures can be accomplished

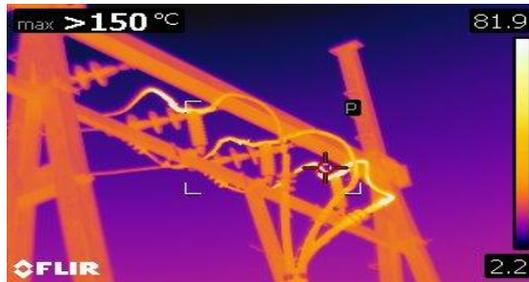
Fig.6. Jumper between overhead and cableAssessment

The jumper between the overhead and the cable were found to want immediate repair.

Equipment	Amb. Temp (° C)	Max Temp (° C)	Msd Temp (° C)	Delta-T (Similar Cmpnts)	P. L. 1	Delta-T (Cmpnt/Amb Temp)	P.L 2	Overall Priority Level	Remarks
JOC	25	81.9	155	73.1	1	130	1	1	Major Discrepancy; Repair Immediately

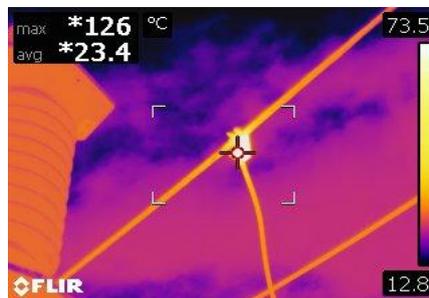
Fig.7. main busbarAssessment

The main bus bar as observed needed to be worked on immediately.

Equipment	Amb. Temp (° C)	Max Temp (° C)	Msd Temp (° C)	Delta-T (Similar Cmpnts)	P.L.1	Delta-T (Cmpnt/Amb Temp)	P.L 2	Overall Priority Level	Remarks
MB	25	73.5	126	52.5	1	101	1	1	Major Discrepancy; Repair Immediately

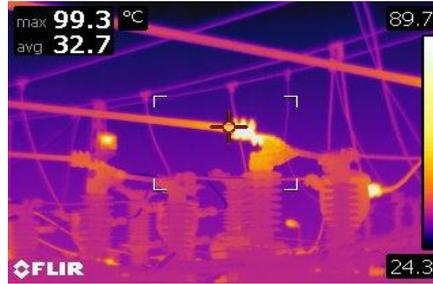
Fig.8. Busbar and isolator joint Assessment

The busbar and the isolator joint needed a little time to repair.

Equipment	Amb. Temp (° C)	Max Temp (° C)	Msd Temp (° C)	Delta-T (Similar Cmpnts)	P.L.1	Delta-T (Cmpnt/Amb Temp)	P.L 2	Overall Priority Level	Remarks
BIJ	25	89.7	99.3	9.6	3	74.3	1	3	Indicate probable deficiency ; repair as

time permits
--	--	--	--	--	--	--	--	--	--------------

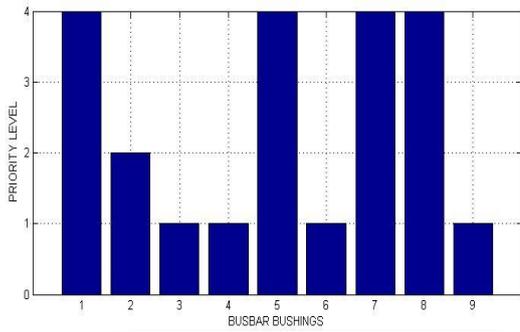
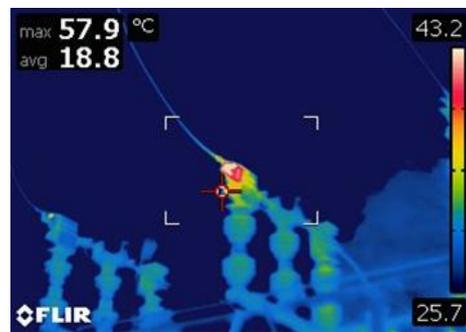
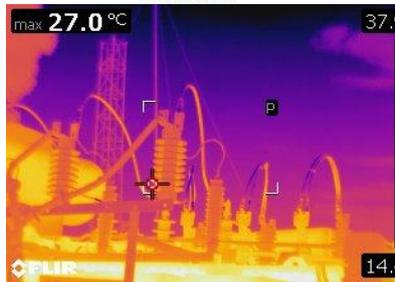
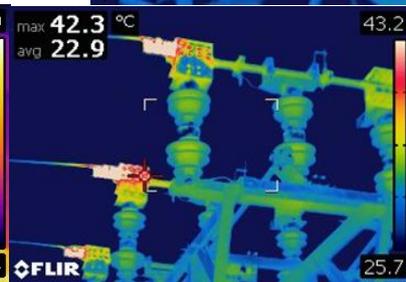
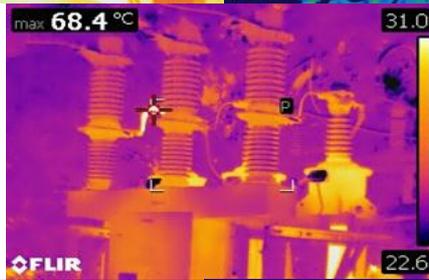
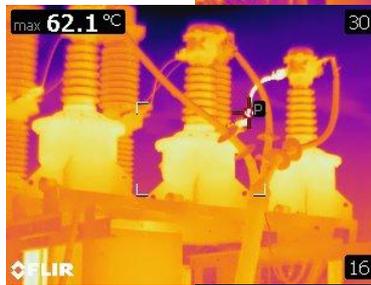
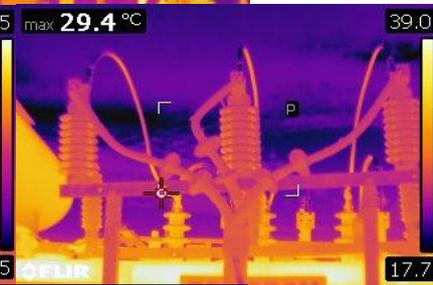
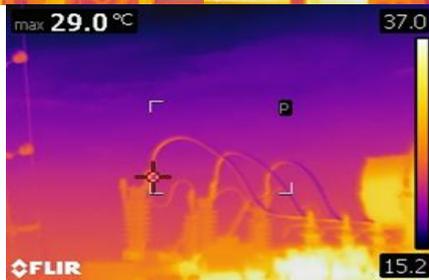
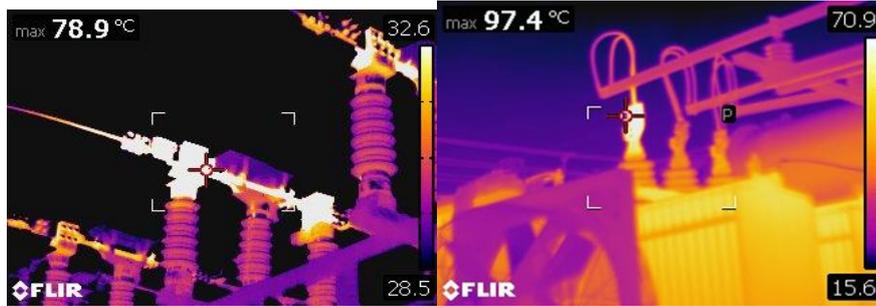
Fig.9. Busbar bushings Assessment

Four (4) of the bus bar bushings need immediate repair.

Equipment	Amb. Temp (° C)	Max Temp (° C)	Msd Temp (° C)	Delta-T (Similar Cmpnts)	P.L.1	Delta-T (Cmpnt/ Amb Temp)	P.L.2	Over all Priority Level	Remarks
BB1	25	43.2	42.3	-0.9	4	17.3	3	4	Possible deficiency; Warrants investigation
BB2	24	43.2	57.9	14.7	2	33.9	2	2	Monitor continuously until corrective measures can be accomplished
BB3	25	32.6	78.9	46.3	1	53.9	1	1	Major Discrepancy; Repair Immediately
BB4	25	30.5	62.1	31.6	1	37.1	1	1	Major Discrepancy; Repair Immediately
BB5	25	39	29.4	-9.6	4	4.4	4	4	Possible deficiency; Warrants investigation
BB6	21	31	68.4	37.4	1	47.4	1	1	Major Discrepancy; Repair Immediately
BB7	25	37.9	27	-10.9	4	2.0	4	4	Possible deficiency; Warrants investigation
BB8	23	37	29	-8	4	6	4	4	Possible deficiency; Warrants investigation

n
BB9	22	70.9	97.4	26.5	1	75.4	1	1	Major Discrepancy; Repair Immediately

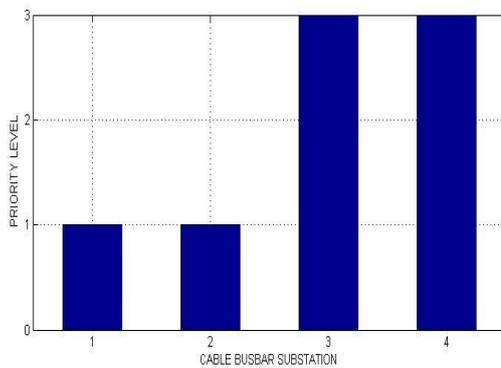
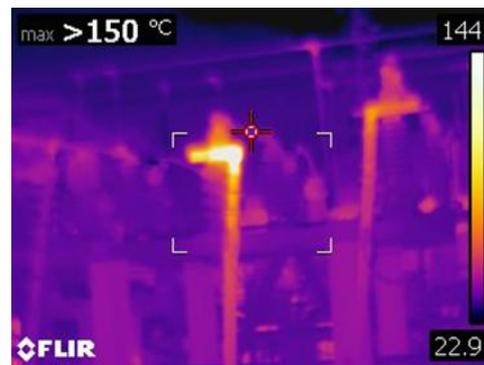
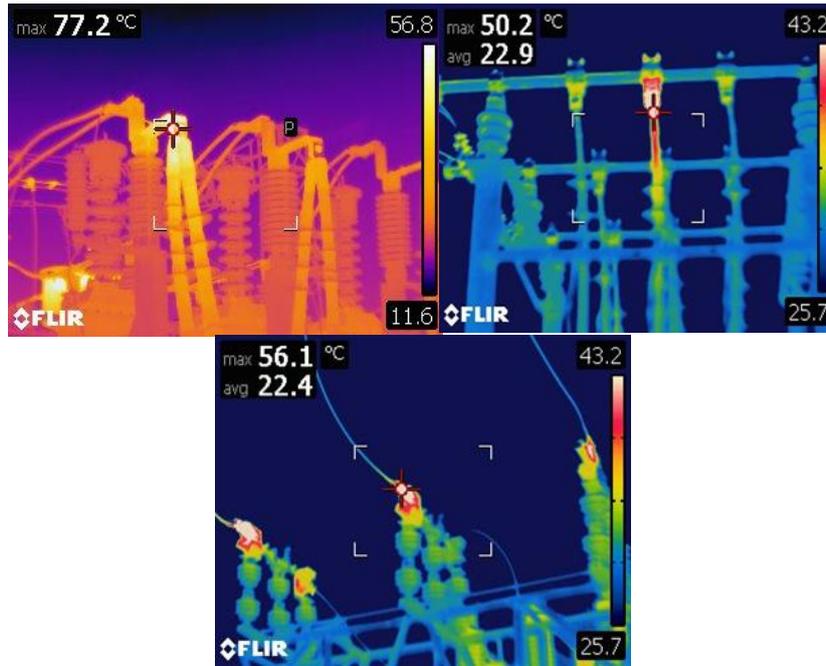
Fig.10 Cable busbar substation Assessment

Two of the cable busbars in the substations need immediate attention.

Equipment	Amb. Temp (° C)	Max Temp (° C)	Msd Temp (° C)	Delta-T (Similar Cmpnts)	P.L.1	Delta-T (Cmpnt/Amb Temp)	P.L.2	Overall Priority Level	Remarks
CBS 1	24	144	163	19	1	139	1	1	Major Discrepancy; Repair Immediately
CBS 2	23	56.8	77.2	20.4	1	54.2	1	1	Major Discrepancy; Repair Immediately
CBS 3	24	43.2	50.2	7.0	3	26.2	3	3	Indicate probable deficiency ; repair as time permits
CBS 4	22	43.2	56.1	12.9	3	34.1	2	3	Indicate probable deficiency ; repair as time permits

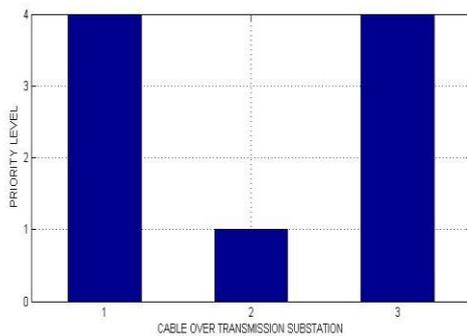
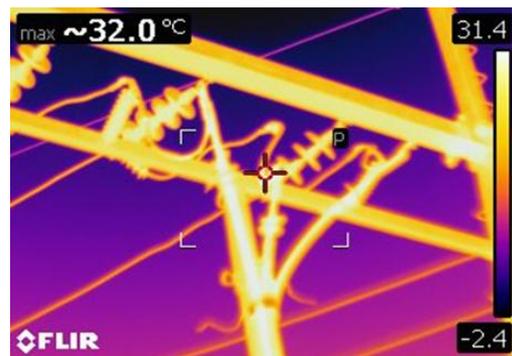
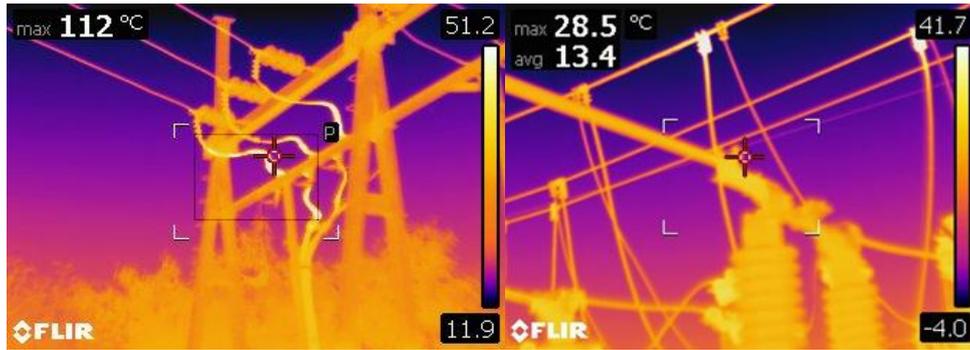
Fig.11 Cable over transmission substation Assessment

Only one (1) of the cable over the transmission substation requires immediate attention.

Equipment	Amb. Temp (° C)	Max Temp (° C)	Msd Temp (° C)	Delta-T (Similar Cmpnts)	P.L 1	Delta-T (Cmpnt/Amb Temp)	P.L 2	Overall Priority Level	Remarks
COTS 1	24	31.4	32	0.6	4	8	3	4	Possible deficiency; Warrants investigation
COTS 2	23	51.2	112	60.8	1	89	1	1	Major Discrepancy; Repair Immediately
COTS 3	25	41.7	28.5	-13.2	4	3.5	3	4	Possible deficiency; Warrants investigation

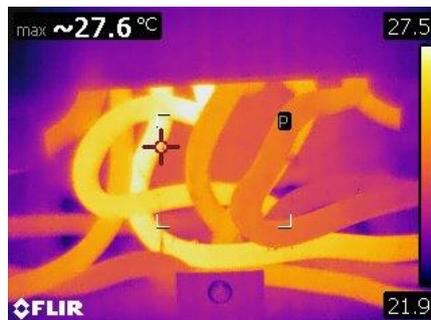
Fig.12. Distribution panel cable termination Assessment

Overall the cable terminated in the distributed panel was healthy.

Equipment	Amb. Temp (° C)	Max Temp (° C)	Msd Temp (° C)	Delta-T (Similar Cmpnts)	P.L.1	Delta-T (Cmpnt/ Amb Temp)	P.L 2	Overall Priority Level	Remarks
DPCT	24	27.5	27.6	0.1	4	3.6	4	4	Possible deficiency; Warrants investigation

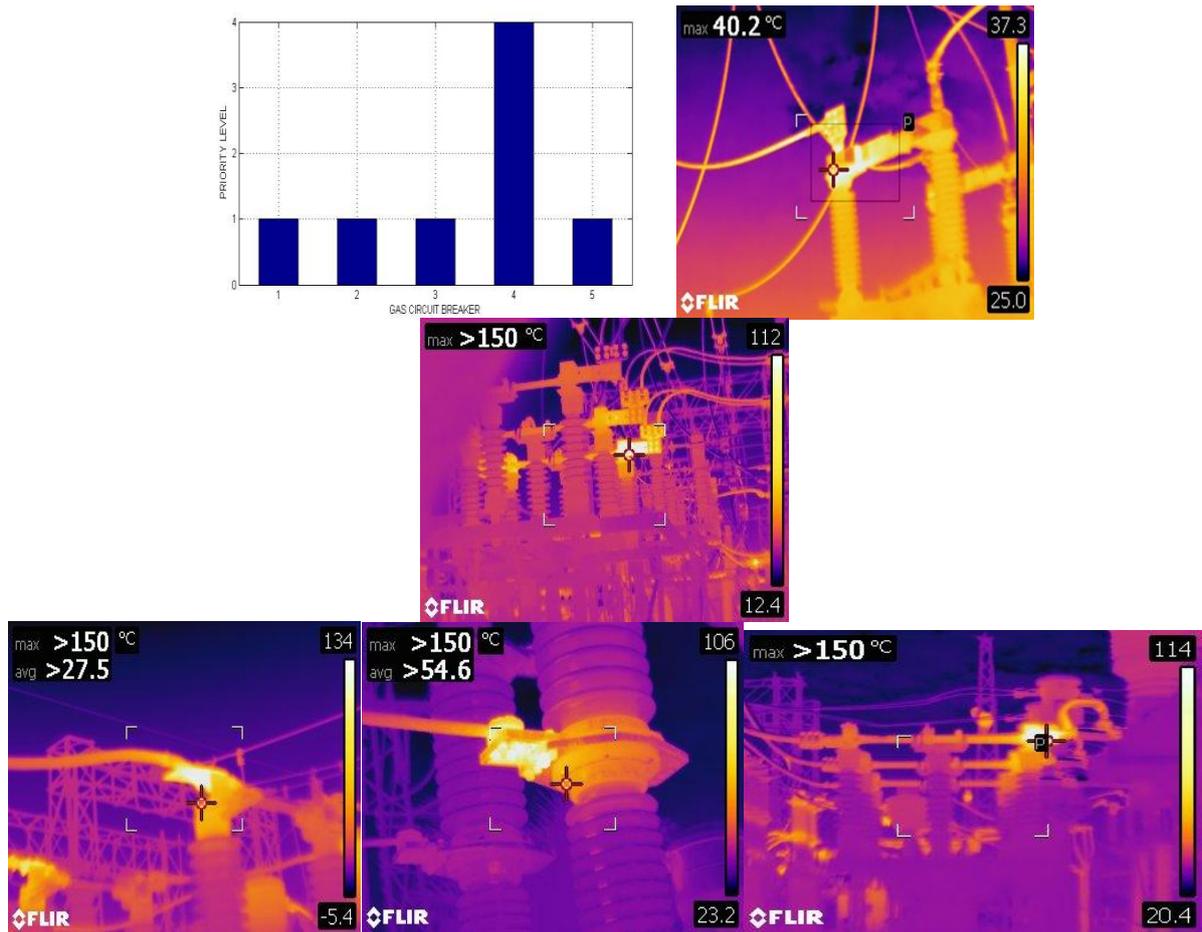
Fig.13. Gas circuit breaker substation Assessment

Only one (1) of the gas circuit breakers was deemed healthy.

Equipment	Amb. Temp (° C)	Max Temp (° C)	Msd Temp (° C)	Delta-T (Similar Cmpnts)	P.L.1	Delta-T (Cmpnt/ Amb Temp)	P.L 2	Overall Priority Level	Remarks
GCBS 1	24	112	165	53	1	141	1	1	Major Discrepancy; Repair Immediately
GCBS 2	24	134	155	21	1	131	1	1	Major Discrepancy; Repair Immediately

GCBS 3	25	106	158	52	1	133	1	1	Major Discrepancy; Repair Immediately
GCBS 4	25	37.3	40.2	2.9	4	15.2	3	4	Possible deficiency; Warrants investigation
GCBS 5	25	114	155	41	1	130	1	1	Major Discrepancy; Repair Immediately
