Static Balancing of Centrifugal Fan

Ekpenyong Ekpo¹, Samuel Audu Seth², Kelas David Kario³, Nasir Muhammad Yelma⁴

^{1,2}(Maintenance Department, Ashaka cem, Lafarge Africa plc)
³(Department of Mechanical Engineering, Modibbo Adama University, Nigeria)

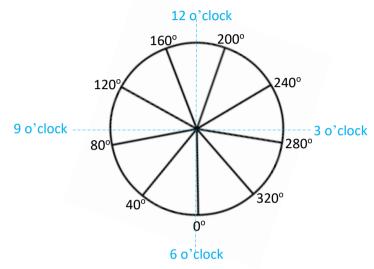
Figure 3: Impeller divisions for static balancing reference points

Surface Preparation with the use of wire brush to remove contaminants and buildup of materials from the impeller to ensure accurate balancing and secure placement of weights. The impeller was manually rotated and allowed to settle. The spot at 6 o'clock position was identified as the heavy spot and marked as 0° presented in figure 3. The impeller was divided into nine 40° intervals, corresponding to the 9 blades. At 12 o'clock was designated for trial weights as it is directly opposite the heavy spot. A 5 g trial weight was mounted at 12 o' clock. The fan was manually rotated to balance the high sport. Subsequently, 17 g and 20 g were tested. The 20 g weight gave the best settling behavior, effectively offsetting the heavy spot. The fan was assembled back and operated with the 20 g trial weight at 12 o'clock and vibration measured and recorded.

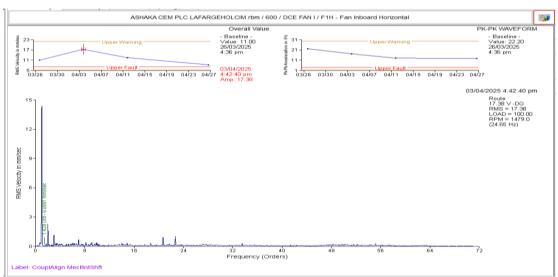
Figure 4a: Fan Drive End (FDE) – Horizontal vibration wave front

These values confirmed the presence of severe unbalance, misalignment and possible structural or assembly defect as shown from the wave fronts in figure 4. The wave fronts exhibited high amplitude, predominantly at 1X frequency, which corresponds to the running speed of the fan (1475 RPM \approx 24.6 Hz). This is a classic indicator of unbalance, as the unbalanced mass generates a centrifugal force synchronous with rotation. Additionally, axial wave components were elevated, especially at the Fan Drive End (FDE), pointing to misalignment or shaft distortion as shown on figure 4c.

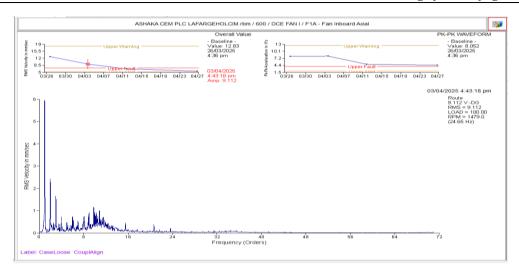
Figure 4c: Fan Drive End(FDE) – Axial vibration wave front

From the initial diagnosis, several critical mechanical faults were identified and addressed. These included an impeller shaft misalignment, which was contributing significantly to axial vibration (figure 4c), a bearing housing mismatch, and casing distortion(cracks). These issues were corrected through detailed inspection and reassembly, followed by alignment of the motor and fan shafts. The alignment process aimed to minimize angular and parallel offset between the rotating components, thereby reducing the stress on bearings and shafts. The vibration reading abtained was recorded in table 2 and the wave front in figure 5.

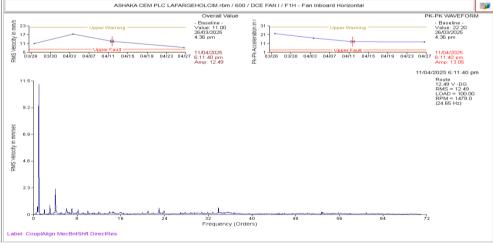
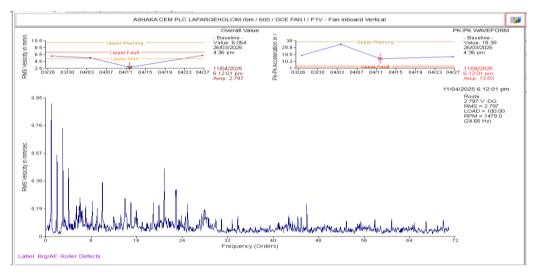
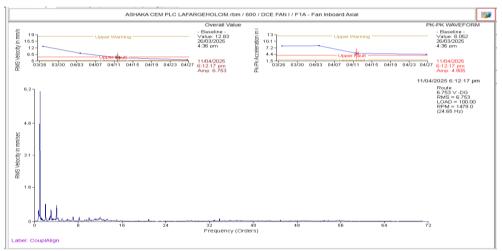
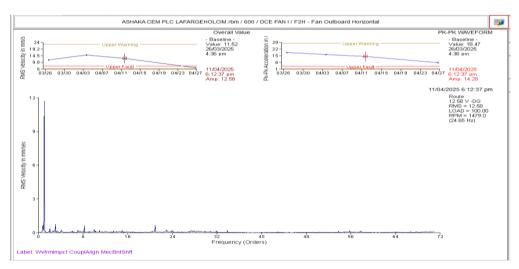
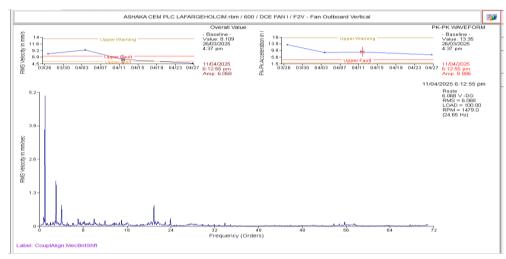
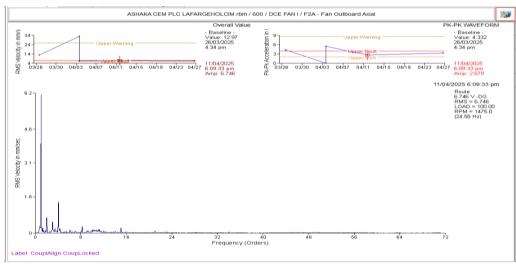
While the mechanical corrections and shaft alignment provided some relief, leading to a slight reduction in vibration amplitudes (e.g., horizontal vibration at FDE decreased from 17.38 mm/sec to 12.48 mm/sec, a 25.4 % reduction), the overall vibration levels remained considerably high and above ISO acceptable limits as shown on the wave fronts (figure 5a-5f), confirming that correcting shaft misalignment was effective. However, the dominant 1X component remained, and overall amplitudes, especially in the horizontal direction, stayed high. This signaled persistent unbalance on the impeller, reinforcing the need for balancing, which the alignment process alone could not fully address.

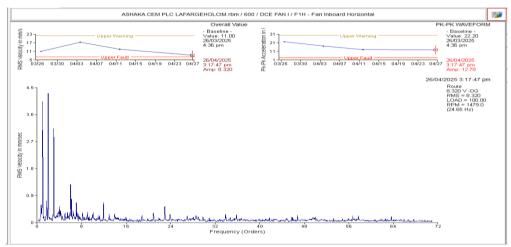
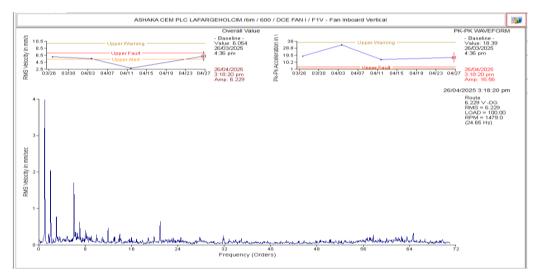
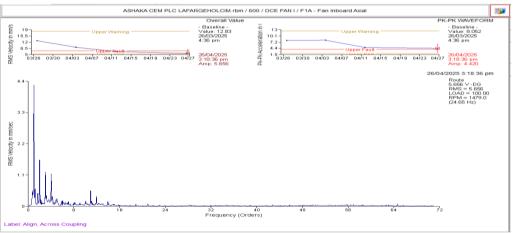
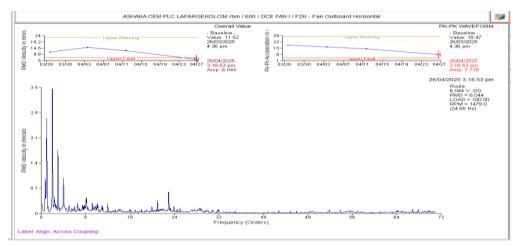
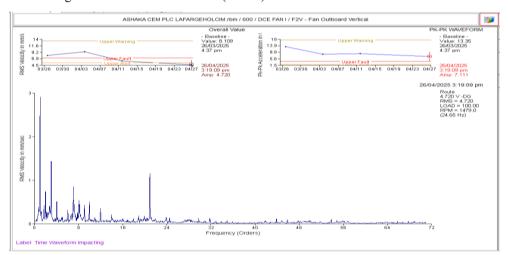
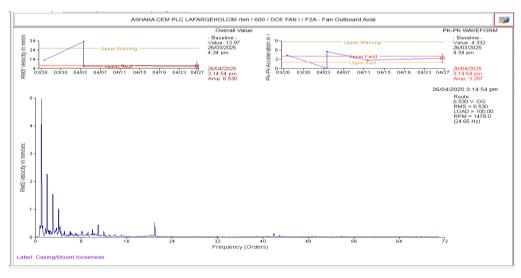
After applying the 20 g trial weight, the wave fronts showed a dramatic reduction in amplitude across all measurement points, particularly at FNDE. For instance, the horizontal vibration at FNDE was reduced from 12.58 mm/sec to 6.04 mm/sec, representing a 51 % reduction from the post-alignment state, confirming the effectiveness of the trial weight in mitigating the primary unbalance force as shown below. While the improvement was most pronounced in the horizontal plane (as expected for static unbalance), notable reductions were also observed in vertical and axial directions, indicating a more stable overall rotational system.

A sequence of trial weights was tested for static correction. 5 g weight at 12 o' clock showed minimal effect. 17 g improved the settling balance but not satisfactorily. 20 g weight demonstrated the most significant correction during manual settling. The 20 g trial weight was mounted at 12 o' clock and the fan were reassembled for operational testing. Upon startup, the new vibration profile was measured across all four bearing locations using the SKF Quick Collect CMDT391 sensor and later confirmed with the CSI 2140 analyzer.

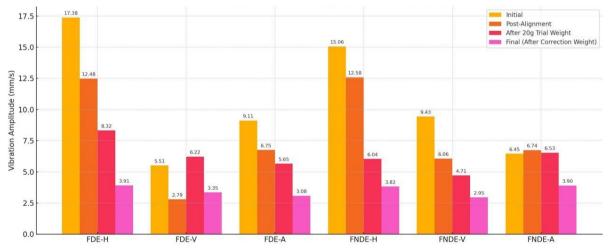
Figure 7: vibration measurement comparison before and after balancing

This clearly demonstrates the success of the final balancing. The vibration levels are now well within ISO 10816 and in good operating limits for this type of machinery. The final horizontal vibration at FDE is 3.91 mm/sec represents an 82% total reduction from the initial state of 17.38 mm/sec as summarized in figure 7. This indicates that the fan impeller is rotating with greatly reduced dynamic forces, leading to improved stability and a significant extension of its operational lifespan. The entire process, from initial fault identification via vibration analysis to mechanical corrections and manual static balancing, underscores the critical importance of a holistic approach to machinery maintenance. This case study effectively illustrates how systematic interventions can restore severely affected rotating equipment to optimal and safe operating conditions.

Initial Measurement: Vibration levels were critically high, with horizontal readings at FDE reaching 17.38 mm/s and at FNDE 15.06 mm/s—indicating severe unbalance and misalignment. Post-Alignment: Mechanical corrections such as shaft alignment and bolt tightening reduced vibration moderately, especially in axial directions. However, horizontal values remained well above ISO 10816 limits, confirming residual unbalance. After 20g Trial Weight: The application of a 20g trial weight significantly improved balance, especially at FNDE where horizontal vibration dropped to 6.04 mm/s (a 52% reduction from post-alignment). This confirmed that static unbalance was the dominant fault. Final (After Correction Weight - 34.55g): Final vibration readings

showed substantial improvements across all directions and locations. The horizontal reading at FDE fell to 3.91 mm/s—a total reduction of 82% from the initial state. All values now fall within ISO 10816 acceptable limits.

This calculated mass (the correction mass) was determined to be optimal for achieving the lowest possible residual unbalance. The 34.55 g was precisely welded at the same position (12 o'clock position). The position choice was validated by the significant drop in vibration after placing the trial weight on that same position. The vibration readings with the correction weight in position was presented in table 4.
