## **Geotechnical Evaluation of Kalijhora Landslide on Sevok – Teesta Bazaar Road, Along NH 10, Kalimpong District, West Bengal.**

**Pranatosh DasMondal\***

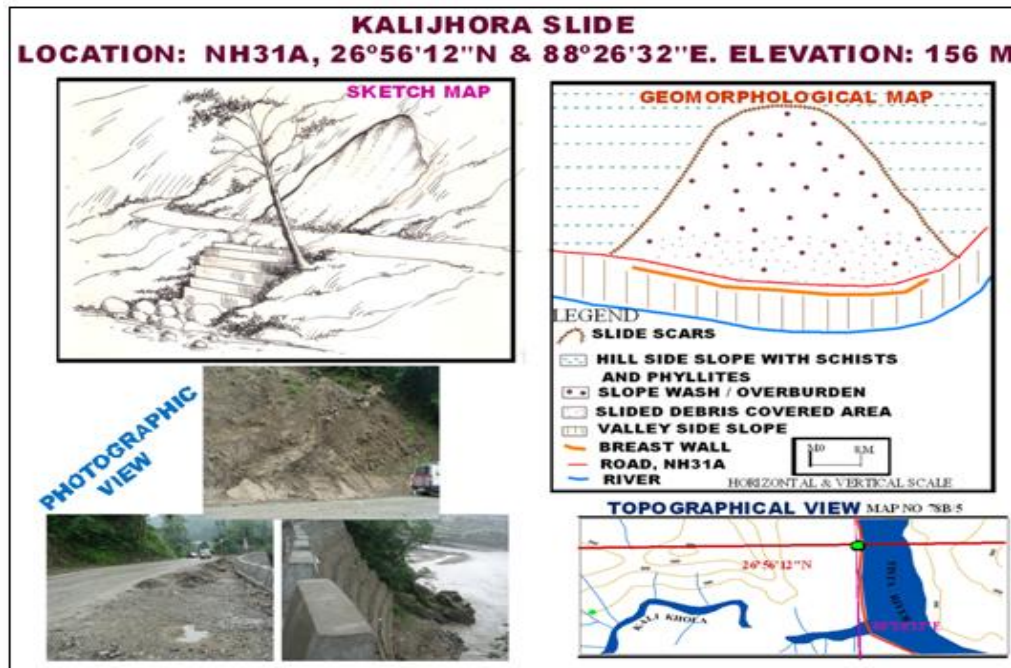
**Fig.2. Morphological map, Topographical, Photographic and Sketch view of Kalijhora slide.**

The Kalijhora landslide (figure 2 and plate 1, 2) is a rotational debris slide. Mostly pebble with sand and silt are involved as slide materials. The length of the scar is 65 m and the wide of the landslide reaches 30 m in the middle part. The slope angle is 40° NE to SW and average depth of the landslide scar is 2.1 m. Total area affected by this slide is 1950 m<sup>2</sup> and total volume of materials displaced is 4095 m<sup>3</sup>. The soil color of the slide area is grey sandy soil. The kalijhora area is vegetated by herbs, shrubs and scattered bushes. Improper land use practices like construction of road and widening of existing road, deforestation due to creation of hydel project etc are the characteristic of the slide area.

Therefore, arresting the toe erosion by Teesta River in the right bank a few heavy cross-beam structures and fixing of heavy precast concrete tripods are required to be constructed, which might be effective in arresting the toe erosion.

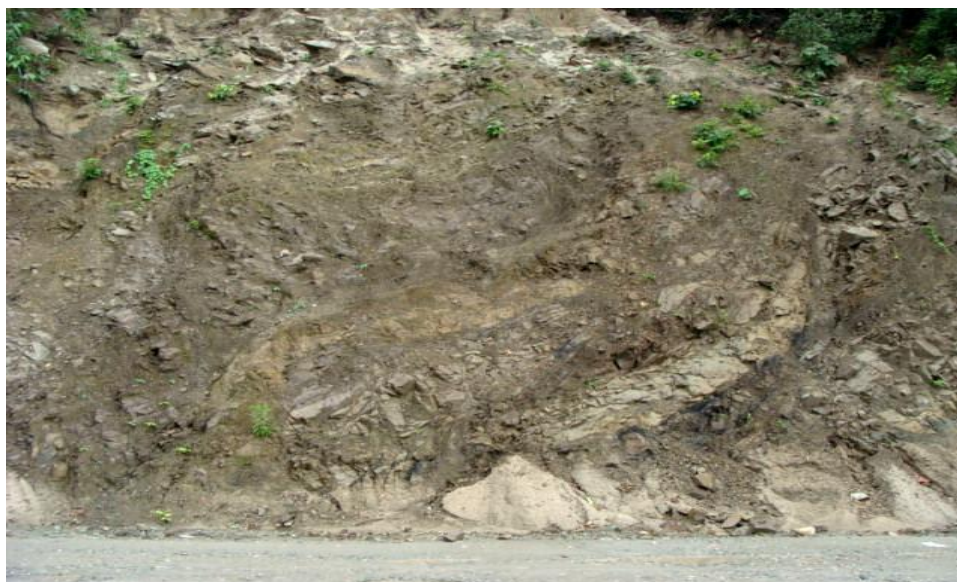
**Plate 1. Upper view of Kalijhora slide, slide face are situated along NH 10.**

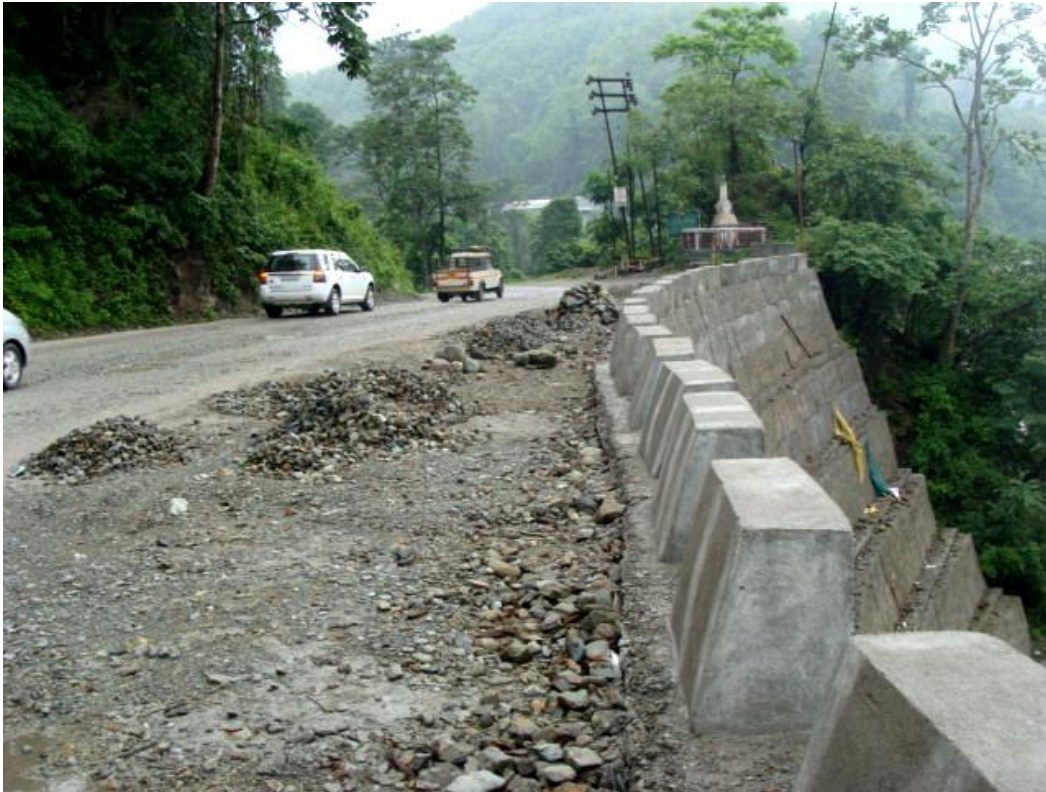
**Plate 2. Road damaged due to Kalijhora slide and toe erosion of Teesta River.**

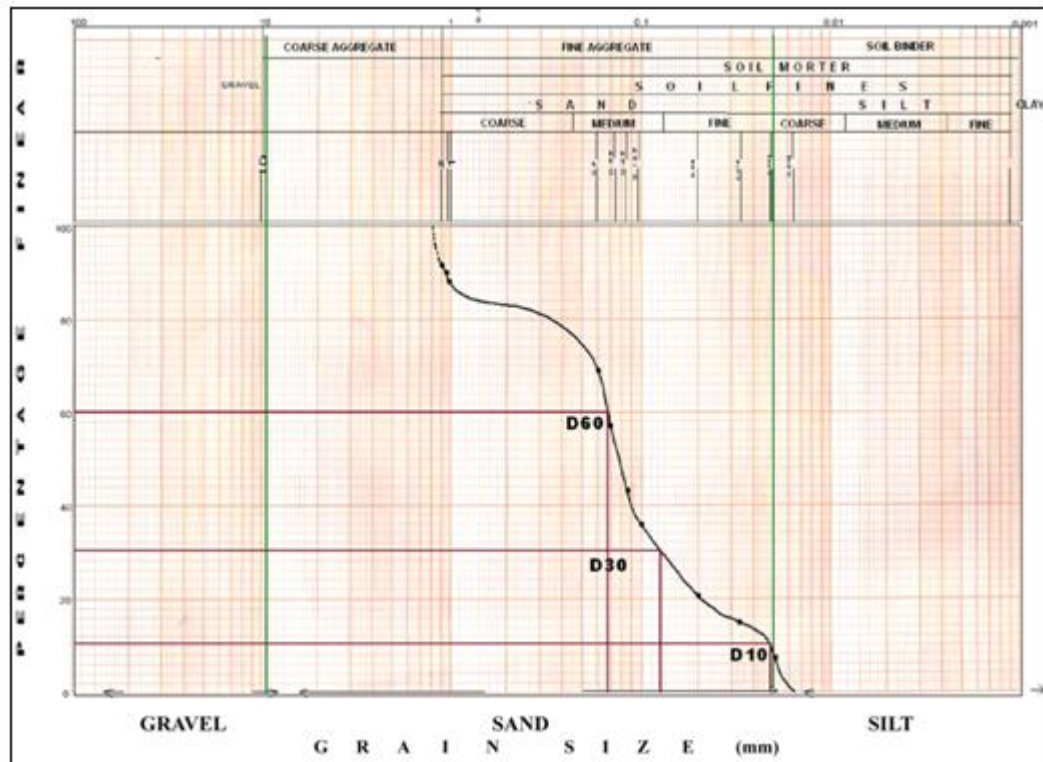
Figure.3: Grain-size distribution Curve of Kalijhora slide.

From this analysis, we get the total percentage of gravel, sand and silt is 8.3, 85.6 and 14.4 respectively. These are plotted in the triangular diagram to find out the types and nature of soil at Kalijhora. According to Unified Soil Classification System (USCS) this is loamy sand soil with 8.3% gravel.

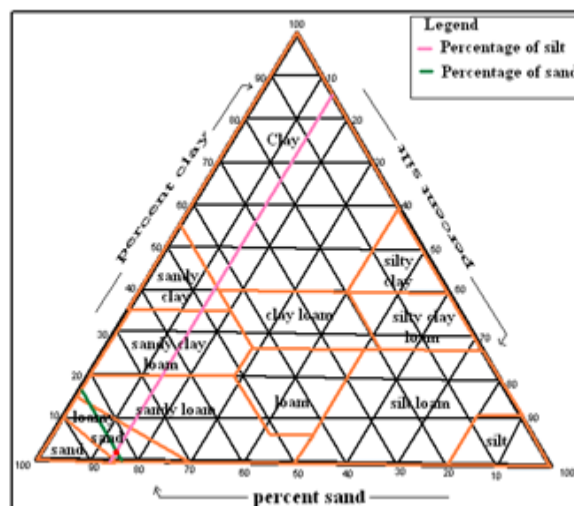
Figure. 4 – Determination of soil types by soil triangular diagram of Kalijhora.

From the grain size distribution curve and soil triangular diagram of the slide mass we find that the soils of the slides area are loamy sand (SM). According to Unified Soil Classification system the range of the soil strength parameters for loamy sand soil (SM) are given below.

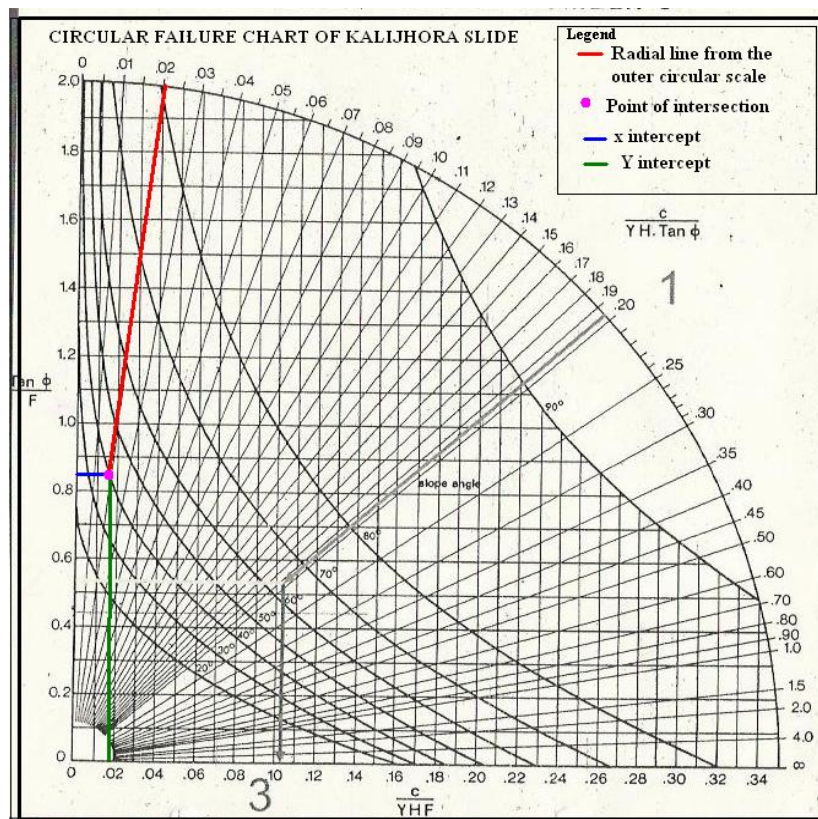
Figure 6. – CFC of Kalijhora.

$$= \mathbf{0.76}$$

Stability analysis of the kalijhora slide has been carried out using CFC (Figure 6.). The Fs value obtained 0.76, which is less than one. The analysis indicates that the slope is critically unstable fewer than 25% ground water condition. However when rainfall occurs, the saturation of slope may be more than 25%. The observation has done in pre monsoon period; therefore, during rainy season the slope will became more unstable and fails every year.
