Slope Stability Evaluation of a Failed Slope in Electric Sub-Station Site at Reckong Pio, Himachal Pradesh, India

Abstract: *The Himachal Pradesh Power Transmission Corporation Limited (HPPTCL) has constructed two buildings for housing 660kV and 220kV sub-stations close to Reckong Pio town in Himachal Pradesh, India. These buildings were constructed on two terraces constituted of glacial moraine deposits. A major landslide occurred during the rains of 2013 with the scarp face of landslide being located close to the building site. After geotechnical studies, the slope was treated adequately with grouted anchors and other required measures. The paper discusses the stability of the slopes in natural condition as well as after taking into consideration the effects of control measures.*

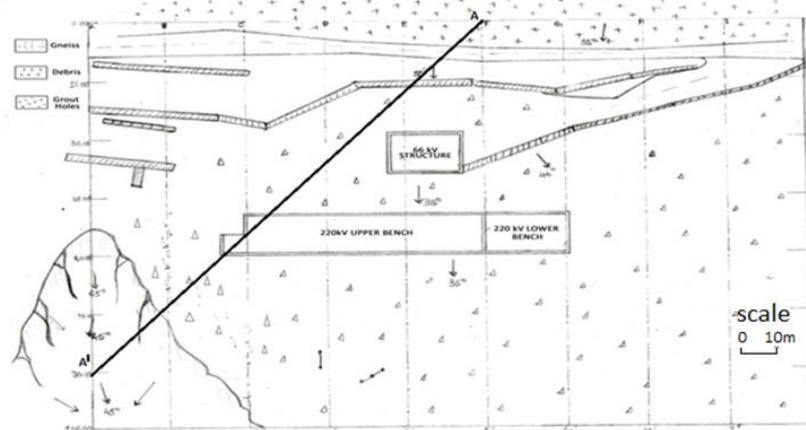
Fig. 1 Plan of area of study

Since a stream course is present in the centre of the landslide area, there may be more erosion and instability during rainfall in addition to creating difficulties to implement control measures. In order to understand the nature of instability and to evolve appropriate control measures, detailed geological mapping and stability analysis were carried out. A geological map (Fig 1) of the area showing various civil structures, extent of landslide and the type of material exposed area have been prepared on a detailed topographical map of scale 1:1000. A section (Fig 2) across the landslide has also been prepared and this has been used for stability analysis.

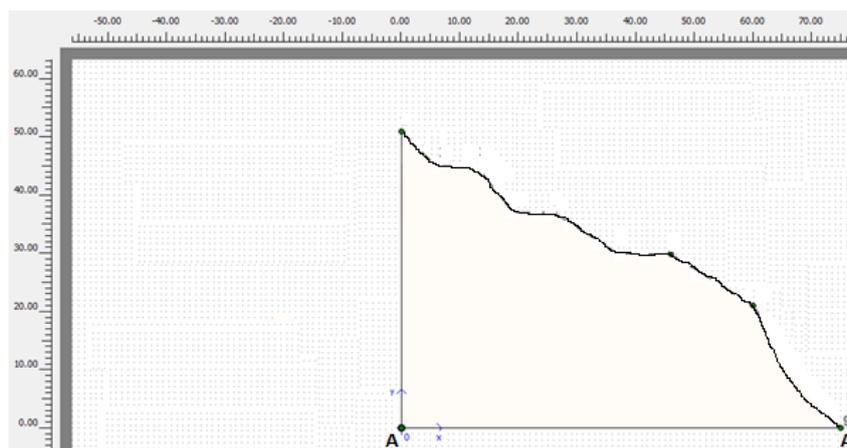
Fig. 2 Geometry of the cross-section drawn on PLAXIS

The factor of safety under dry condition using the section given in Fig 2 has been calculated. The material properties indicated in Table 1 have been used for the analysis. The analysis has been carried out for dry as well as saturated conditions. The analysis indicates that the factor of safety for dry condition without reinforcement is 1.57 and hence the slope is stable. However, the factor of safety in saturated condition without reinforcement is 0.92. This indicates that the slope becomes unstable under saturated condition.

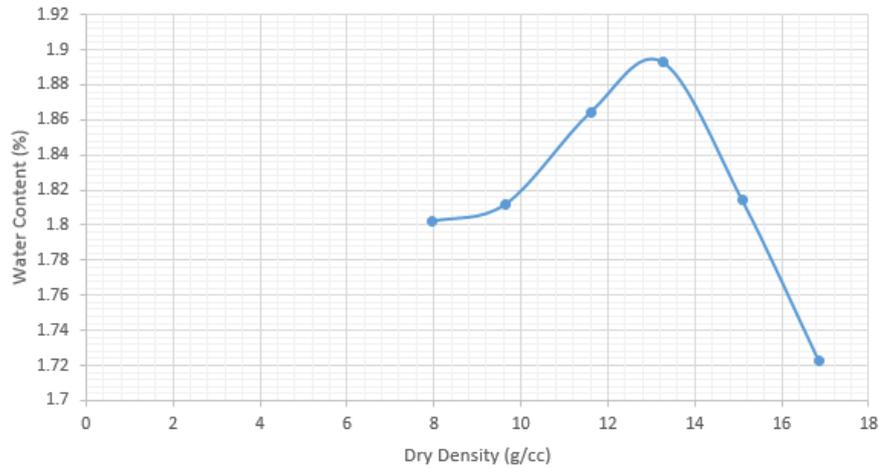
Fig. 3 Curve between Dry density and Water Content in percent

This laboratory test was performed for a specified compaction effort, to find out the relation between dry density and moisture content of the soil. Both the parameters were plotted (Fig. 3) in order to find the optimum moisture content. From the curve, the values of maximum dry density and optimum moisture content are obtained as 1.893 g/cm³ and 13.26% respectively.

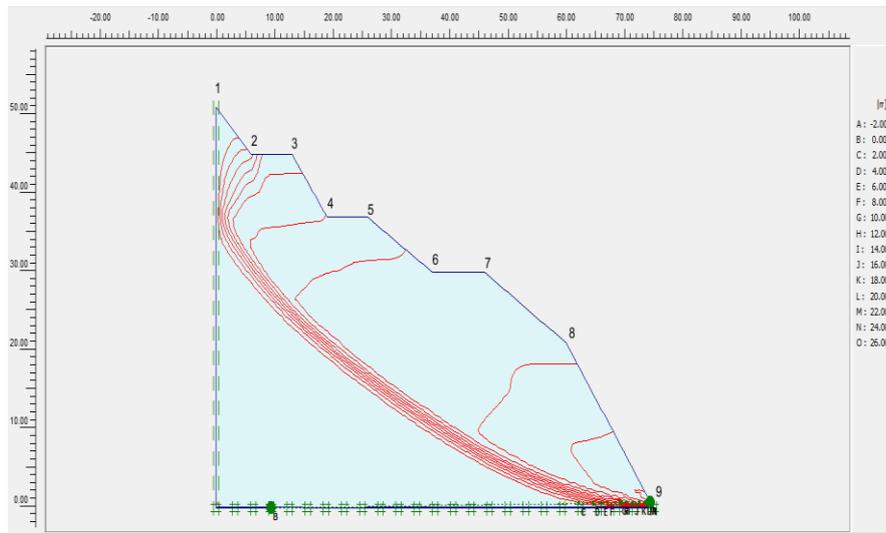
Fig 4. Horizontal displacement contours for dry slope mass without reinforcement

From the Fig 4, the contours indicate the varying values of horizontal displacement in different locations of the cross-section. The values at the critical points are mentioned in the Table 2 below.

Points	4	5	6	7	8
Displacement (m)	14	15	16	17	19

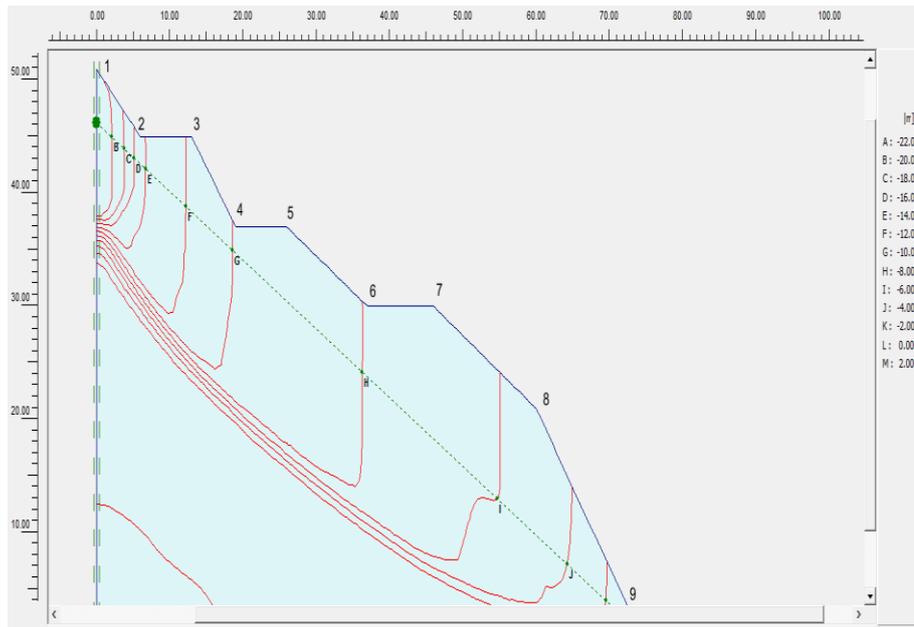
Fig 5 Vertical displacement contours for dry slope mass without reinforcement

From the Fig 5, the contours indicate the varying values of vertical displacement in different locations of the cross-section. The values at the critical points are mentioned in the Table 3 below.

Points	4	5	6	7	8
Displacement (m)	-10	-9	-8	-7	-5

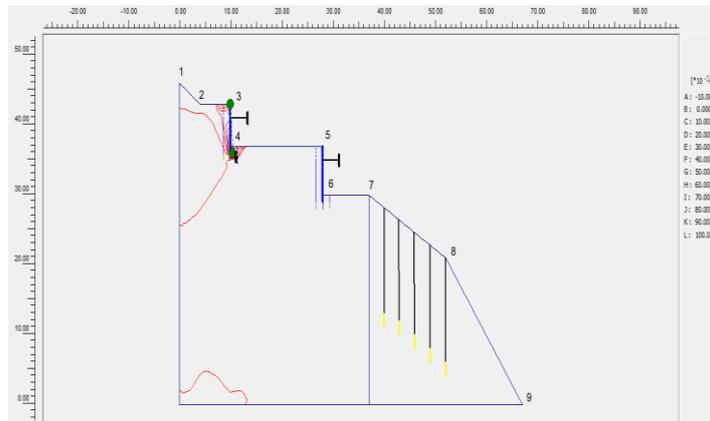
Fig 6 Horizontal displacement contours for dry slope mass with reinforcement

The software indicates the extent of horizontal and vertical displacements after incorporating the effects reinforcements within the slope for dry condition. The points 4-8 seen in the slope geometry (Fig. 6) has been used for further displacement analysis. These are critical points in the analysis and the values of displacement are critical in determining the overall safety. The horizontal displacements deciphered from the figure are given in the Table 7. The vertical displacements have also been understood from Fig. 7 and are included in Table 7.

Horizontal	Point	4	5	6	7	8
	Displacement (m)	0.07	0	0	0	0
Vertical	Point	4	5	6	7	8
	Displacement (m)	-0.2	-0.04	-0.04	-0.04	-0.04

In order to improve the stability of the slope, the major treatment carried out at the site includes a series of 20m deep grouted anchors, which form a subsurface barrier preventing the progress of the landslide towards upslope. In order to estimate the efficacy of the treatment, it is essential to carry out stability analysis with the reinforcements in place under dry and saturated conditions. For that purpose, the PLAXIS software has been used with the same material properties. The properties of the grout used in the analysis are given in the Table 4. In addition, the properties of the anchor rod and the subsurface RC wall are given in the Tables 5 & 6. Since a subsurface reinforce wall been created just above the crown of the landslide, the analysis has been done considering this as a RC wall.
