## **A Geophysical Investigation for Subsurface Characterization and Structural failure at the Site of a Building, Southwestern Nigeria**

**Abstract :** This study reports a geophysical survey involving the electrical resistivity method utilizing the Vertical Electrical Sounding (VES) and Electrical Imaging techniques conducted around the distressed walls of a School building with the aim of studying the causes of distress in the walls and characterizing the soil conditions of the area. A total of 20 Vertical Electrical Sounding (VES) stations were occupied using Schlumberger Configuration with AB/2 varying from 1 to 65 m. In the electrical imaging, dipole-dipole array was adopted and the two traverses were occupied in the S-N and E-W directions close to where the wall cracks were manifested. Four geoelectric sequences were delineated within the study area. These include the topsoil, weathered layer, partially weathered/fractured basement and fresh basement. Two linear features (suspected fault) were identified by the electrical imaging on bedrock along the S-N direction. Results identified differential settlement resulting from incompetent subsoil materials and faulted bedrock as

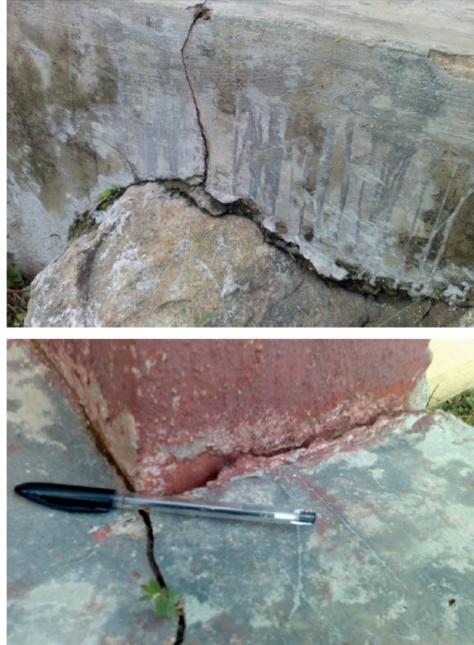
In order to ascertain the causes of such failure, which manifests as ground subsidence, major cracks and dislocation of the walls of a school building in south-western Nigeria (Fig. 1), a geophysical investigation involving the electrical resistivity method was therefore carried out with the aim of delineating geoelectric layer and their geoelectric parameters, mapping the soil corrosivity and identifying possible geologic structures such as fractures and faults that may be responsible for the structural failure of the building.

**Figure 1: Surface expression of the bedrock and effects on a major pillar**

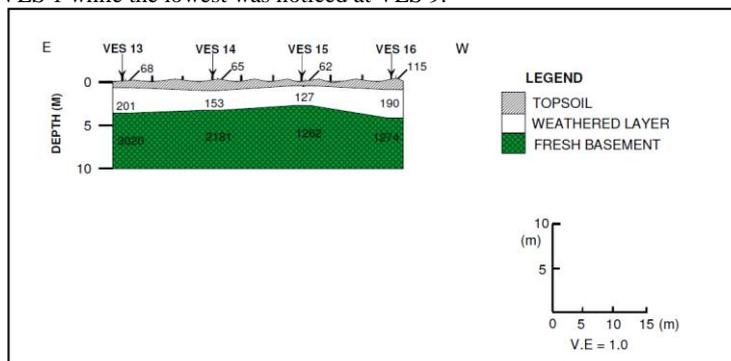
Figure 8: Geoelectric Section along E-W Direction

The geoelectric section along E-W direction (Fig. 8) identified three geoelectric/geologic subsurface layers comprising the clay/sandy clay topsoil (resistivity varies from 62 ohm-m to 115 ohm-m and thickness ranges from 0.6-1.5m); sandy clay/clayey sand weathered layer (resistivity varies from 127 to 201 ohm-m and thickness ranges from 1.5-2.6m) and fresh basement (resistivity varies from 1262 to 3020 ohm-m).

The depth to rock head ranges from 2.4m to 4.1m. The overburden is also generally thin but thinnest at VES 15 (2.4m) and thickest at VES 16 (4.1m). The bedrock relief gently dips down towards eastern flank (Left end), except for the significant basement depression noticed at VES 16 on the western flank (Right end).

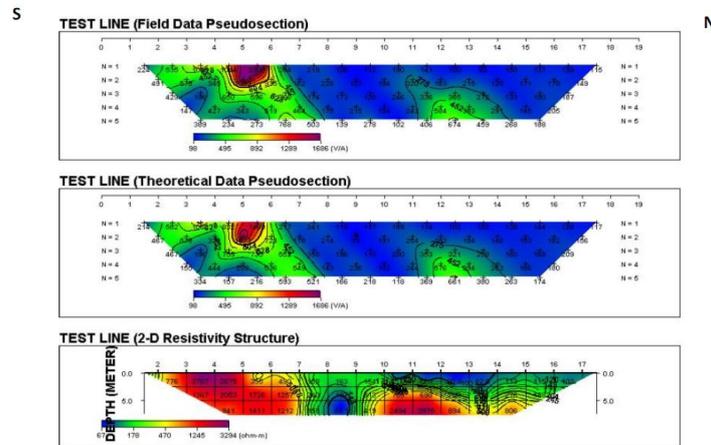
**Figure 9: 2-D Modeling of Dipole-dipole along S-N Direction**

The Dipole-Dipole pseudosections and the 2-D resistivity structure along S-N direction are shown in Fig. 9. The 2-D resistivity structure revealed three geologic layers; topsoil (blue colour), weathered layer (green colour) and the fresh basement rock (yellow and purple colour). The topsoil was subsumed into the weathered layer in many places due to its thickness. The bedrock was outcrop between stations 2 and 7. The bedrock shows two vertical discontinuities that are typical of linear structures along the S-N direction. The linear features are located between stations 7 and 10 and stations 12 and 14. The suspected linear structures are of significant depth extent (> 5m). The low resistivity zone between stations 7-10 (35-

50m) could be diagnostic of a suspected fault zone with a width of approximately 9m. The suspected fault zone falls within the extremely failed segment of the investigated building. The uneven nature of the bedrock was also revealed by the 2-D resistivity structure.

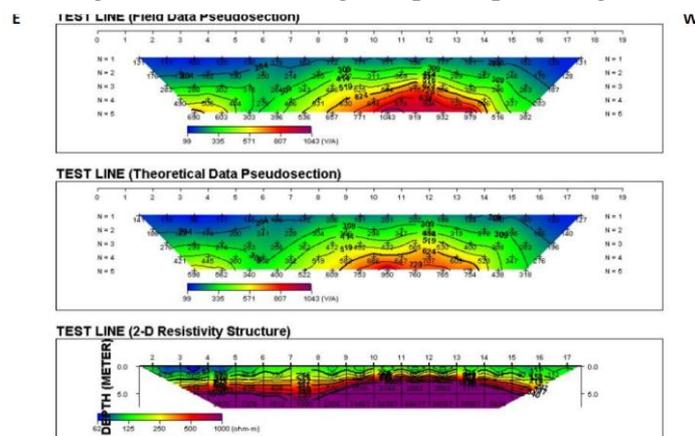
**Figure 10: 2-D Modeling of Dipole-dipole along E-W Direction**

Fig. 10 shows the Dipole-Dipole pseudosection (field and theoretical data) and 2-D resistivity structure along E-W direction. Three geologic layers were delineated by the resistivity structure. This includes topsoil (blue colour) which only appears between stations 2 and 5 and subsume into weathered layer along other stations due to its thinness; the weathered layer (green) and the basement bedrock. The relatively uneven nature of the bedrock along this direction is also revealed by the 2-D resistivity structure. There is no evidence of discontinuity within the bedrock typical of suspected fault.

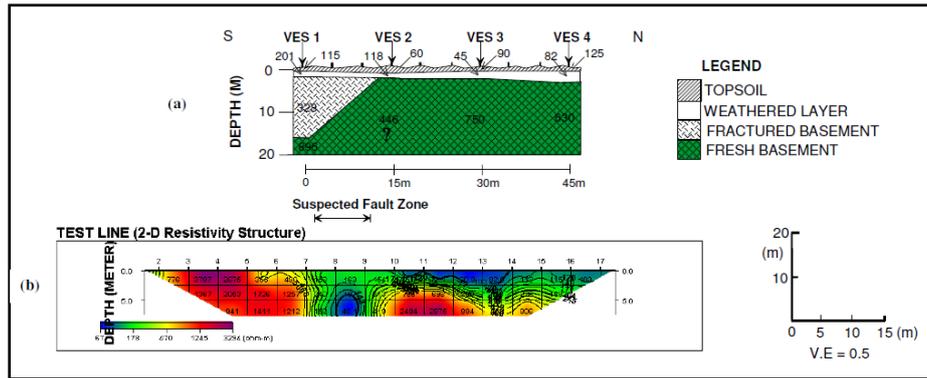
Figure 11: Correlation of Geoelectric Section and 2-D resistivity structure along S-N Direction

Along S-N direction traverse, both the topsoil and the weathered layer in the upper 0-2m are clayey (Fig. 11a and b). The basement relief is uneven and outcrop between stations 2 and 7 (Fig 11b). Both the geoelectric section (Fig. 11a) and the 2-D resistivity structure (Fig. 11b) shows that the basements are shallow along this direction. The identified linear feature between stations 7 and 10 (Suspected fault) (Fig. 11b) correlated with where a basement fracture is delineated by the geoelectric section (Fig.11a).

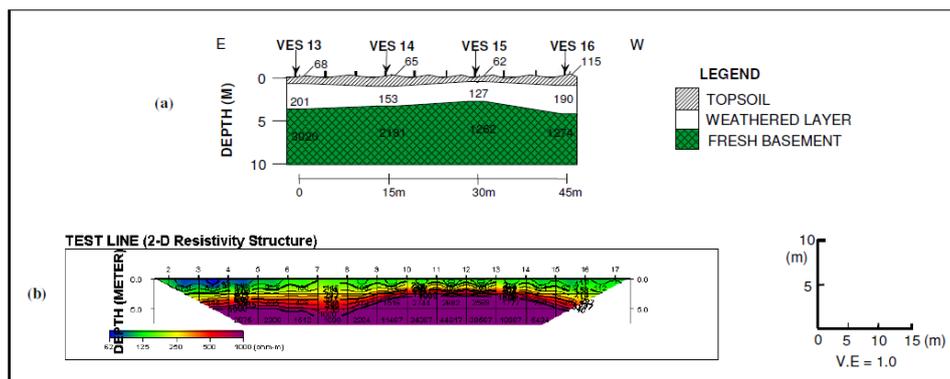
Figure 12: Correlation of Geoelectric Section and 2-D resistivity structure along E-W Direction.

The correlation of the geoelectric section and the 2-D resistivity along E-W direction are shown in Fig.12 (a and b). The upper 0-4m composed of clay/sandy clay/clayey sand, which are characterised by low resistivity values (Fig. 12a and b). The basement topography along the E-W direction is relatively even (Fig. 12a and b). The featurelessness (structurally) of the 2-D resistivity structure (Fig. 12b) are indications of a near homogeneous subsurface sequence (Fig 12a).
