Geo-electric Investigation of the Cause of Structural Failure Indices on a Set of Administrative Blocks

Abstract: *Electrical resistivity imaging has been employed to investigate the causes of structural failure related cracks on a set of administrative buildings in southwestern Nigeria. The goals were to determine the distribution of subsurface geologic lithologies beneath the set of buildings and therefrom infer the relative strengths of such lithologies. Data were collected along four geo-electric traverses using the ABEM1000 Terrameter unit. The dipole-dipole array was utilized with an electrode separation of 5 m. Observed field data were processed and inverted using a 2.5D finite-element modeling inversion algorithm. Results indicate that the northeastern half of the site is underlain by unweathered basement rocks overlain by thin (generally < 4 m) soil cover, while the southwestern region is dominated at depths beyond 4 m by low-resistivity water-saturated clays and some weathering tills. The clays apparently receive abundant supply of water from a seasonal stream channel adjacent to the westerly administrative blocks. The block presenting with the most damage has been built

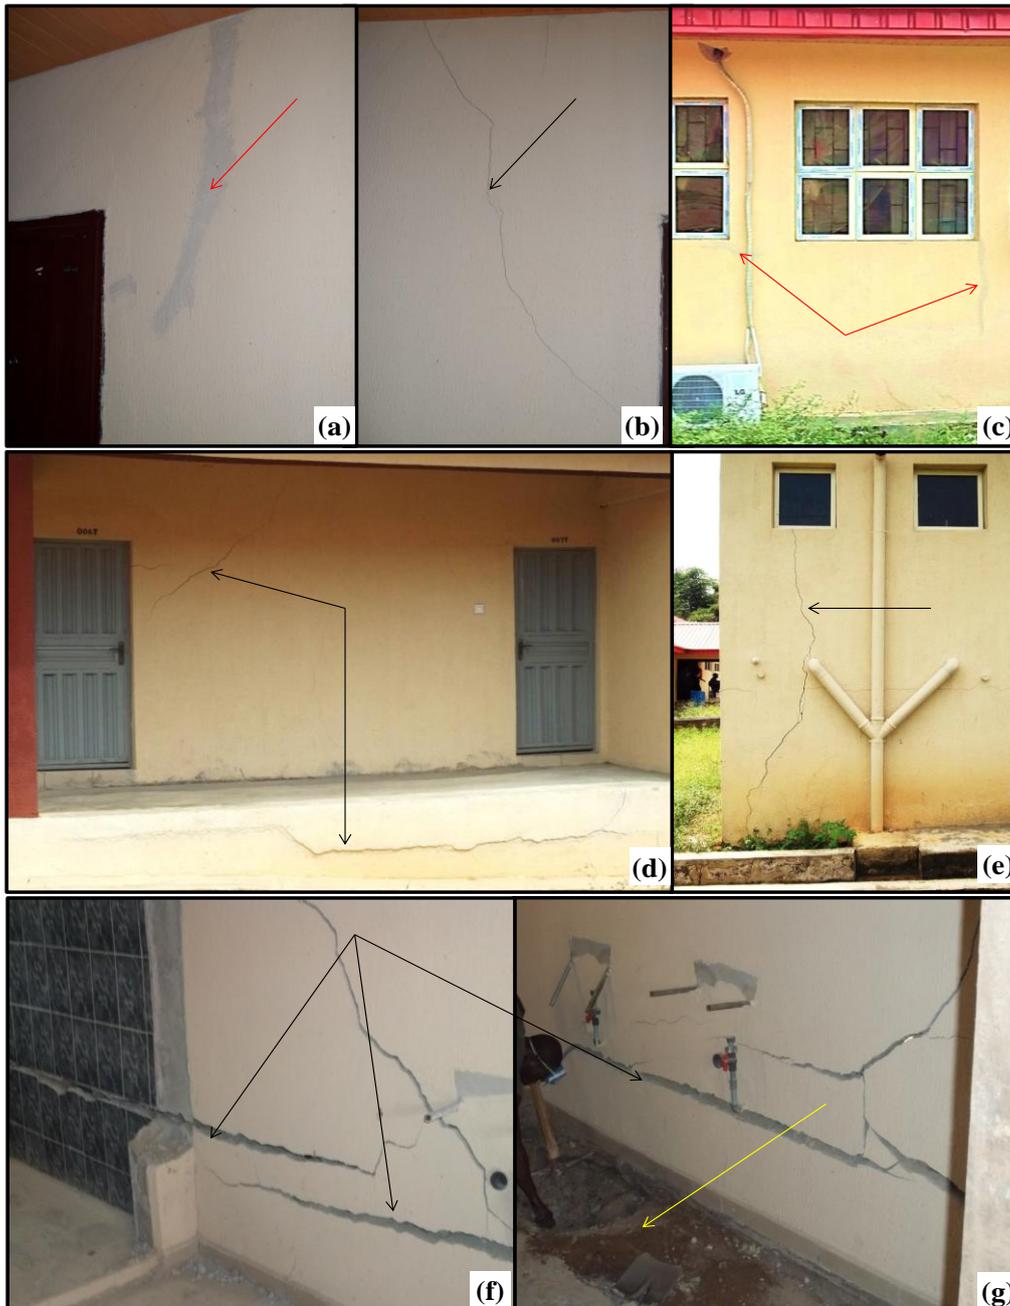
During a routine administrative visit to the U- complex in 2013, hair-line cracks were observed on the interior walls of the southern block (Fig. 2a and b) of southerly block of the complex. These cracks were observed to span from the side of the doorway to the ceiling and occurred on virtually all rooms north of the central corridor of the building. Further observations revealed similar cracks on window frames of the north-facing wall of the building, some of which had been repaired (Fig. 2c). More extensive cracks were observed on the southern end of the eastern block (Block 1), a section which houses conveniences attached to the building. The cracks were restricted to the southern end on this block and included long vertical and lateral hair-line cracks on doorway, floors and internal and external walls (Fig. 2d - f). In the interior of the conveniences section, failure signs further included a sunken floor (Fig. 2g). No cracks were observed on the western block (Block 2). Since the building was only recently constructed and commissioned for use in 2012 and the University management known to be keen on construction standards, initial suspicion was that the observed signs of failure were most probably related to differential settling of the building as a result of variation in the load bearing strengths of subsurface materials at the site. Therefore it was decided that a geo-electric survey of the site be undertaken to obtain insight into possible variations in subsurface material and plausible causes of the observed failure indices.

Fig. 2: Structural damage cracks on the U- complex buildings: (a) – (c) cracks on the interior and exterior walls of Block 3; (c) & (d) cracks on exterior walls of the conveniences of Block 1; and (f) & (g) lateral cracks and sunken floor in the interior of the conveniences of Block 1. Repaired cracks (red arrows); unrepaired cracks (black arrows) and sunken floor (yellow arrow)

vertical cracks have developed, and sections of the floor have begun to cave-in (Fig. 2f - g). This section is currently undergoing palliative repair measures. Block 3 apparently sits upon water saturated clays all through at depth, the clay section being thicker along the southern wall relative to the northern wall. Apparently, this building is also experiencing differential settlement. This explains the hair-line cracks which have developed on both its internal and external wall, particularly in doorways and on window frames. Block 2 possibly spans water saturated clays and deep weathering tills. The water saturated clays along this profile at depth is relatively narrower and deeply buried. This perhaps explains why this building is yet to develop any sign of foundation related failure. At least no visible cracks have been noticed on this block. Much cannot however be said of the future. As utilization progresses, it will be necessary to closely monitor this building for possible signs of distress.

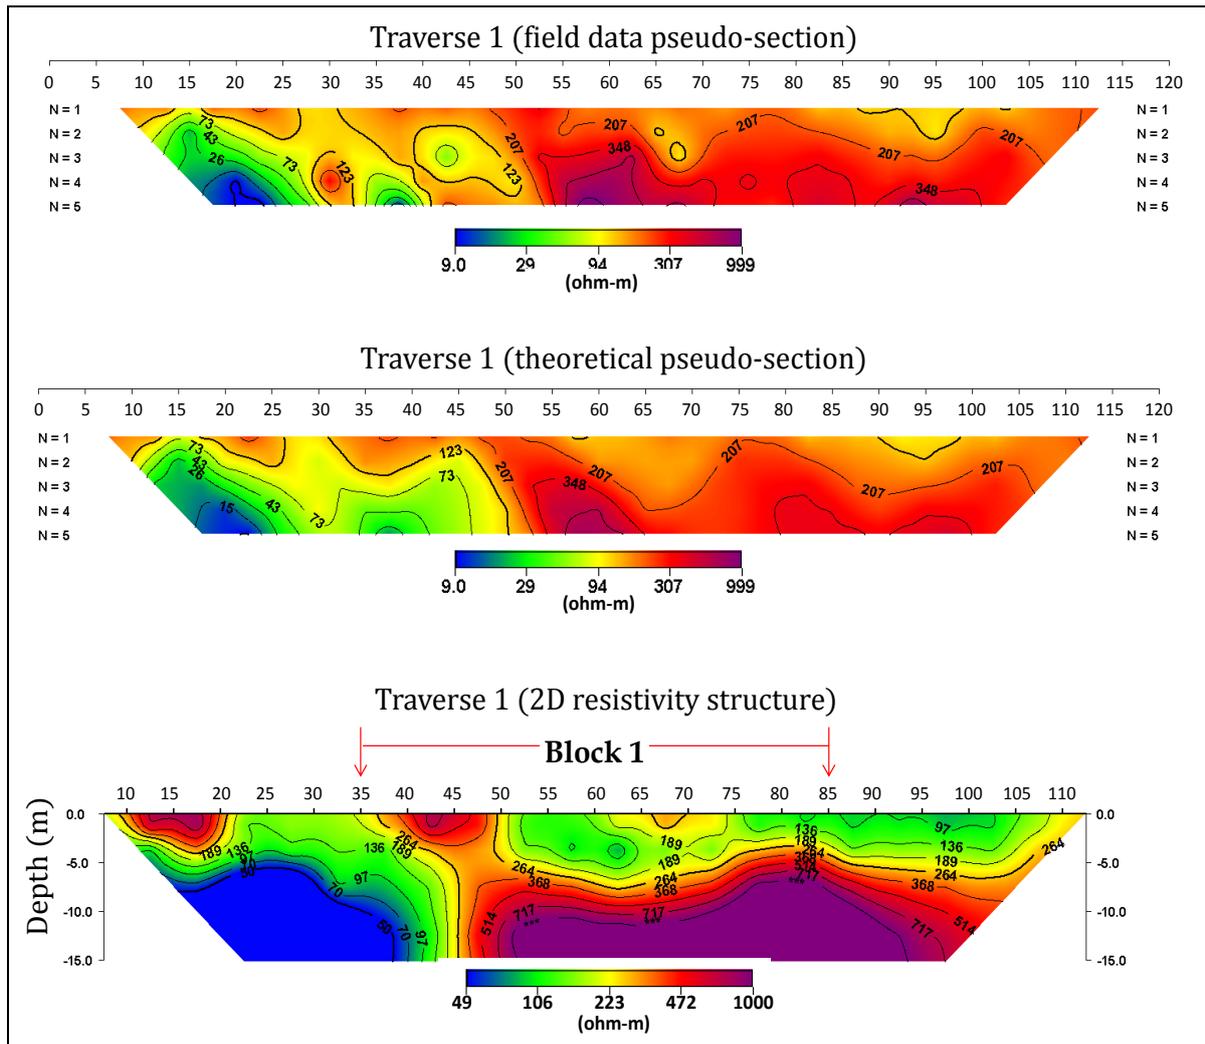
Fig. 3 presents a composite display which consists of three images; the observed field data pseudo-section, the computed theoretical data pseudo-section and the inverted 2D resistivity structure beneath Traverse 1 (Tr. 1) location. This traverse is 1.2 m east of the walls of the east block (Block 1) of the complex. The robustness of the inversion can be gauged by the level of similarity between the resistivity distribution patterns in the observed field data pseudo-section and the theoretical data pseudo-section.

Fig. 3: Composite pseudo-sections of the results of 2D resistivity inversion along Traverse 1; (a) Observed resistivity data (b) Computed resistivity distribution; and (c) Inverted resistivity structure. At depth Block 1 has been built over the southern edge of the high resistivity basement rock response onto low resistivity clays. The location of Block 1 is indicated in red arrows.

The subsurface resistivity distribution beneath the Tr. 1 indicates continuous low to moderate resistivity responses in the near-surface all-through the length of the profile. This resistivity pattern generally ranges from 100 – 250 Ohm-m. This pattern is punctuated along the profile at positions 9 – 22 m, 35 – 50 m, and 62 – 73 m by even higher resistivity responses sometimes in excess of 350 Ohm-m. This low to moderate resistivity response has an average thickness of 5 m. At portions which appear as troughs this response reaches depths in excess of 5 m. In the southern extreme of the profile, the response may reach depths of up to 8 m. This pattern is interpreted to represent the *insitu*-weathering topsoil at the survey site. This topsoil is capped by loose sands at the survey site. Higher resistivity sections within this pattern possibly indicate sections of the topsoil richer in clayey fractions which have dried-out due to the long dry season. Some of these clay-rich soils can be observed at locations on the surface within the site. At deeper levels for most of the profile, specifically from position 45 m till the northern limit of the profile, the resistivity response is dominated by very high resistivities. This response extends from an average depth of 5 m downwards and has consistently high resistivity values generally in excess of 300 Ohm-m. The upper limit of this response consists of two trough-like depressions each roughly 1.5 m deep. The southern limit of this response is vertical at about the 45 m mark. This response was interpreted as the un-weathered bedrock at the site. Further southwards at depth, there exists a dome-shaped very low resistivity response with resistivities generally lower than 80 Ohm-m. Vertically, this response extends from an average depth of 5 m downwards and laterally, it extends from the southern limit of the profile till a little beyond the 40 m mark. The contact between this very low resistivity response and the adjacent higher resistivity response is vertical and sharp. This response pattern was interpreted as one of two possibilities: (1) deep-weathering water saturated *in-situ* clays which have developed in trench-like depressions in the bedrock of

the area (Aminu, 2015); or (2) clay-filled subterranean fluid migrations paths created by fracturing of the bedrock. To the latter effect, it is instructive that the contact between this response pattern and the adjacent high resistivity response interpreted as un-weathered basement is vertical. Also, the rocks of the area have experienced at least two deformational episodes which have resulted in the creation of numerous fractures and minor folds [17].

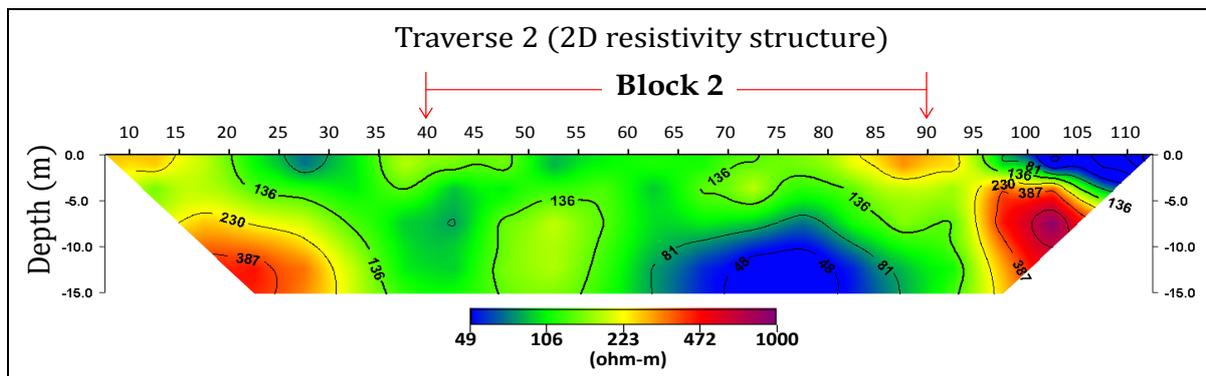
Fig. 4 is the inverted 2D resistivity structure beneath Traverse 2 (Tr. 2) location. This traverse is 1.2 m west of the walls of the west block (Block 2) of the complex and roughly 15 m east of the course of the seasonal stream in the area. The resistivity distribution beneath this profile is dominated by low to moderate resistivity responses in the range 80 -200 Ohm-m. It runs all-through the profile at shallow levels within the exception of locations 25 – 30 m and 98 m on to the northern limit of the profile. At these locations it is punctuated by very low resistivity near-surface materials with resistivities less than 80 Ohm-m. At depth in the profile, this response extends downward till the section limit between positions 30 and 95 m. In the interval 60 – 90 m it shallows and drapes down on a dome-like very low resistivity response. Lateral and vertical variations in the resistivity of this response are higher compared to that observed on Tr. 1. The resistivities are generally lower and vary over shorter distances and depth ranges. This response is again interpreted to represent the *in-situ* weathering topsoil at shallow levels and weathering remains of the original basement rock at the survey site at deeper levels. At either extremes of this profile, the response at depth consists of high resistivity values in excess of 230 Ohm-m. The northern segment of this high resistivity response occurs from a depth of about 2.5 m downwards. Its southerly limit is vertical while its upper limit dips towards the north. This dip possibly indicates of the presence of a trough-like depression similar to that observed in Tr. 1. The upper limit of the southern segment of this response occurs at a deeper level, from roughly 6 m downwards and is convex towards the surface (dome-like). This response is also interpreted as the un-weathered bedrock within the area. A third response occurs at depth from 60 m to 90 m along the profile. This pattern is a very low resistivity signature with values generally less than 82 Ohm-m. Its shallowest point is at 77 m where it extends from 5 m depth downwards. Its upper limit dips downwards on both sides of this peak forming a dome-like structure. This signature is further interpreted to represent either of the two possibilities suggested for the dome-like very low resistivity pattern on Tr. 1; in-situ clays filling weathering trenches or fracture subterranean fluid migration pathways.

Fig. 4: Inverted 2D resistivity structure beneath Traverse 2. The traverse is dominated by moderate resistivity responses with the exceptions of the southern and northern limit where it presents with high resistivity responses and the dome shaped low resistivity response between positions 60 m and 87 along the traverse. Block 2 at depth straddles moderate and low resistivities at depth

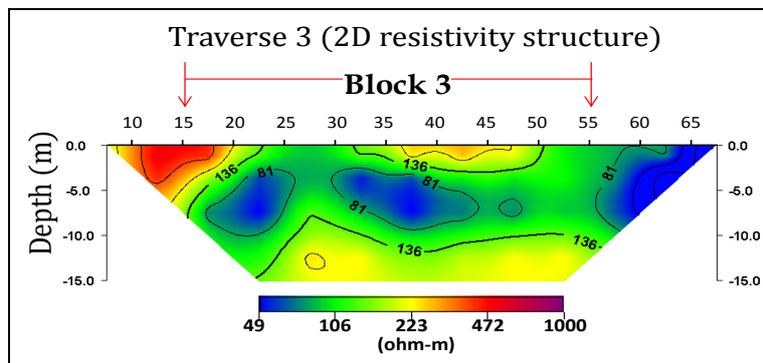
Fig. 5 is the inverted 2D resistivity structure beneath Traverse 3 (Tr. 3) location. This traverse straddles east to west at a distance 1.2 m north of the front wall of the south block (Block 3) of the complex. In the shallow near-surface section of Tr.3, very low resistivity responses are dominant. This response exists as a laterally continuous pattern with its upper and lower limits undulating severely and paralleling one another for almost the entire profile. The response value is generally less than 82 Ohm-m. The upper limit of this response reaches to the surface from 25 – 30 m and from 55 m to the western limit of the profile. For most of the profile the upper limit is at a depth of 3 – 4 m but reaches to 6 m towards its eastern limit. The average thickness of this response is 7 m. This response is interpreted to represent deep-weathering water saturated *in-situ* clays in the area. This pattern is capped between position 30 m and 55 m along the profile by moderate resistivity responses (130 – 250 Ohm-m) which likely represent surficial topsoil at the site. In the eastern extreme of the profile, a wedge of high resistivity responses extends from the surface till a depth beyond 6 m. This response possibly represents dried-out clay-rich fractions of the topsoil at the site. At depths generally in excess of 10 m along the profile, moderate resistivity responses with resistivities in the range 130 – 250 Ohm-m dominate. The response is continuous and its upper surface undulates rapidly. Its undulation has likely informed the undulation of the

shallower low resistivity signature above it and could indicate rapid variations in weathering resistance of the original basement rock beneath the profile. This pattern is here interpreted to represent the weathered basement rock at the site. The bedrock along this profile has apparently experienced deeper weathering than along Tr. 1.

Fig. 5: Inverted 2D resistivity structure beneath Traverse 3. Undulations of the moderate and low resistivity patterns possibly indicate lateral variations in resistance to weathering of the original basement rock. Block 3 straddles low resistivity responses at depth.

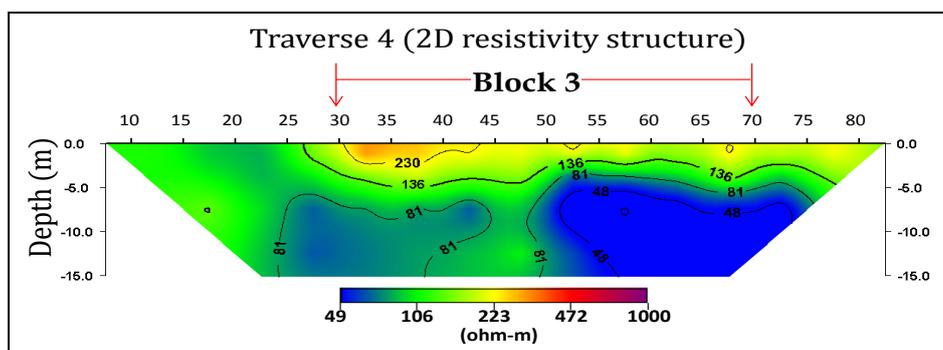
Fig. 6 is the inverted 2D resistivity structure beneath Traverse 4 (Tr. 4) location. This traverse straddles east to west at a distance 1.2 m south of the rear wall of the south block (Block 3) of the complex. At depth, profile Tr. 4 is dominated by very low resistivity response (< 82 Ohm-m) patterns. The exceptions are two signatures of slightly higher resistivities just above 100 Ohm-m. The first is in the eastern extreme of the profile while the second vertically segments the very low resistivity response pattern in two. Both segments of the low resistivity response pattern have upper surfaces which are slightly depressed forming troughs. The western segment extends from an average depth of 4 m downwards while the eastern segment has an average upper limit 6 m beneath the ground surface. The eastern segment further extends to the surface between positions 15 m and 25 m. This low resistivity response is once again interpreted at deep-weathering clays at the site. In the near-surface interval, moderate resistivity responses exist nearly all-through the profile. This response pattern possesses resistivities in the range 130 – 250 Ohm-m and has an average thickness of 4 m. It drapes downwards above the low resistivity responses filling troughs on their upper limits. This response pattern is absent between positions 15 m and 25 m where it has been replaced by the upward extension of the low resistivity pattern. This pattern is interpreted as the surficial topsoil at the site.

Fig. 6: Inverted 2D resistivity structure beneath Traverse 4. The low resistivity response pattern along the southern wall of Block 3 is much thicker and extends vertically from an average depth of 4 m till the limit of the section. Its upper limit also undulates similarly to that on Traverse 3.

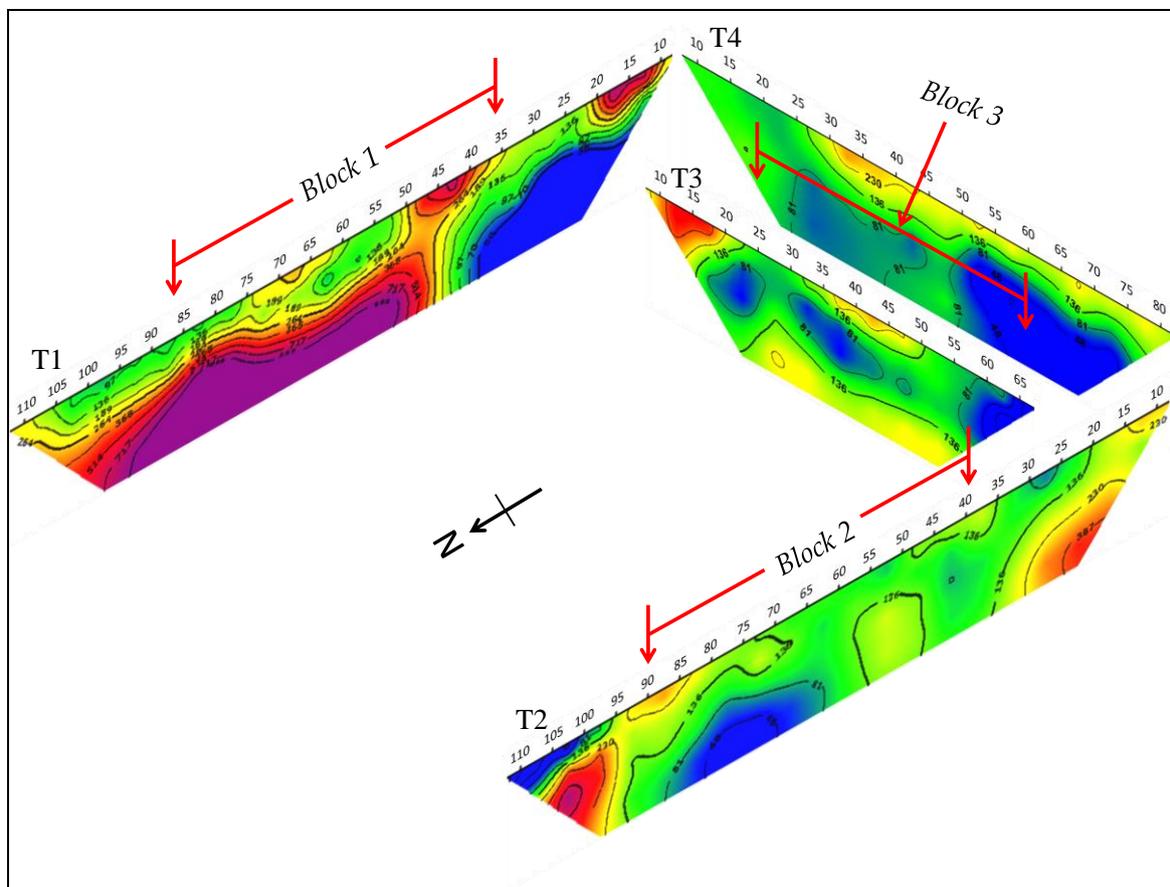
The 2D inverted resistivity sections obtained for the surveys were arranged into a composite fence diagram to give a pseudo-3D representation of the subsurface electrical property distribution at the survey site (Fig. 7). It is likely that the high resistivity responses are continuous in the subsurface between Tr. 1 and the northern section of Tr. 2. In such a case, the survey site to the north and northeastern section would be underlain by the un-weathered basement rocks of the area. To the south and southwest, low resistivity deep-weathering water clays would generally predominate at depths in excess of 4 m. The exception could be in the southwest extreme of the area. The water saturated clays apparently emerge onto the site through a relatively narrow dome-shaped tunnel path in the west imaged along Tr. 2. This area adjoins the path of the seasonal stream

running N-S across the site. The water saturated clay response thereafter apparently fans out in a funnel-shaped fashion in the southeasterly direction. The morphology of the clay body changes rapidly. Along Tr. 2, the response extends from about 5 m from the surface to depths in excess of 15 m. Further south at Tr. 3, the response thins to about 7 m with its upper and lower limits undulating rapidly. Average depth range of its upper surface for most of the traverse is 3 – 4 m while its lower surface grades downwards into relatively more weathering resistant remains of the basement rocks. Further south at Tr. 4, the thickness of the clays increases considerably. Its upper limit averages a depth of 5 m from the surface and the response extends beyond the vertical limit of the section. This rapid variation in thickness could be related to variations in resistance to weathering of the original basement rocks of the area. Alternately, if the troughs have originated from fracture induced preferential weathering, the variations could be a reflection of the degree of fracturing that have generated these deep weathering sections and may also be the result of the amount of fluids such paths channel in the subsurface [8]. Whether the troughs are fracture induced or not has not been ascertained in this study. However, it is noteworthy, that the southern limits of the un-weathered basement at the site are vertical in the inverted resistivity sections, particularly on Tr. 1. This could be an indication of a fracture related origin. Also, the upper surface of the basement response on Tr. 1 in the proximity of this vertical basement scarp, presents as a concave upward trench. Similar near-scarp trenches have been reported in proximity to subsurface fracture induced basement scarps [8].

Fig. 7: Composite fence plot of all three traverses. In the northeastern sections, the site is dominated by high resistivity responses. The low resistivity response (blue) appears to emerge unto the site through a dome-shaped submerged section towards the northern end of Traverse 2 but quickly fans out covering most of the southern parts of the site. Refer to figure 1 for actual spatial separation between traverse.

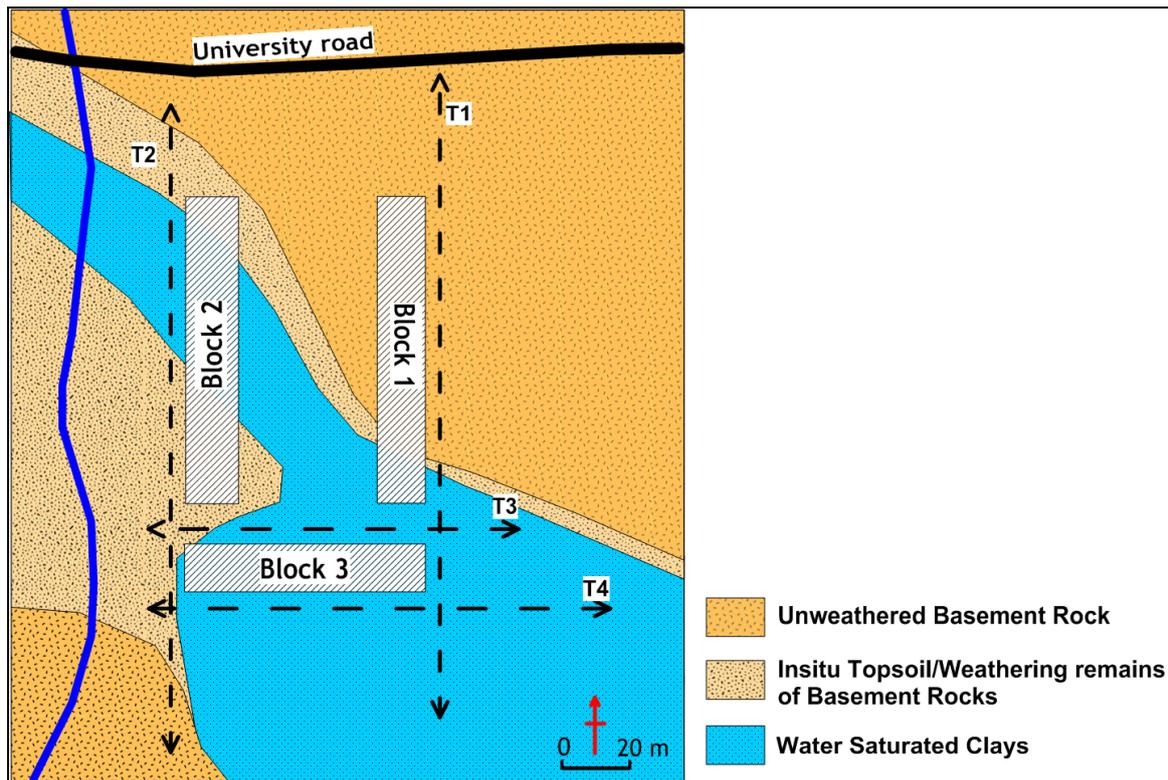
Fig. 8 is the superposition of the field site layout upon the derived conceptual model of the subsurface at the survey location for an average depth beneath the surface of 5 m. For most of the site, the eastern administrative block of the complex sits upon basement rocks at depth, however, its southernmost end has been built across a vertical scarp-edge of the basement onto water saturated clays at depth. This has apparently informed a cantilever-style differential settlement of the building between the northern section which lies on thin topsoil above basement rocks and the southern section which lies at depth on water saturated clays. This is indicated by extensive hair-line cracks which have developed on the external walls and corridor pavements of the building. In the interior of this section which houses conveniences attached to the building, wide lateral and

Fig. 8: Conceptual subsurface model of the study area at an approximate depth of 6 m beneath the ground surface. Block 1 has been built over the edge of the un-weathered basement onto inferred water saturated clays leading to differential settling of the conveniences section of building and the resulting damage. Block 3 sits at depth entirely on water saturated clays with differential settling resulting from difference in thickness of the clays along its north facing and south facing walls.
