Geophysical Investigations of a Pavement Failure Along Akure-Ijare Road, Southwestern Nigeria

Abstract: Geophysical investigations were carried out along two failed segments of Akure-Ijare road, named locality 1 and locality 2, with the aim of establishing the cause(s) of the incessant pavement failure along the road. The geophysical investigations involved the Very Low Frequency Electromagnetic (VLF-EM) and Electrical Resistivity Methods. The VLF-EM measurements were taken at intervals of 10 m along traverses parallel to road pavements. Two techniques were adopted for the electrical resistivity method namely: the vertical electrical sounding (VES) and a combination of horizontal profiling and sounding using dipole-dipole configuration with inter stations separation (a) of 5 m and an expansion factor (n) that varies from 1 to 5. The Schlumberger configuration was used for the VES with $AB/2$ varying from 1 to 65 m. Nine (9) and twelve (12) VES were carried out at localities 1 and 2 respectively. The VLF-EM method revealed that the road pavement is founded on a weakly conductive material devoid of major geological structure. The Vertical electrical sounding curves range from A, H t

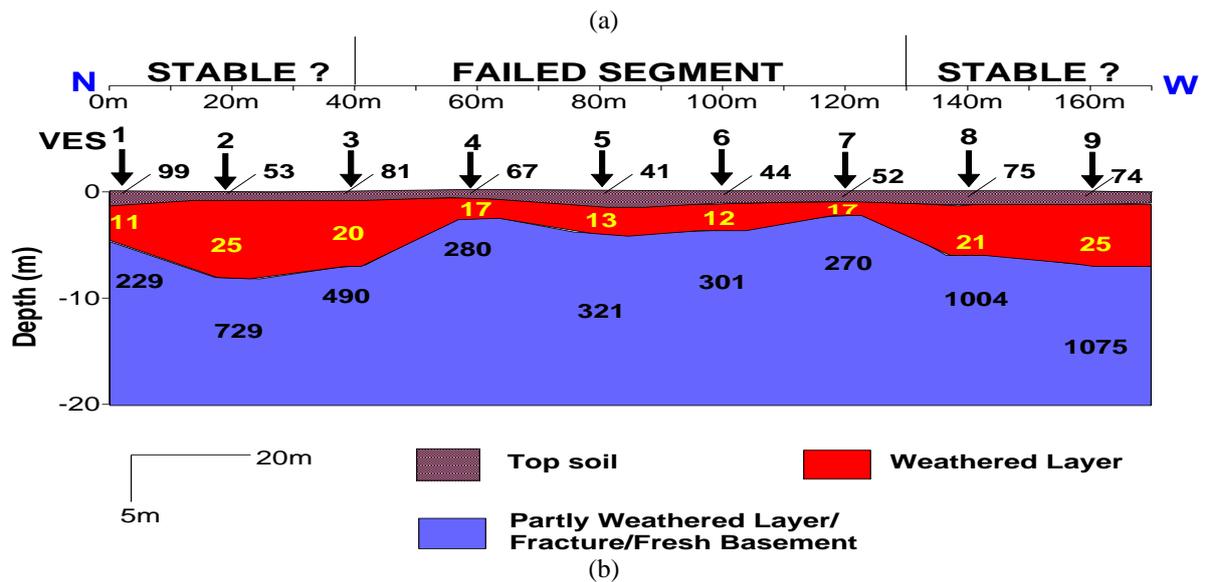
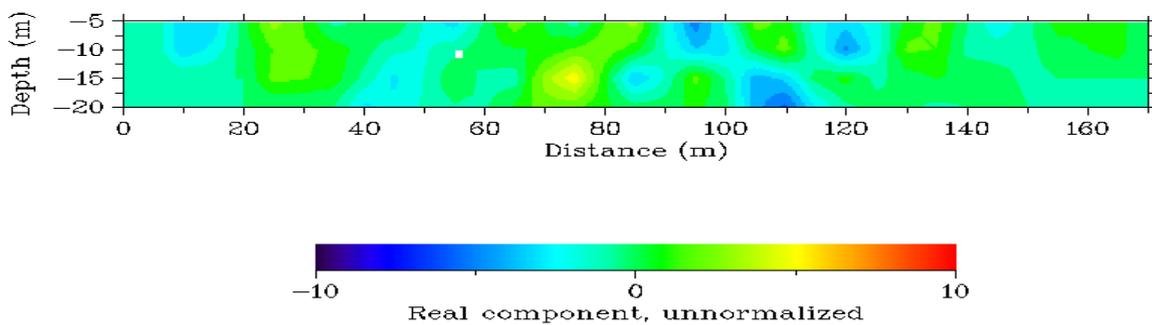
At locality 1, both the topsoil and the subsoil (weathered layer) in the upper 0 - 5 m are clayey within the failed and the classified stable segments on both flanks “Fig. 8a and 8c”. The 2-D resistivity structure correlates well with the geoelectric section displayed in “Fig. 8a”. The 2-D resistivity structure shows evidence of basement depression at distance between 35 and 45, 55 and 70 m and 110 and 125 m. As revealed by the resistivity structure, the bedrock topography is uneven “Fig. 8a and 8c”.

The VLF-EM 2-D model “Fig. 8b” identified weakly conductive (faint-yellow colour) targets typical of clay material or possible linear features with pockets of fairly resistive material (blue colour) as shown on model. Their depth extents are generally within the upper 20 m on both the classified stable? and the failed segment. However, the 2-D resistivity structure shows some discontinuities in the basement such as fracture/fault, lithological contact e.t.c. that can act as a weak zones, which might have resulted to the failure of the road between distances 35 and 45 m, 55 and 65 m, and 113 and 127 m. The locations of these geological features are generally within the failed segment.

The overburden thickness along the failed segment is generally very thin. From the above it can be concluded that, both the failed and the classified stable? segments are founded on topsoil/subsoil of very low resistivity (< 100 Ω-m) which is typically clay, and both segments contain geological features such as fractures, faults, lithological contact e.t.c which are zones of weakness that may increase porosity and fluid permeability of the subsoil and hence decrease the engineering capability of the road pavement. Therefore road pavement failure at this locality may have been precipitated by the incompetent clayey topsoil/subsoil, geological features and thin over and thin overburden thickness.

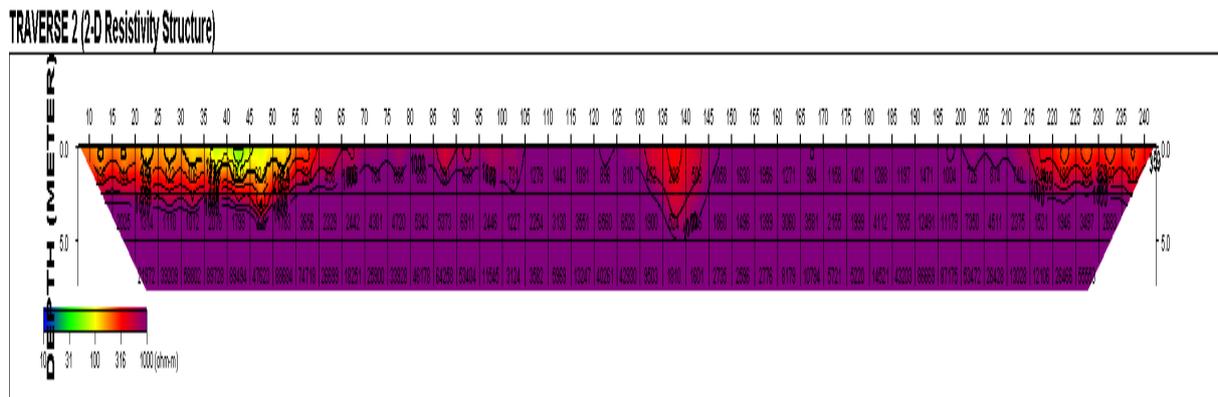
(c)
Figure 9: (a) Geoelectric Section, (b) 2-D Inversion Model and (c) 2-D Dipole-Dipole Resistivity Structure at Location 2.

At locality 2, both the topsoil and the weathered layer in the upper 0-3 m are composed of clay, sandy clay, clayey sand and laterite beneath the failed and the classified stable? segments “Fig. 9a and Fig. 9c”. This indicates high degree of heterogeneity in the upper layer. The geoelectric section and the 2-D resistivity structure confirm the shallow nature of the basement bedrock (generally less than 2 m) along the failed segment of the road compared to the classified stable? segments which shows an appreciable overburden thickness (generally greater than 2 m) at both flanks. However, the geoelectric, 2-D VLF-EM model and 2-D resistivity show no indication of geological features such as fractures/faults and lithological contacts in the bedrock, but the bedrock mostly outcrop along the failed segment.

The failure at this locality may have been precipitated by the heterogeneity and clayey nature of the upper layer. Also, lack of proper drainage at the road embankment and poor construction material may have enhance the failure at this locality since the road is expected to be stable due to shallow nature of the bedrock.
