## **Geoelectrical Investigation of a Failed Portion of Ajaokuta-Itobe Road, North-Central Nigeria.**

**Abstract:** A Geoelectrical investigation was carried out along a segment of the Ajaokuta- Itobe highway in Kogi State, North-Central Nigeria with the aim of establishing the cause(s) of the failure of that portion of the road. Vertical Electrical Sounding (VES) involving the Schlumberger array and 2-D imaging using the dipole-dipole configuration were both utilized along a 200m traverse established parallel to the road covering both the stable and failed portions. Four subsurface geologic layers were inferred from the result of the 2D imagine. A topsoil with resistivity values ranging from 42Ωm to 84.4Ωm, weathered layer with very low resistivity values from 14.7Ωm to 38Ωm, fractured basement (Resistivity varying between 92.1Ωm to 227Ωm) and the fresh basement with resistivity value as high as 2440Ωm. The curve types identified from the interpretation of the Vertical electrical Sounding were HA, AA, HA, and A type, with the number of layers delineated by the geoelectric section being four (4). The topsoil (sandy clay) for the first three (3) VES points have resistivity values o

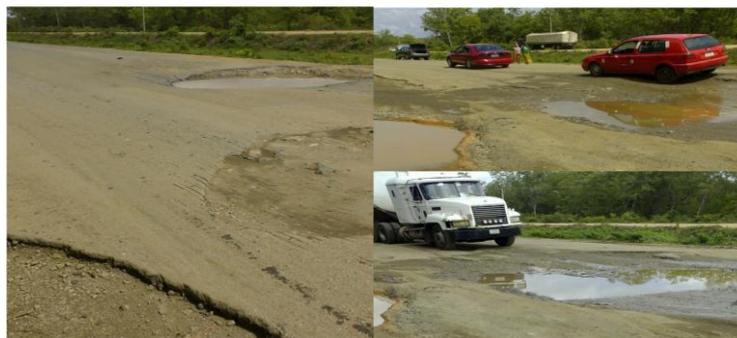
**Figure 2.0** Failed portions of Ajaokuta-Itoke Road.

Following a preliminary site visitation that enabled survey planning and geologic mapping, an approximately NW – SE Traverse of over 200m was established parallel to the road pavement, and was made to cut across the stable and the failed segment of the road (Figure 2.0). Electrical resistivity method involving Vertical Electrical Sounding (employing Schlumberger array) and 2-D electrical imaging (utilizing dipole-dipole configuration) was then used for the geophysical investigation. For the 2-D resistivity image, an inter-electrode spacing of 5m was adopted while inter-dipole expansion factor ( $n$ ) was varied from 1 to 5. The dipole-dipole data was inverted using the DIPRO software and the result was presented as pseudosections. Four Sounding stations were established at 15m, 85m, 115m and 170m as informed by the interpretation of the 2-D image (4.0). The apparent resistivity values which were obtained at current electrode spacing ( $AB/2$ ) ranging from 1 to 65m were plotted against the electrode spacing ( $AB/2$ ) on bi-logarithmic graph sheets. Partial curve matching was carried out and this was followed by 1-D forward modeling using WinResist geophysical software version 1.0 (Vander Velpen, 1988). The result of the VES interpretation was further used for the construction of geoelectric sections along the traverse.

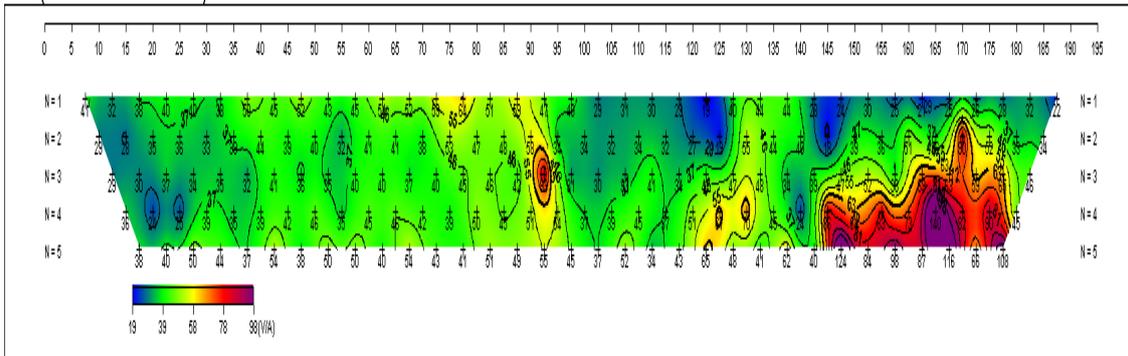
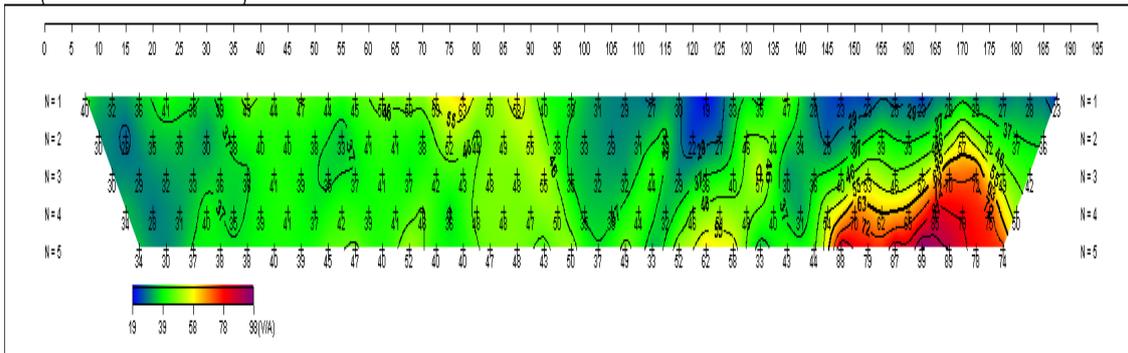
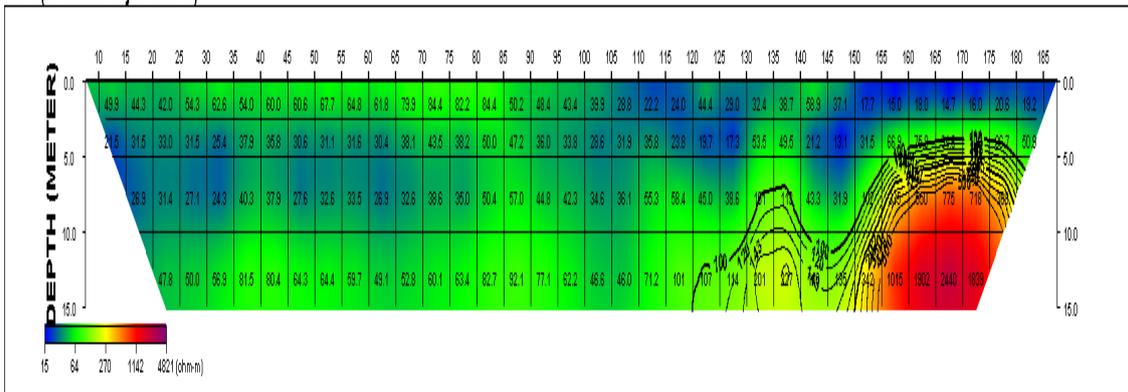
**Figure 3.0** The inversion model of traverse:(A) Field Data Pseudo section (B) Theoretical Data Pseudo section (C) 2-D resistivity structure

Figure 3.0 shows the pseudosection generated for the acquired 2-D resistivity imaging. Four subsurface geologic layers can be inferred from the result of the 2D imagine. A topsoil with resistivity values ranging from 42Ωm to 84.4Ωm, weathered layer with very low resistivity values from 14.7Ωm to 38Ωm, fractured basement (Resistivity varying between 92.1Ωm to 227Ωm) and the fresh basement with resistivity value as high as 2440Ωm.

The topsoil which is probably sandy clay varies in thickness from the failed portion of the road to the stable portion. At the stable portion (a distance between 25m and 90m), this topsoil is about 2.5m thick whereas; at the failed portion (between 90m and 190m) the very low resistivity along this path is closely related to the weathered layer which indicate that the topsoil have probably been washed away by erosion along this area or is merged with the weathered layer.

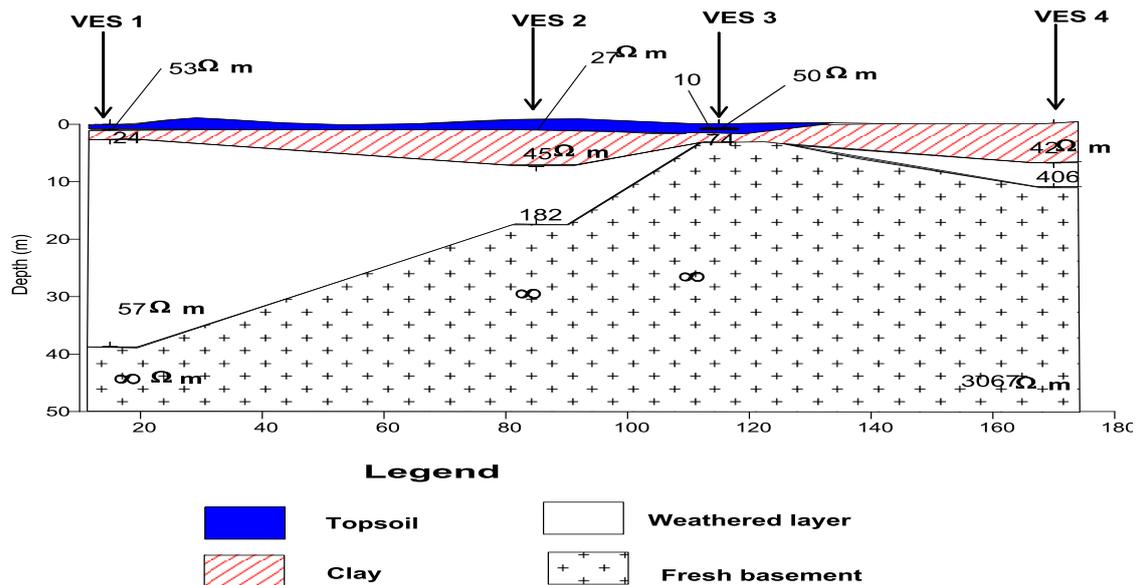
**Figure6.0:** Geoelectric section along the established traverse.

The interpreted VES curves obtained from the study area is summarized as shown in table 1.0. The curve types identified include HA, AA, HA, and A type, with the number of layers delineated by the geoelectric section being four (4) (Fig 6.0). The topsoil (sandy clay) for the first three (3) VES points have resistivity values of  $54\Omega\text{m}$ ,  $27\Omega\text{m}$  and  $50\Omega\text{m}$  with thickness of 0.9m, 0.9m and 0.7m respectively. For the fourth VES point, the topsoil has been replaced by the weathered layer with resistivity value of  $42\Omega\text{m}$  and thickness of 6.7m. The second layer (clay) has resistivity values ranging from  $10\Omega\text{m}$  to  $45\Omega\text{m}$  and its thickness is in the range of 2 to 7m. The third layer delineated with resistivity values of  $57\Omega\text{m}$ ,  $182\Omega\text{m}$ ,  $74\Omega\text{m}$  and  $406\Omega\text{m}$  (which is the weathered basement) is very thick at VES point 1(36m) but almost disappears at VES point 3. Its thickness at VES points 2 and 4 are 10m and 4.4m respectively. The fourth layer having resistivity values between  $406\Omega\text{m}$  and infinity represents the fresh basement rock.

The interpretation of the 2D resistivity imaging as well as the geoelectric section generated from the VES shows that the failed portion of the road is underlain by a low resistivity material (probably clayey sand) with the clay layer making it to the surface at some points. Whereas, the subsurface soil beneath a stable highway pavement is expected to possess sufficient strength to enable it support the load imposed on it. Unfortunately clay cannot be described as a competent material because; though it is highly porous, it is less permeable owing to poor connectivity of its pores; it will therefore expand and retain water easily but will collapse if exposed to sufficient pressure from the weight of vehicles. This repeated expansion and collapse is inimical to road construction and will eventually lead to road failure. It is therefore clear from the interpreted results that, a possible cause of the failure is the presence of Clay and even the clayey nature of the topsoil on which the road pavement is founded. Another possible cause is the closeness of the weathered layer to the surface since these is also an incompetent material. Finally, the presence of near surface linear features such as faults, fractured zones, fissures and joints may have contributed to the failure however; a more detailed geophysical investigation will be needed to draw such a conclusion. It is recommended therefore that a lasting repair or construction may be done by cutting to a depth beyond the incompetent materials and filling with more competent materials like laterite or concrete.
