Esthetic Rehabilitation of Ellis Class VIII Fracture in 14 Year Old Patient- A Clinical Case Report

Case description: Here, a case of complicated crown fracture of tooth number 11 and 21 in a 14 year old boy is presented. Ellis class VIII fracture tooth was restored with conservative approach of root canal treatment followed by prosthetic treatment by post and core and Porcelain Fused to Metal crown. The patient was asymptomatic clinically and radiographically after 3 months follow up.

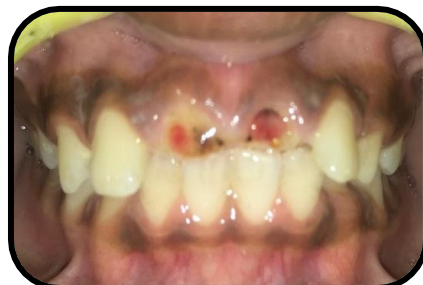
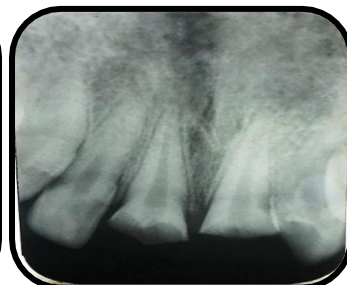
Fig. 1

A 14 years old Male patient accompanied by his mother reported to the Department of Pedodontics and Preventive Dentistry; Himachal Dental College, Sundernagar, Himachal Pradesh, with a chief complaint of broken anterior teeth following trauma since 1 week along with worn out teeth in mouth (fig 1 & fig. 2). Detailed history revealed that the patient had fallen from desk while playing during school hours and was associated with pain and swelling in the maxillary anterior region. Pain was dull and continuous in nature that subsided on taking medication whereas swelling was diffuse and limited to the upper front region of the lip. On clinical examination, his both maxillary central incisors(11, 21) were diagnosed as complicated crown fracture (WHO Classification)

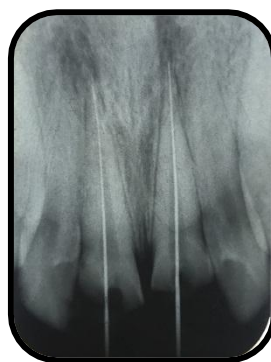
Fig. 3

Following isolation with rubber dam, Access opening was carried out using no. 4 round bur (dentsply, maillefer) and canal orifices were located along with working length determination with Apex locator (Propex, Dentsply) with respect to 11 and 21 (fig. 3) and pulp was extirpated. The shaping of the canal was done using modified crown down technique with nickel titanium rotary files - Pro Taper Gold. The orifices and the coronal parts are prepared with S_x files, coronal and middle third of canals were shaped with shaping files S₁ and S₂, and the apical portion of the canal with F₁ and F₂ files. The solution of 1% NaOCL in combination with 17% EDTA was used for rinsing. After finishing the preparation and drying the canal, obturation was done using lateral condensation technique with F₂ gutta-percha cone with respect to 11 and 21 (Fig. 4) followed by composite buildup (Fig. 5). After 1 week, the post space was prepared in 11 and 21 using Gates Glidden drills (no. 3), leaving 4-6 mm of gutta-percha at the apical third of both teeth (Fig. 6&7). Fibre post (Tenax, ParaPost) was then trimmed according to adequate length. It was used to strengthen the teeth, as they are more aesthetic and lessens the chances of teeth fracture. The dual core resin (Coltene, ParaCore) was used to cement the post and core build up. Crown preparation was done with respect to 11 and 21(Fig. 8) and Impression was made in putty and Porcelain Fused to Metal crowns were given. (Fig. 9).

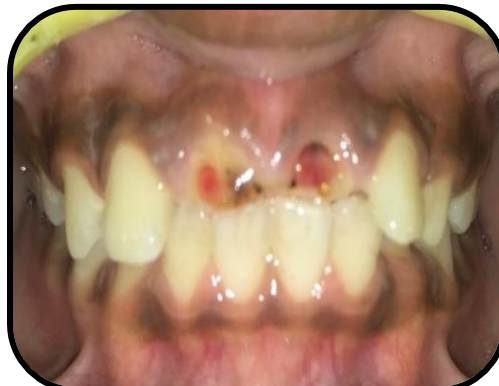
Pre operative

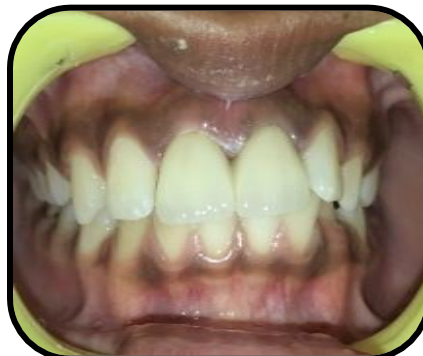
Post operative
