Preliminary Investigation Of Road Failure In Parts Of Ogbia Local Government Area, Bayelsa State, Nigeria Using Electrical Resistivity Imaging

Abraham, B.O. And Ibe, S.O.

(Department Of Physics, Federal University Otuoke, Bayelsa State, Nigeria)

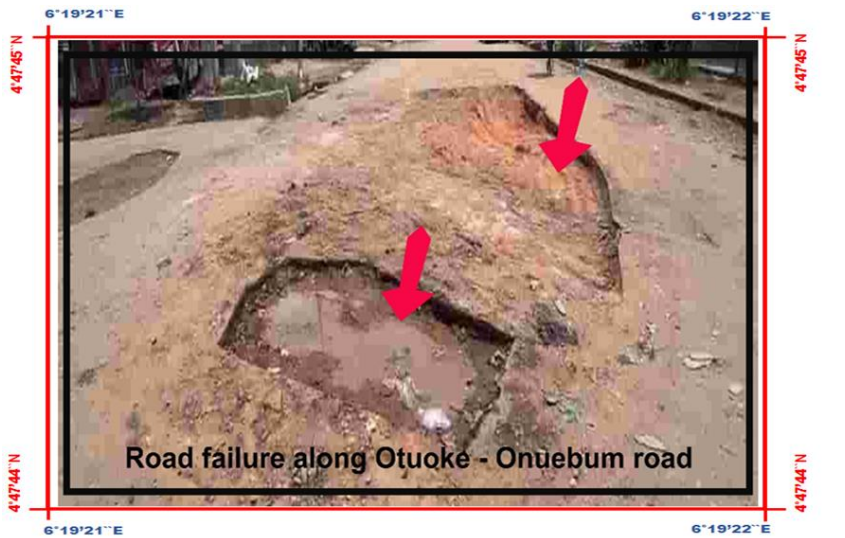
Figure 2: Image of failed portion of Otuoke – Onuebum road.

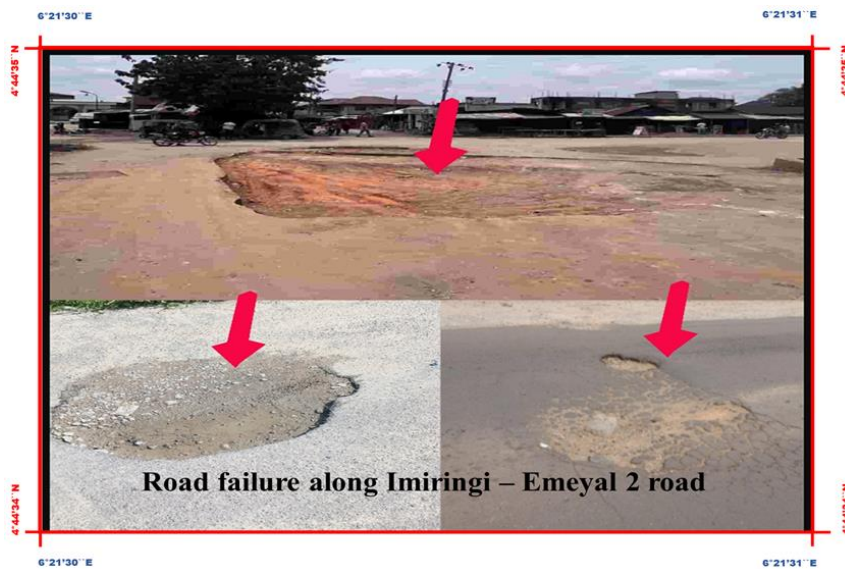
Figure 3: Image of failed portion of Imiringi – Emeyal 2 road

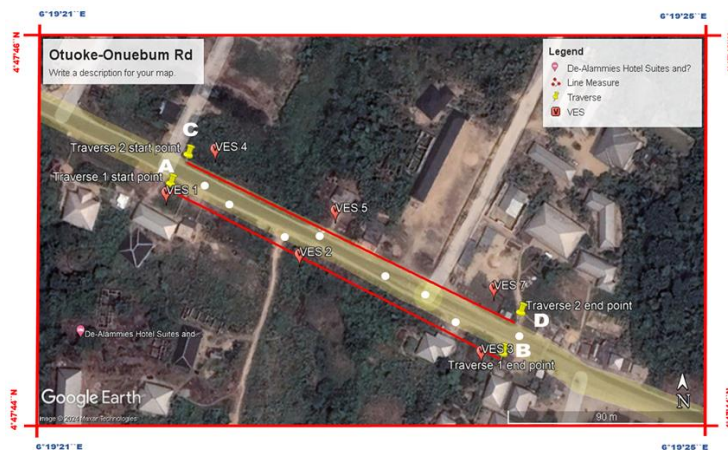
Figure 4: Google map of the study area showing Profiles where Data were collected along Otuoke - Onuebum Road.
