Management of Crown Dilaceration Using Natural Tooth Pontic: A Case Report

Abstract: Dilaceration of permanent teeth usually is a consequence of traumatic injuries to the primary teeth. Although it may appear anywhere along the long axis of the tooth, i.e., crown, cemento-enamel junction, or root, most often the root is involved. Crown dilacerations, however, is a rare condition representing 3% of the total injuries. The presence of such teeth in the aesthetic zone is often distressing for the patient, socially and psychologically, thereby seeking early intervention. This article describes the immediate replacement of a dilacerated permanent mandibular left central incisor using a fiber-composite resin splint (FRC-Ribbon) with the natural tooth crown as pontic following surgical extraction of the dilacerated tooth.

The present case report describes aesthetic and restorative treatment of a permanent mandibular left central incisor with crown-root dilaceration using a fiber-composite resin splint with the natural tooth crown as pontic following surgical extraction of the concerned tooth.

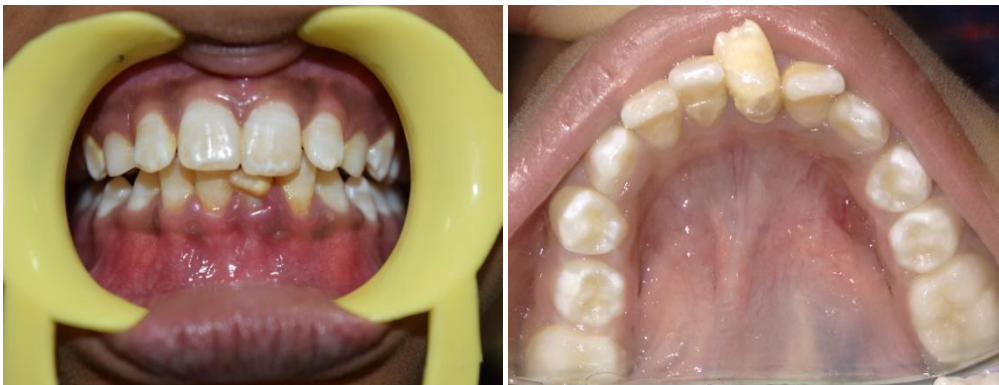
A 12 year old male autistic patient reported to the Department of Pediatric Dentistry, at Post Graduate Institute of Dental Sciences, Rohtak with the chief complaint of impingement of lower lip due to malformed lower left front tooth and wanted extraction of the same. Intra-oral examination revealed angulation with respect to crown portion of lower left permanent central incisor in labial direction suggestive of dilaceration (Figure 1 (a) and (b): Pre-operative view showing dilacerated crown of left mandibular central incisor). The past dental history of the patient revealed excessive gagging and vomiting during radiographic procedure in the previous

Figure 1 (a) and (b): Pre-operative view showing dilacerated crown of left mandibular central incisor.

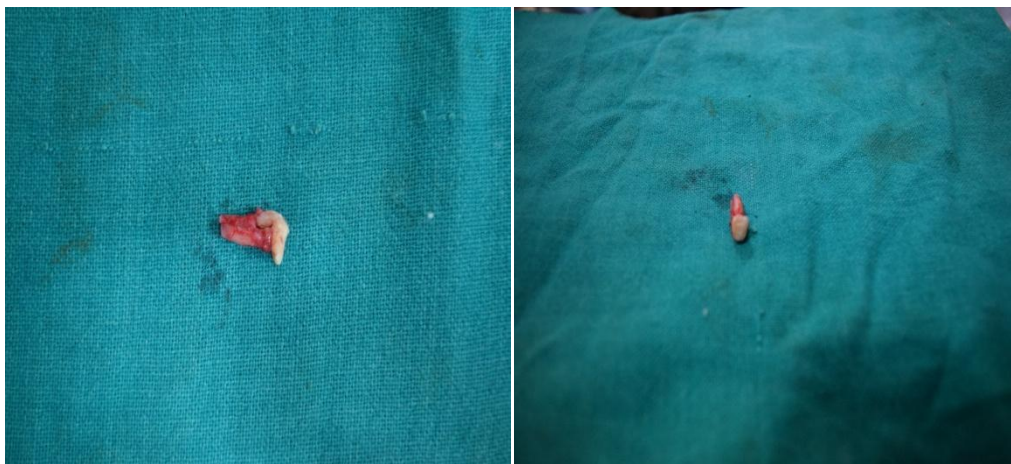
Considering the parent's concern about aesthetics and age of the patient, extraction of the dilacerated incisor was planned followed by fabrication of a Fiber Reinforced Composite (FRC-RIBBOND) using the same tooth. The tooth was extracted and placed in saline. On observation, crown appeared to be severely dilacerated. (Figure 2 (a) and (b): Dilacerated tooth after extraction). The root of the extracted tooth was resected at the cemento-enamel junction using a straight fissure bur. Pulpal remnants were extirpated, the pulp chamber was irrigated with saline, and the access was sealed with composite resin. (Figures 3: Access cavity prepared on the crown, Figure 4: Sealing of the access cavity with composite resin).

Figure 2 (a) and (b): Dilacerated tooth after extraction.

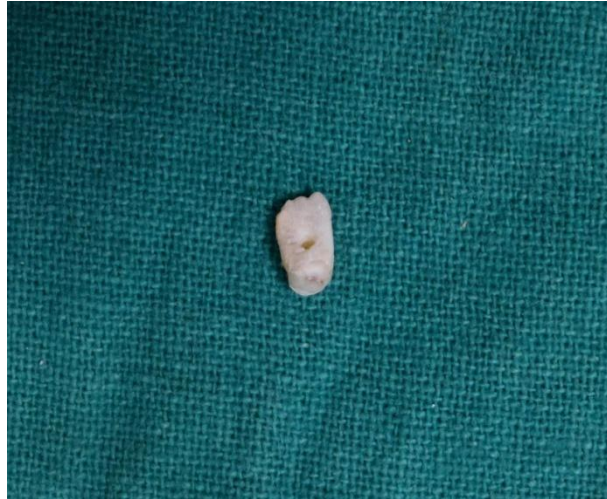
Figure 3: Access cavity prepared on the crown.

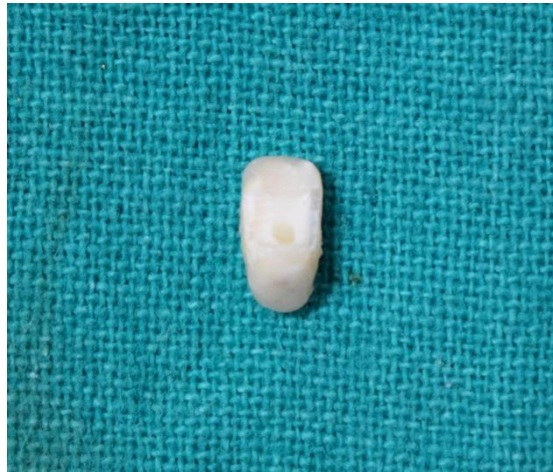
Figure 4: Sealing of the access cavity with composite resin.

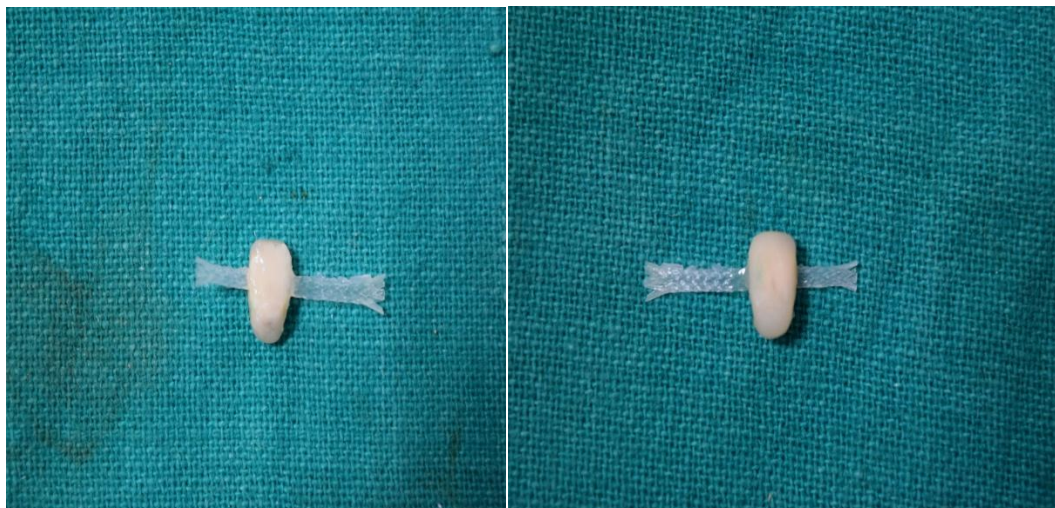
Figure 5 (a) and (b): Final prepared crown with attached Ribbond fiber.

A horizontal groove was made in the middle third of the lingual aspect of the crown to a depth of nearly two mm in order to accommodate the thickness and width of FRC. The adequate length of the Ribbond fiber was measured using a dental floss. Lingual surface of the extracted and adjacent teeth were etched with 37% phosphoric acid for 15 seconds, and then thoroughly cleaned and dried. The fiber was soaked in bonding agent and adapted onto the lingual surface of the extracted tooth ensuring adequate fit into the groove and was light cured from multiple directions for 20 seconds. ((Figure 5 (a) and (b): Final prepared crown with attached Ribbond fiber). The Ribbond fiber adapted on the extracted crown was then positioned in its space and adapted to the adjacent teeth.

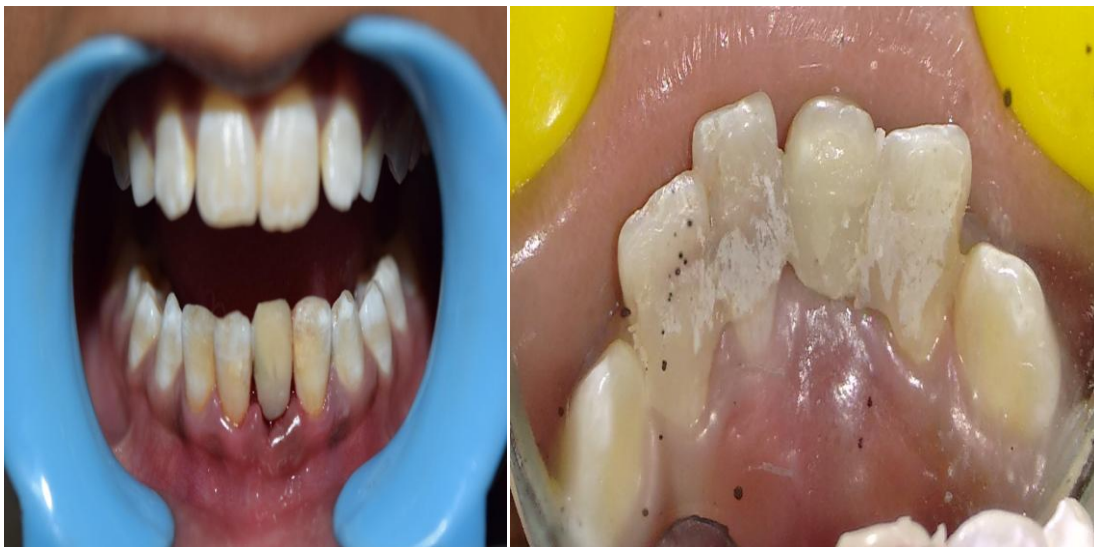
Figure 6 (a) and (b): Immediate post operative view.

After confirming the correct position, the remaining fiber was coated with composite and light cured. (Figure 6 (a) and (b): Immediate post operative view). Subsequently, the occlusion was checked and finishing and polishing was performed. The final position of the tooth was confirmed radiographically. The patient was motivated to maintain good oral hygiene and regular follow ups. One year follow up revealed satisfactory functional and aesthetic results. (Figure 7: Post operative view after one year follow up).

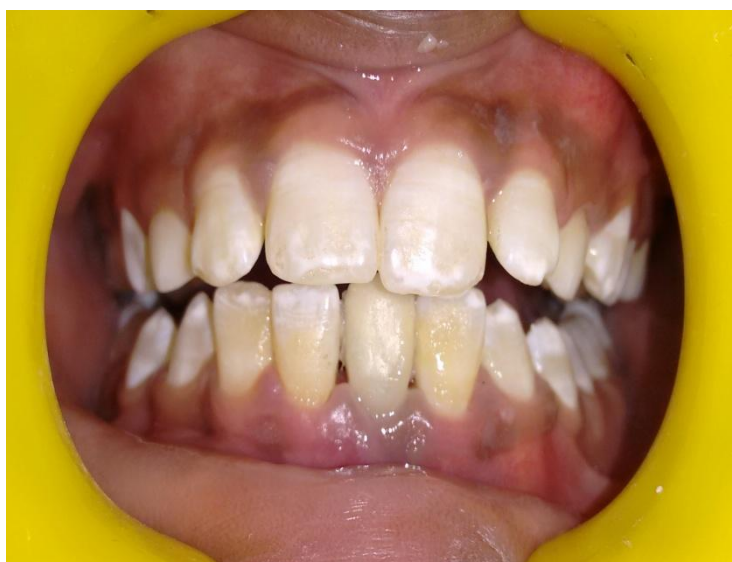
Figure 7: Post operative view after 1 year follow up.
