Tefu Bete Kristian: A Preliminary Investigation on a Neglected Rock-hewn Church, Lay Gaynt District, Northern Ethiopia

Tsegaye Ebabey Demissie

(Department of Anthropology, Hawassa University, Ethiopia)

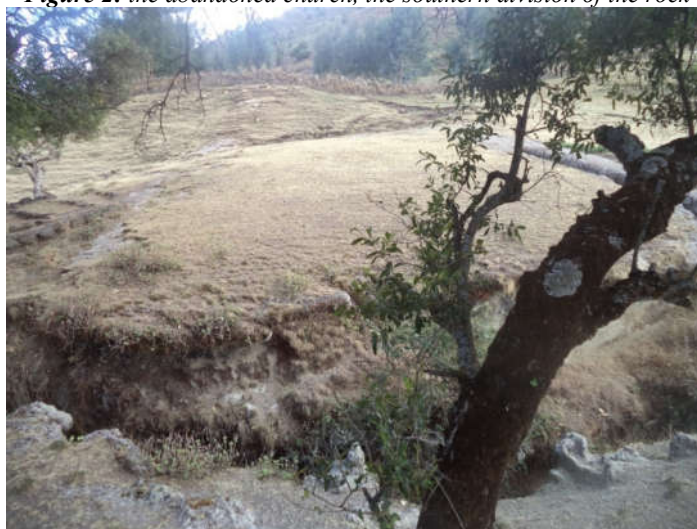
Figure 2: *the abandoned church, the southern division of the rock*

Tefu Bete Kristian (the abandoned church) is a monolithic structure carved from single living rock, white volcanic tuff sunk in to a sloppy plain. On the site, there was a plan to excavate two independent monuments from the bedrock. The plan of the excavation along the southern part of the rock is fully unrealized. However, an extensive trench excavated to divide the rock into two parts is an indication for its initiative. The end of the trench in the western end of the rock is unclear because of the soil deposited over it through time. The trench that separated the two blocks of rock measures 50 by 1.5 meters and 12.75 meters in maximum height. The height is taken from its mid part which is minimally filled with dusts. It is the longest and the deepest trench of the site. Besides, in the absence of archaeological excavation, it is quite difficult to give further description about this part. However, the southern part of the rock in appearance had a good opportunity to carve a big hypogeum.

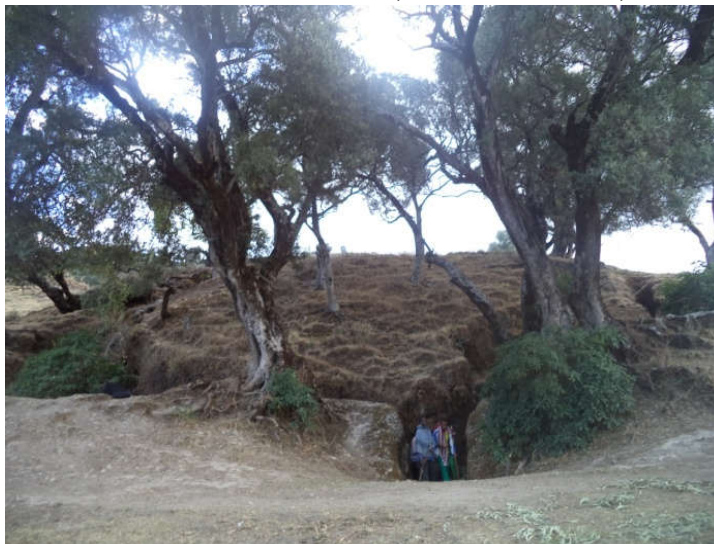
Figure 3: *The abandoned rock-hewn church, the northern division, northern view*

More attention is given to the northern division of the rock in which excavation of a hypogeum is realized. Its plan tends to be round. It is surrounded by trenches which separated the church from its parent rock. The longest trench is already described above. Another trench that measures 16 by 2 meters with varying height is hollowed out in the western part of the northern complex. A third trench is also planned to drain flood run out from the southern side. It is connected with another short trench that separates the southern complex from its parent rock. It also leads in to an entrance opened towards the southern division of the rock. The excavation of the trenches and tunnels, as it is well developed at Lalibela rock-hewn churches (Mengistu 2012, p. 74), have different purposes including networking separately excavated rock-hewn churches, draining water from interior courtyards and entrance and exit peoples.

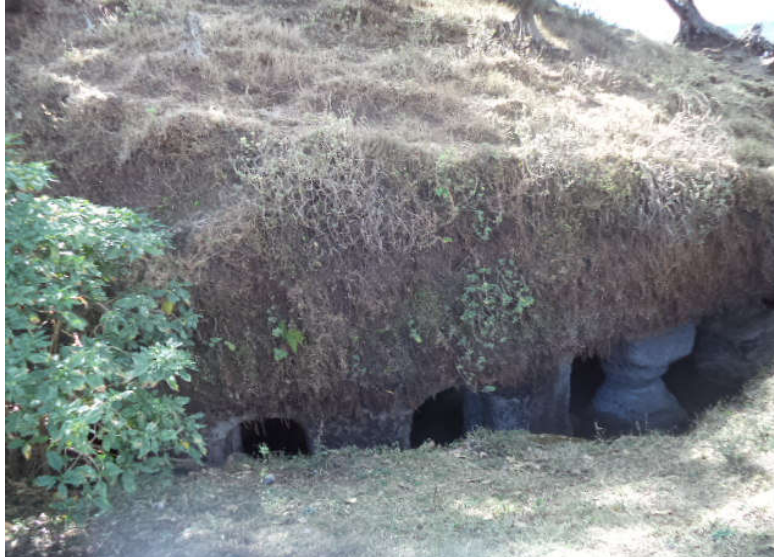
Figure 4: *The abandoned church, eastern view of the rock-hewn church*

An irregular entrance is opened in the northern side allowing access to different parts of the hypogeum. The hypogeum has two major parts- the exterior and the nave. The plan of its exterior part is somewhat unusual. It has no exterior rock wall protection in its frontal side; rather colonnades surround it. The hewer seems to have had an intention to make the exterior hall of the monument open to light. Instead of a rock wall, there are 22 crudely shaped colonnades flanked into two rows along the eastern, northern and western front of the hypogeum. The plan of these colonnades in terms of their arrangement, style and appearance is unusual in

comparison with the external colonnades at Bete Medhane Alem, Lalibela, and Gennete Maryam near Lalibela. The colonnades are sculpted merely to support the roof and, unlike the columns in the nave, they have no any kind of architectural affinities. The roof in the exterior part is uneven and little decorated. This part generally measures 7.5 meters in length, 18meters in width and 2.25meters in maximum height (more than one meter to the ground may be filled by alluviation). Here, all height measurements of the hypogeum are already taken above the deposit that layered in the floor of the church. Excavation work to get the rocky floor of the church for the purpose of measurement is not made. It is because I believe that it is better to leave this activity for the sake of further detail archaeological work. This part was probably a chanting room that could congregate many people together.

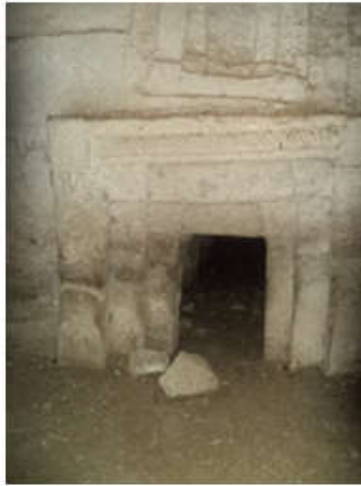
Figure 5 (left): The abandoned church, an entrance in to the nave

In the western exterior side, there is a separated room situating immediately along the northern main entrance. A rock wall has protected it. It has a doorway that measures 1.5m height and 0.75m width. Recently domed features garnish its roof. On the rock wall of this part, which is also part of the nave, features of rectangular false windows are evidenced. It also constitutes recent modified features that are possibly made by the local herders. To the north of this room becomes a narrow passage connected with the longest trench mentioned above. A rock wall protects the internal part, the nave, of the monument. In its western and northern facades, there are two rectangular doorways which equally measures 1.5m height and 0.75m width. They imitate corner posts which are very common architectural elements of window and door styles of the Aksumite civilization. There is also another entrance which was opened in the southern side of the nave. However, it is closed by alluviation collected in the course of time over the floor of the nave. The nave has five windows with different shapes; none of them has distinguished architectural elements.

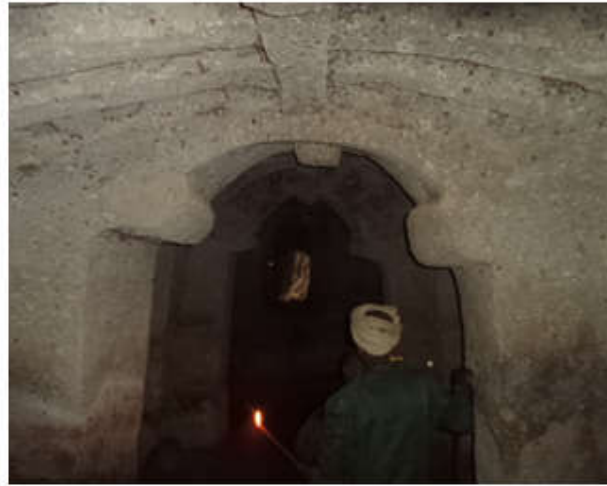
Figure 6 (right): The abandoned church, a portico view into the sanctuaries

The nave roughly takes rectangularity in its planning and measures 10 by 7.5m with approximate height of 2.30m. It is divided into different parts following the west-east internal church arrangement tradition coinciding with the ritual performances of Ethiopian Orthodox Church. These divisions include *qiddist* (holy) and *qiddiste qiddusan* or *meqdes* (holy of holies or sanctuary). There are four pillars erected compartmenting these parts and to support the roof. Unlike the exterior colonnades, these pillars are carefully carved and connected each other by architraves. They also have parallelly molded capitals and protruding boss at the center of their arches. Their entablature is very thick. The arched columns formed a portico view towards the sanctuaries.

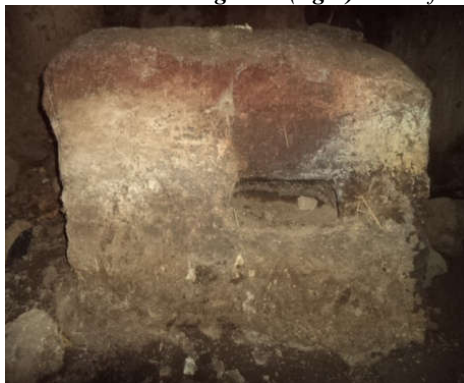
Figure 7 (left): One of the rock-hewn altars in Tefu Bete Kristian

The eastern inner most part is the holy of holies (sanctuary) of the nave. It takes a tripartite sanctuary which could be separated by movable curtains. Except the middle one, the two sub-sanctuaries have importable monolithic *menabirt* (altars) carved from the main rock. They have rectangular shape. One of them has small parts minimally hollowed out to put incense for liturgical and ritual services which were performed before it becomes abandoned. The tradition of carving importable altars from rock is evidenced in different rock-hewn churches of the country. Some churches have more than one altar such as Girar Maryam, Meqet; Mesenna Medhane Alem, Lay Gaynt, and Tembeqot Medhane Alem, Meqet. Some examples are presented by Tsegaye (2014: 85-86).

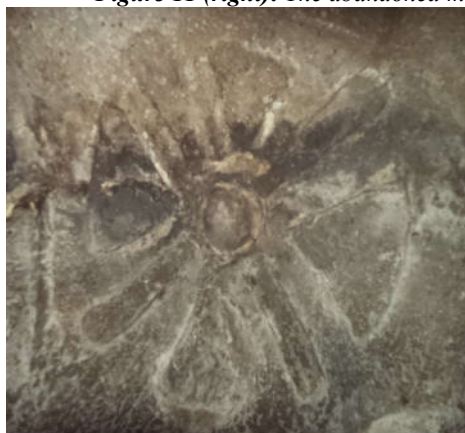
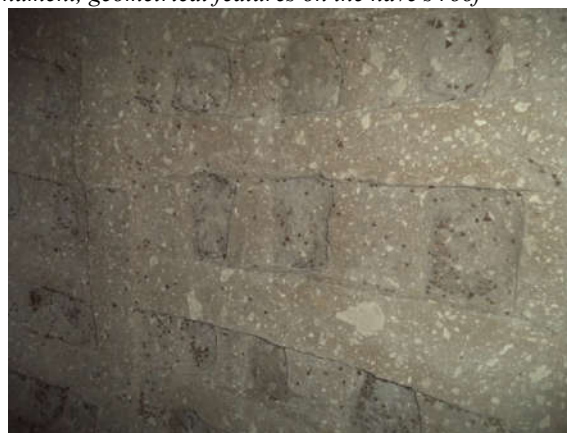
Figure 10 (left): The abandoned monument, an embellishment engraved in the nave's roof
Figure 11 (right): The abandoned monument, geometrical features on the nave's roof

The roof of the nave is dominantly architected and symbolized with Christianized and geometric elements including crosses, arches, entablatures, and engraved beams that form the ceiling of the roof. These elements are dominantly engraved on its roof. Varied styles of geometric designs, cruciform features and domes with different forms are witnessed as a ceiling of the roof. Rectangular and triangular geometric designs are mainly used. Cruciform features are engraved accompanied by different geometrical signs. A cruciform figure adorned by circular geometric features is apparently sculpted at many places. A cross encircled by triangular geometrical design is the other decorative feature of the roof. This style is widely used in the church of Wuqiro Medhane Alem. There is a domed feature with a central protruding boss surrounded by lines that have connection with the boss. Between the lines, triangular designs are engraved.

Rectangular and triangular geometric features take the basic architecture of the nave's roof. Such application of geometric features as a meaningful decoration is evidenced at Yimrhanne Kristos in Lasta (Phillipson 2009, p. 78; Mengistu 2012). The roof in the sanctuary is architected with circular domes. The central domed roof is decorated by engraved cross. The rest two domes have a sign of small circular feature at the center. Examples of these domes are evidenced in the nearby church of Mesenna Medhane Alem and in various churches of Meqet (Tsegaye 2014, p. 83).

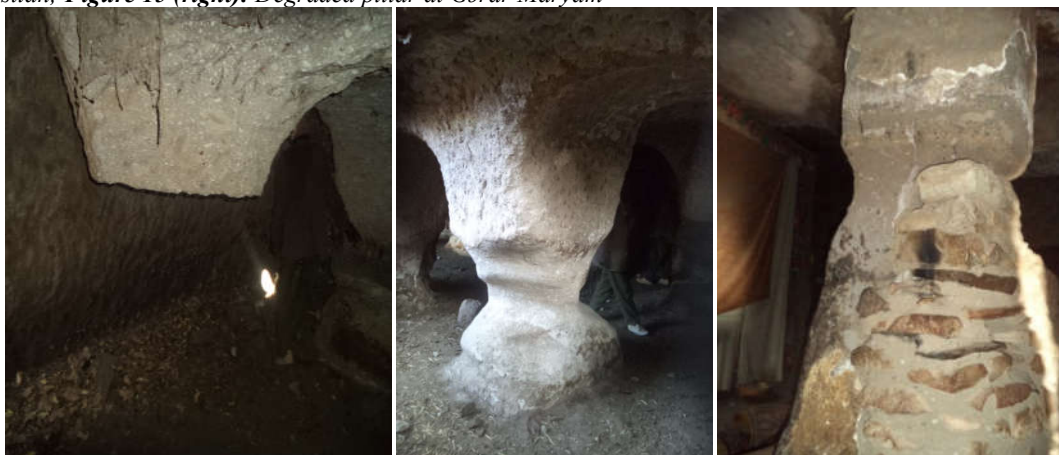
Figure 13 (left): Broken column at Tefu Bete Kristian; **Figure 14 (middle):** Degraded column at Tefu Bete Kristian; **Figure 15 (right):** Degraded pillar at Gərar Maryam

Currently, as I have observed, there are undesirable human activities made by the local people. These activities have been made for a long period. The local people are still using the church as a barn or mew for their animals. This has various impacts on the aesthetic and architectural values of the historic monument. The contact of the animals is evidenced particularly on its exterior colonnades. Five of the colonnades are broken and some others are detrimentally sand down due to animal contact or leant. The segments of the broken pillars are still evidenced attached with the roof and the base.

This paper is a pioneering to provide detail preliminary bases for further archaeological and historical investigations that have to be done on this neglected cultural heritage. The monument needs an urgent protection from further destructive activities. Creating awareness among local communities is indispensable to effectively protect it. From its wider implication, by looking at the situations of this lost heritage, emphasis on the identification, inventory and protection of antiquities in the countryside shall to be taken as an important task of stakeholders in heritage conservation. Valorization of cultural heritage has to be emphasized in line with the developmental activities of the country. The delaying and negligence to manage cultural heritages is most dominantly related with the absence of a sound enforcement of heritage management activities throughout the country. This problem is of course accompanied by lack of experts in the field of heritage management, which is another challenge that shall be considered. This study intimates that future archaeological work on the site will provide relevant evidence about this church in particular in the area in general.
