## Performance of RC Beam Column Connections Subjected to Cyclic Loading

**Abstract :** Structures and lifelines designed for typical loading are often badly damaged or can collapse during earthquakes. The observations from recent earthquakes show that many RC structures have failed in the brittle behaviour of beam-column connections due to the deficiency of seismic details in the joint regions. Joint shear failures have been observed recently in many existing RC structures subjected to severe earthquake loadings. In this study, RC beam column specimen was casted and tested for excitation of cyclic loading. Attempts are made to study the performance of the test specimen by studying loop hysteresis, maximum push and pull load and load at the propagation of first crack.

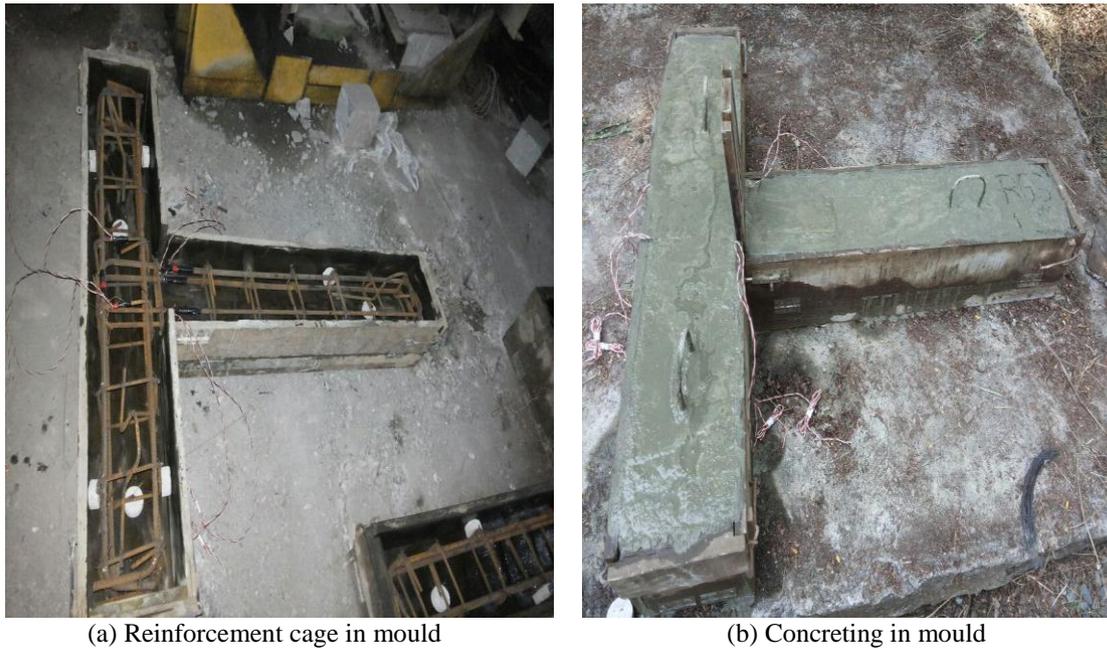
**Fig. 3 Preparation of Test Specimen**

For the construction of beam column specimen, foldable wooden moulds are prepared so set specimen can be easily removed from the mould. These moulds can be reused. As per details given in **Fig. 2** reinforcement bars are provided. **Fig. 3** shows the wooden mould with reinforcement bars placed inside it. Strain gauges were fixed with reinforcement bars in order to study the strain developed in the bars when the specimen is loaded. After the assemblage of the beam and column reinforcement, the assembly was put into the formwork and was made ready for casting as shown in **Fig. 3 (a)**. The plain concrete used in all groups was prepared by proportion 1: 1.57: 3.20. The concrete was poured in the formwork horizontally. The compaction of the concrete was performed using a vibrator to produce uniformity throughout the specimen. A needle vibrator with a head of

25 mm diameter was used for compaction. The trowels were used to finish the concrete allowing a smooth surface for crack mapping as shown in **Fig.3 (b)**.

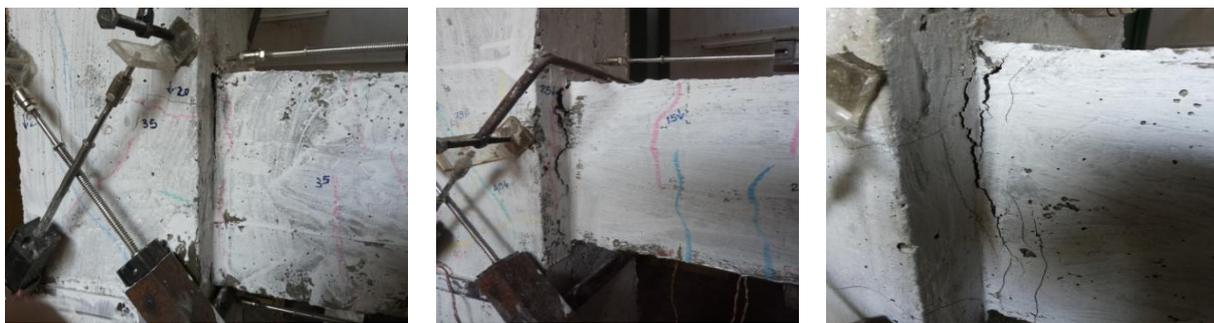
Fig. 5 Crack and Damage Pattern of Beam-Column Specimen

The corresponding restoring force was measured as 15.72 kN down. In the fourth cycle, a load of 24.95 kN was applied down and 22.58 kN up to the specimen and new flexural and flexural–shear cracks formed along the beam length. In the sixth cycle, vertical crack formed in the joint region at beam-tip load of 29.68 kN due to bond-slip of the beam bottom bars. During the eighth cycle, diagonal shear cracks developed in the joint region, and the specimen reached a load of 31.06 kN at a beam-tip displacement of 35.9 mm. Repeating the same cycle, the beam reached the same displacement but at lower load level and the beam bars started to slip out of the joint with an associated reduction in the developed strain in the bars. The final failure pattern is shown in Fig. 5.

Ten full displacement cycles were applied to the test specimen. In the first loading cycle, the specimen was loaded up to 9.63 kN up and 9.38 kN down to test the instrumentations. First flexural crack was observed during second cycle at displacement of 10 mm (drift ratio of 1.18%).
