Geoarchaeology of Elephantine Rock-cut Tombs, Aswan, Egypt

*Fatma M. Helmi, Atef A. Brania

Conservation department, Faculty of Archaeology, Cairo University, Egypt

Fatma M. Helmi. "Geoarchaeology of Elephantine Rock-Cut Tombs, Aswan, Egypt." IOSR Journal of Applied Geology and Geophysics (IOSR-JAGG) , vol. 5, no. 4, 2017, pp. 77–87.

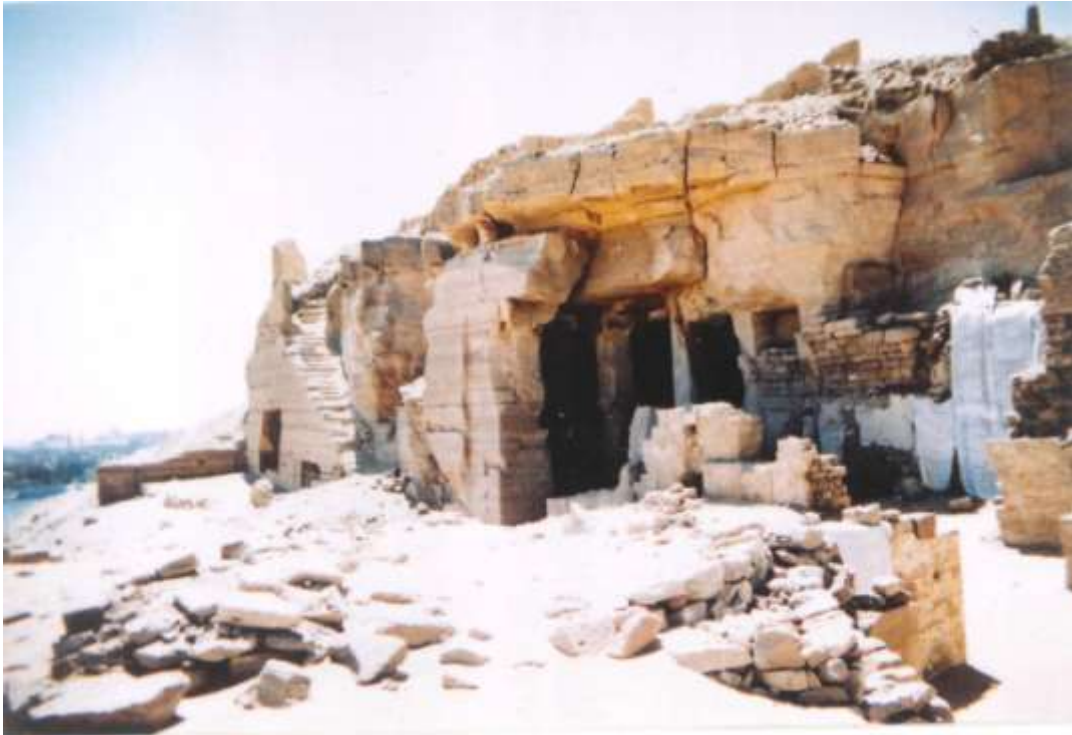
Fig. 1 The joints spreaded in the rock of one of the Elephantine tombs (Khones).

Several deterioration factors act on these rock-cut Elephantine tombs: Endogeneous and Exogeneous, the endogeneous factors concern the nature of the rock itself which has heterogeneities in the mineralogical composition, and that presence of many joints. The exogeneous factors include: temperature variation, wind, moisture (condensation & evaporation), biological effect of (insects, birds & animals), and natural disasters such as earthquakes. This led to a fall, destruction of some tombs; distortion and deterioration in their mural paintings, such as flaking, scaling, exfoliation, and fragmentation, see figs 1-4.

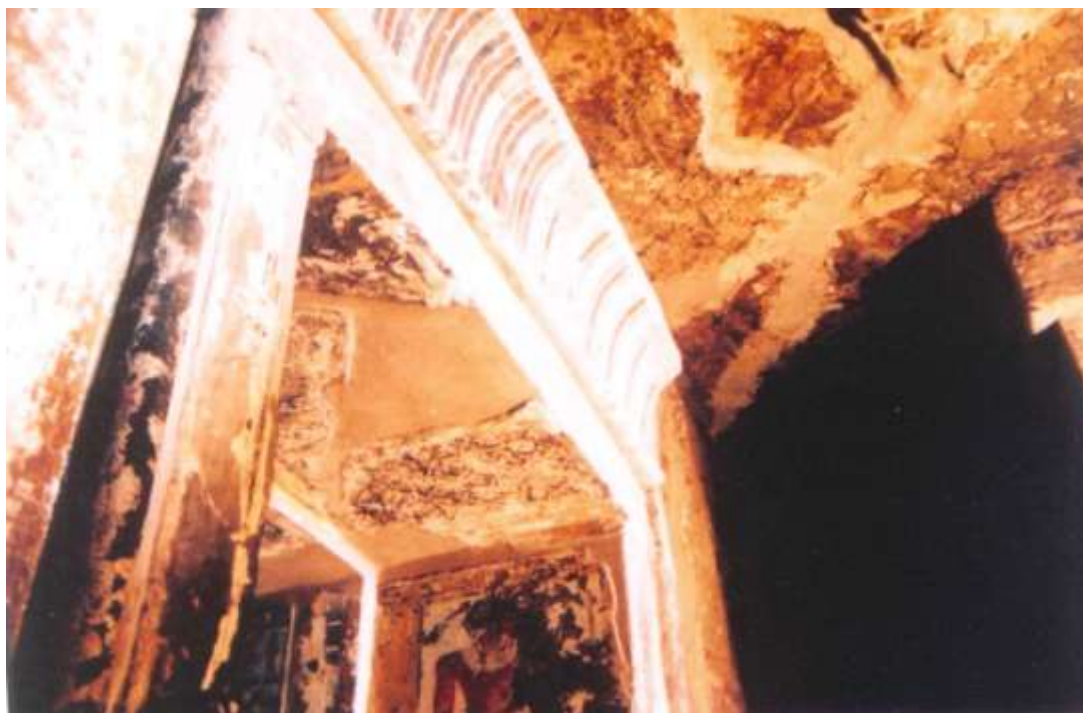
Fig. 3 Deterioration inside one of the Elephantine tombs.

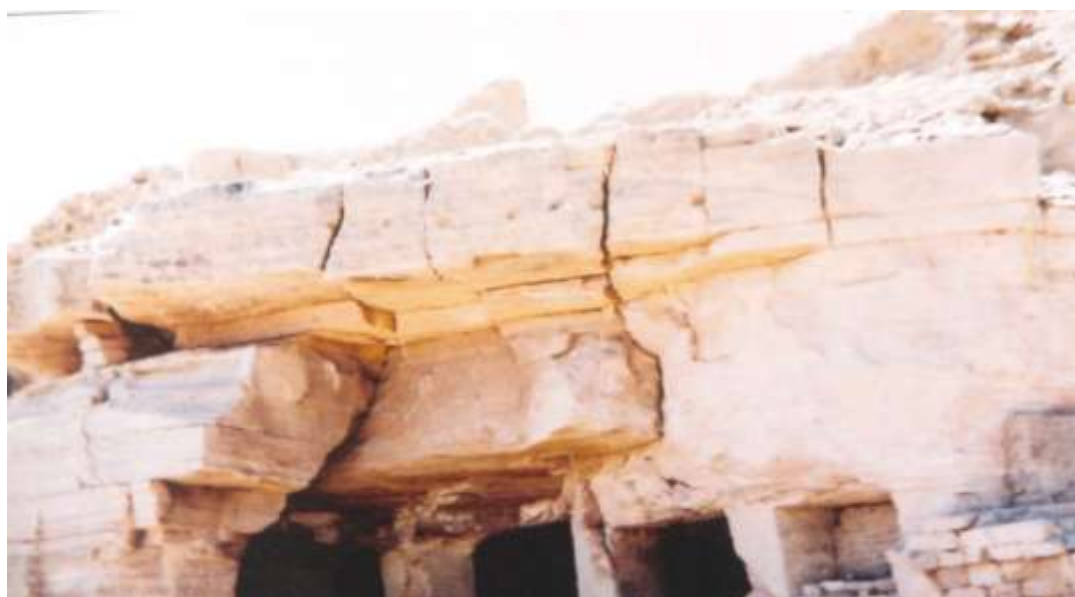
Fig. 4 Details of the serious joints existed in khones tomb.

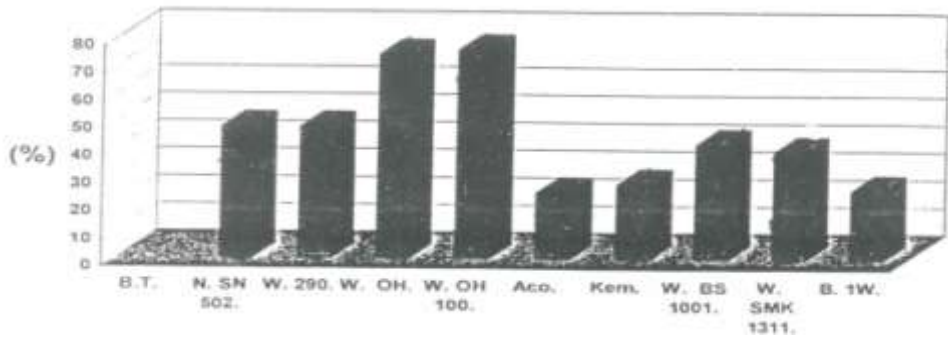
Fig. 15 The increase rates in compressive strength of sandstone after consolidation.

Physical properties of sandstone are: porosity: 20.1%, water absorption: 12.5, Bulk density: 1.64 gm/cm^3 , compressive strength: 19.2. Data showed that the treated sandstone with nitocote SN 502 gave the best results, there was no effect on the appearance, and become hydrophobic. In case of paraloid B-72 and addicon, they were failed due to darkening in colour. So they were excluded in the next experiments. The nine another consolidants showed good enough results. Fig 15 shows the increase rates in compressive strength of sandstone after consolidation. Whereas figs. 16,17 show the decrease rates in porosity and water absorption respectively.
