Displacement monitoring on surrounding buildings of an excavation using a total station

Abstract: *In present, the engineering structures such as buildings, tunnel walls, bridges, railroad tracks are monitored for ensuring early warning of structural failure. The displacements of the structures are measured currently by using accelerometers, GNSS and geodetic total stations. In this paper, the monitoring and analysis results of displacement, which are created by the underground parking construction locates in Kağıthane-Yeşilce District (Istanbul, Turkey), on the surrounding buildings by using total station are presented. Total station is a measurement device which defines the coordinate of a point indirectly from measured angles and distances. Total station measures the distance by using the travel time of a light wave for reaching a point (monitoring prism) and reflecting back. In this study, 20 monitoring prisms were mounted to four surrounding buildings of the exaction area. The buildings were monitored for 13 days (from 06.07.2017 to 29.07.2017) and the interval of the measurements was 20 hours. Finally, the displacements of the buildings are found generally at north direction

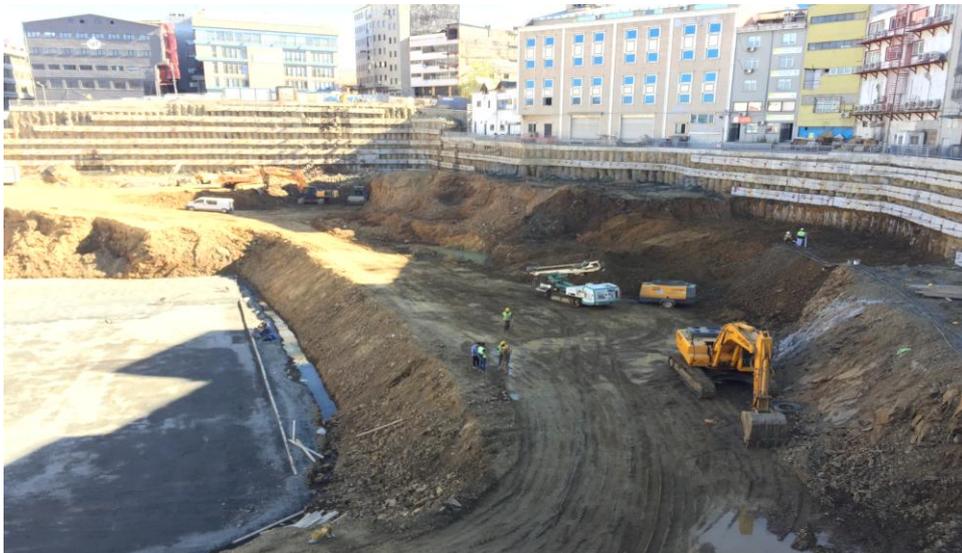
The underground parking construction was begun at 2017 in Kağıthane-Yeşilce District in Istanbul city (Fig. 1). For monitoring the effect of the underground parking construction to the surrounding buildings, twenty monitoring prisms (Fig. 2) were placed on the facades of four surrounding buildings. The buildings were named with their apartment gate numbers as 7, 9, 11 and 13, respectively (Fig. 3). Four monitoring prisms were placed on the building No: 7 and these prisms called as point no; 10, 11, 23 and 24. On the building No: 9, four monitoring prisms were mounted with point numbers; 12, 13, 21 and 22. Seven monitoring prisms and five monitoring prisms were placed on building no: 11 and building no: 13, respectively. The prisms numbers of building no: 11 were 14, 15, 16, 17, 18, 19 and 20. The point no: 14 and 15 were placed on the side facades and the others were on the facades. The prisms numbers of building no: 13 were called as 25, 26, 27, 28 and 29. Among them, the point no: 25 and 26 were placed on the side facades and no: 27, 28 and no: 29 were on the facades.

Figure 1. The view of the underground parking construction which locates in Kağıthane-Yeşilce District in Istanbul city

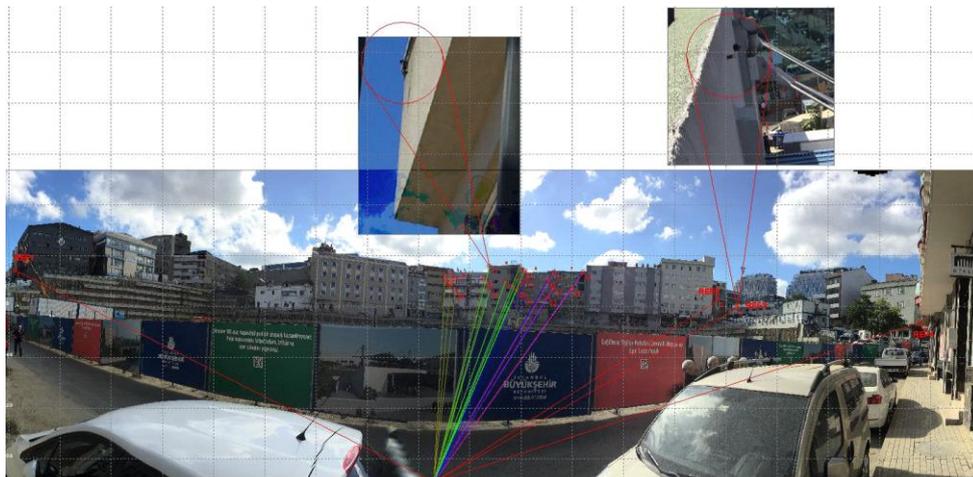
Figure 2: The view of underground parking construction, the monitored buildings and the monitoring prisms and reference points.

The total station was positioned precisely with resection from REF1, REF2, REF3 and REF4 and after providing self-consistency at total station, the measurements with four full ranges were begun for deformation points. The interval of the measurements was 20 hours. The measurements which obtained at 6th July 2017 were chosen as the base measurements and the coordinates of the observation points (Fig. 2) were given at Table 2.

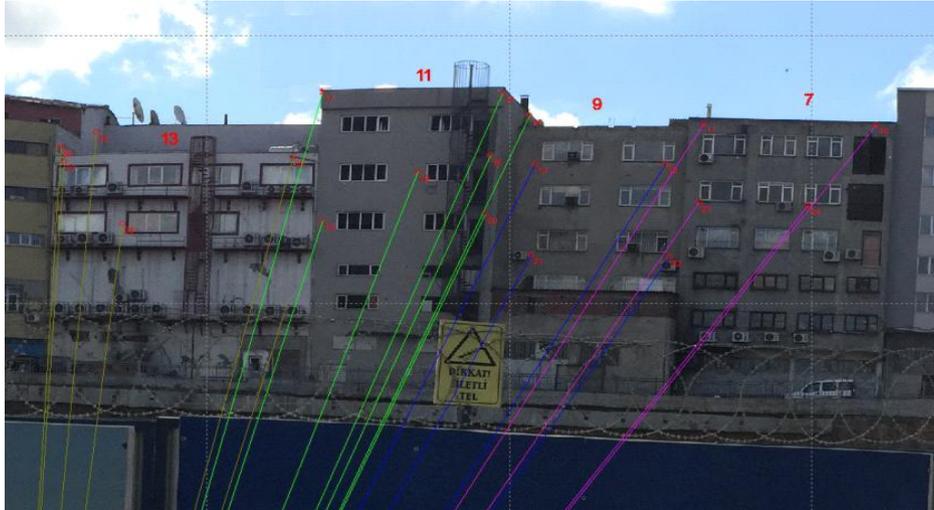
Figure 3: The monitored surrounding buildings named with the apartment gate number with 7, 9, 11 and 13. The numbers shown on the buildings present the point numbers of the monitoring prisms.

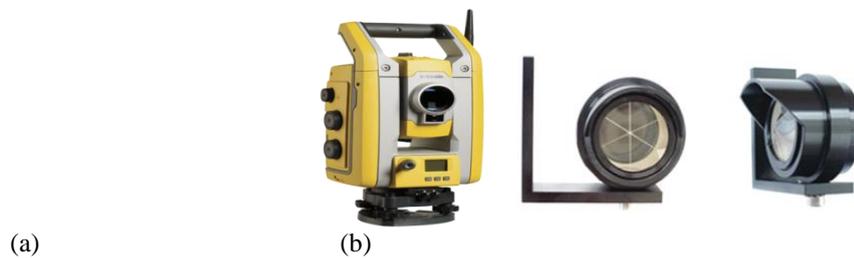
Figure 4: a) Trimble S5-1 Total station [23] b) Monitoring prism (25mm) [24]

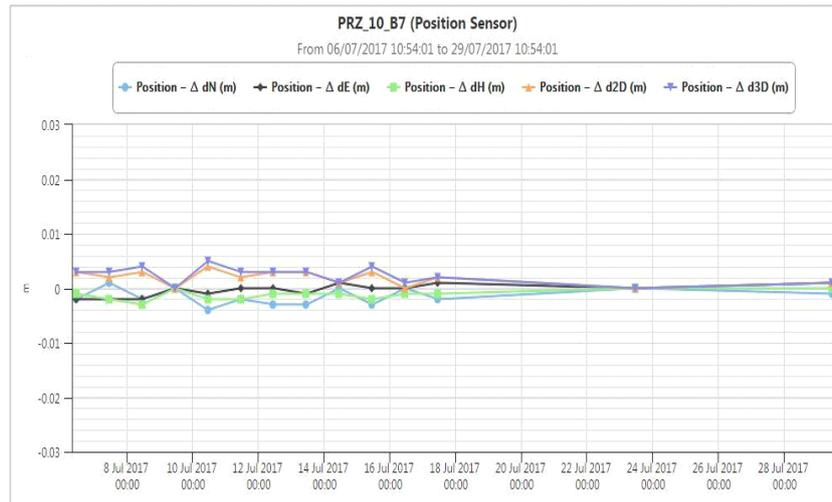
Figure 4: The observed position differences between the days 06.07.2017- 29.07.2017 on north (dN), east (dE), elevation (dH), 2D (d2D) and 3D (d3D) of monitoring prism No: 10 placed on building No: 7.

The monitoring prisms No: 10, 11, 23 and 24 are located on building No:7. If the measurement in 06.07.2017 assumed as the reference, for monitoring prism No:10, the position ranges between 0.0027 m (observed in 07.07.2017) and -0.0016 m (observed in 10.07.2017) at North, ranges between -0.0003 m (observed in 07.07.2017) and 0.0031 m. (29.07.2017) at East and ranges between -0.0018 (08.07.2017) and 0.0012 m (23.07.217) at elevation (Table 3). For prism No:11, the position ranges between 0.0039 m (07.07.2017) and -0.0019 m (10.07.2017) at North, ranges between -0.0008 m (07.07.2017) and 0.0033 m (17.07.2017) at East, ranges between -0.0014 m (08.07.217) and 0.0014 m (23.07.2017) at elevation (Table 4). For prism No:23, the position ranges between 0.0049 m (07.07.2017) and -0.0017 m (10.07.2017) at North, ranges between -0.0003 m (07.07.2017) and 0.0032 m (17.07.2017) at East, ranges between -0.0010 m (08.07.2017) and 0.0016 m (27.07.2017) at elevation (Table 5). For prism No:24, the position ranges between 0.0047 m (07.07.2017) and -0.0016 m (10.07.2017) at North, ranges between 0.00 m (06.07.2017) and 0.0031 m (09.07.2017) at East, ranges between -0.0012 m (07.07.2017) and 0.0007 m (27.07.2017) at elevation (Table 6). Therefore, the monitoring prism No: 10, the max. displacement at North is 4.3 mm, at East is 3.4 mm and at elevation is 3.0 mm. The max. displacement at North, East and at elevation is 5.8 mm, 4.1 mm and 2.8 mm, respectively for the monitoring prism No: 11. The max. displacement at North, East and at elevation is 5.6 mm, 3.5 mm and 2.6 mm, respectively for the monitoring prism No: 23. The max. displacement at North, East and at elevation is 6.3 mm, 3.1 mm and 1.9 mm, respectively for the monitoring prism No: 23. If these values and the Figs. 4, 5, 6 and Fig. 7 are evaluated together, it can be said that the displacement on building No:7 is seen generally at North directional and 2D and 3D displacement are monitored.

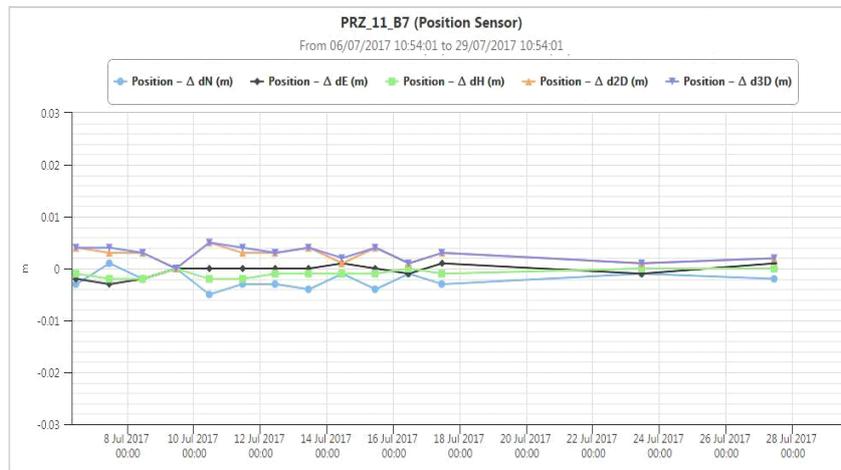
Figure 5: The observed position differences between the days 06.07.2017- 27.07.2017 on north (dN), east (dE), elevation (dH), 2D (d2D) and 3D (d3D) of monitoring prism No: 11 placed on building No: 7.

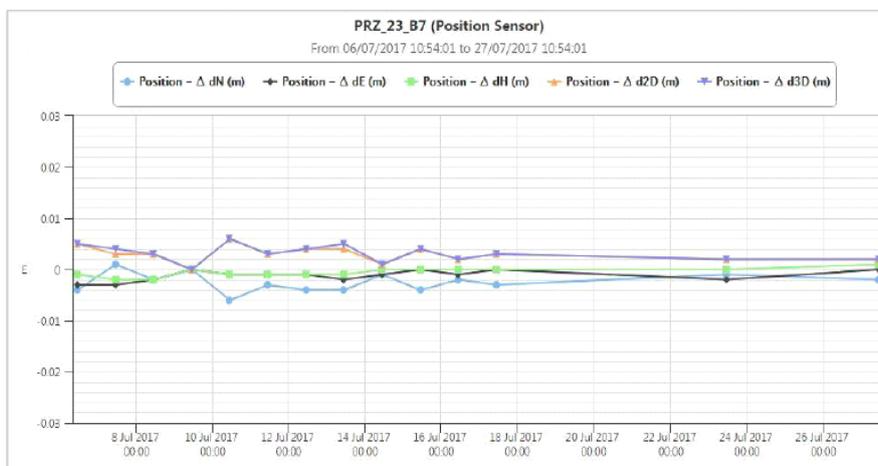
Figure 6: The observed position differences between the days 06.07.2017- 27.07.2017 on north (dN), east (dE), elevation (dH), 2D (d2D) and 3D (d3D) of monitoring prism No: 23 placed on building No: 7.

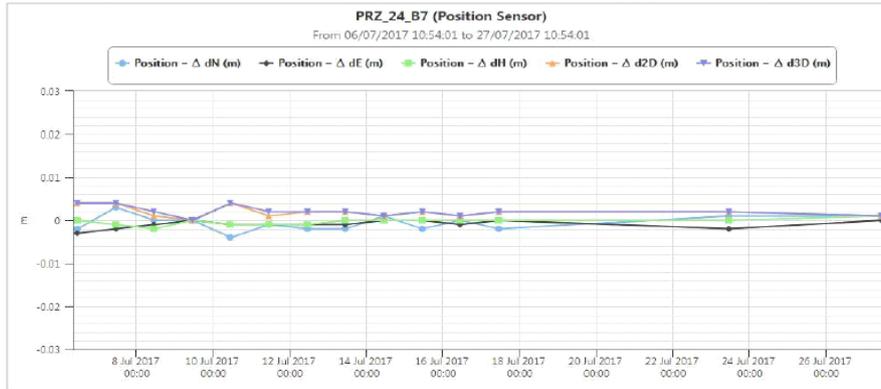
Figure 7: The observed position differences between the days 06.07.2017- 27.07.2017 on north (dN), east (dE), elevation (dH), 2D (d2D) and 3D (d3D) of monitoring prism No: 24 placed on building No: 7.

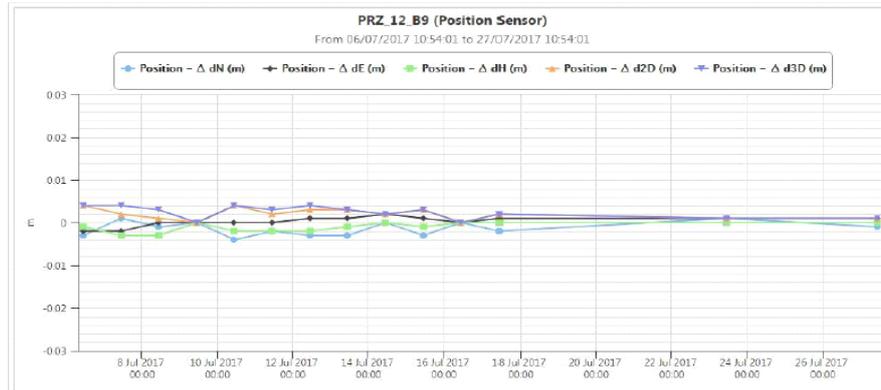
Figure 8: The observed position differences between the days 06.07.2017- 27.07.2017 on north (dN), east (dE), elevation (dH), 2D (d2D) and 3D (d3D) of monitoring prism No: 12 placed on building No: 9.

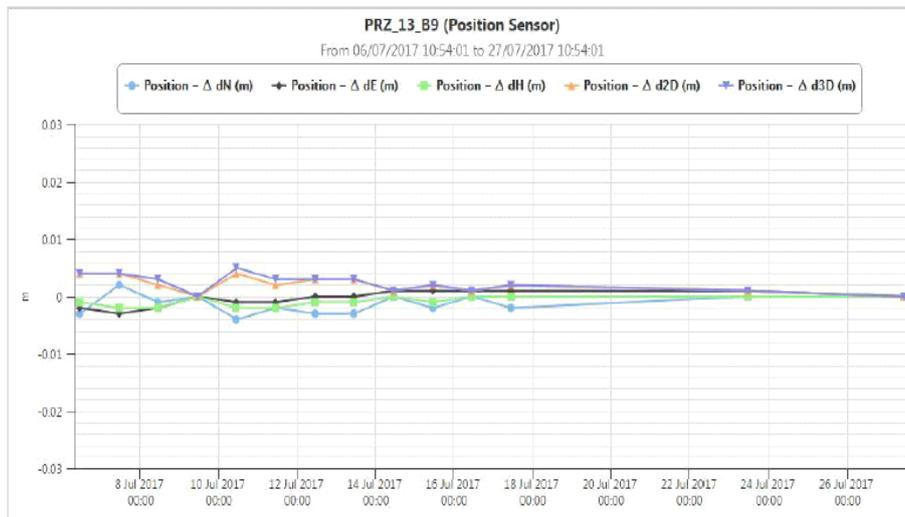
Figure 9: The observed position differences between the days 06.07.2017- 27.07.2017 on north (dN), east (dE), elevation (dH), 2D (d2D) and 3D (d3D) of monitoring prism No: 13 placed on building No: 9.

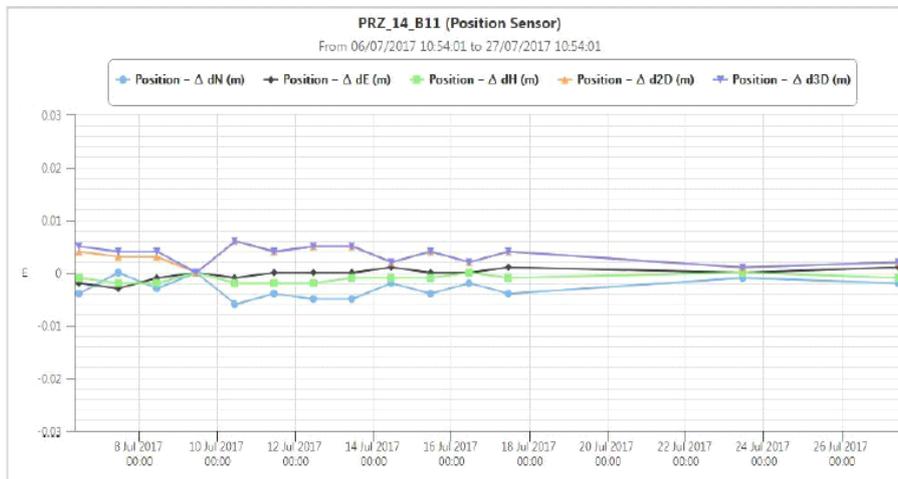
Figure 11: The observed position differences between the days 06.07.2017- 27.07.2017 on north (dN), east (dE), elevation (dH), 2D (d2D) and 3D (d3D) of monitoring prism No: 14 placed on building No: 11.

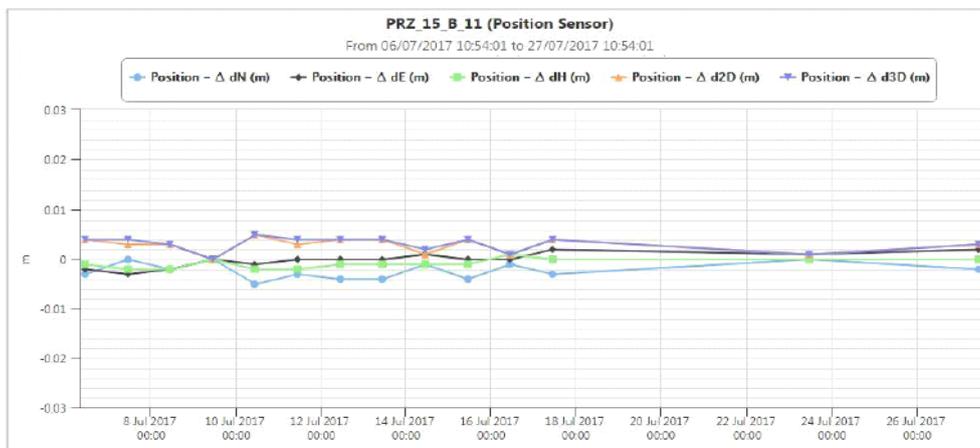
Figure 12: The observed position differences between the days 06.07.2017- 27.07.2017 on north (dN), east (dE), elevation (dH), 2D (d2D) and 3D (d3D) of monitoring prism No: 15 placed on building No: 11.

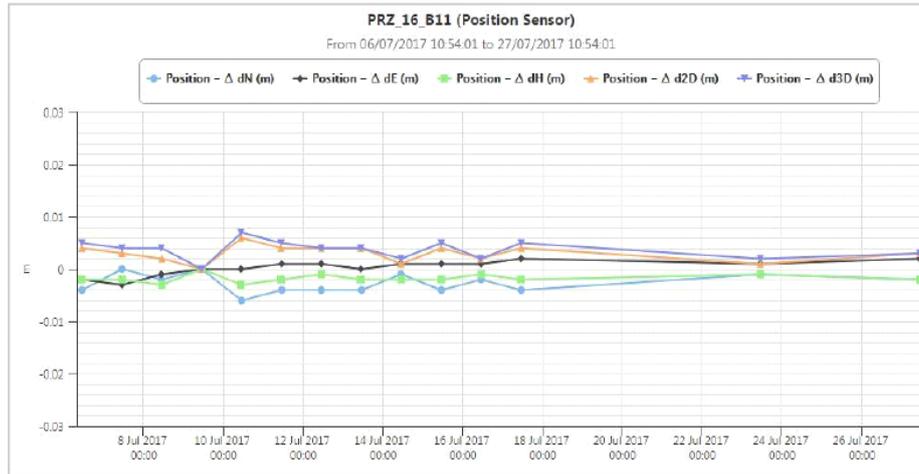
Figure 13: The observed position differences between the days 06.07.2017- 27.07.2017 on north (dN), east (dE), elevation (dH), 2D (d2D) and 3D (d3D) of monitoring prism No: 16 placed on building No: 11.

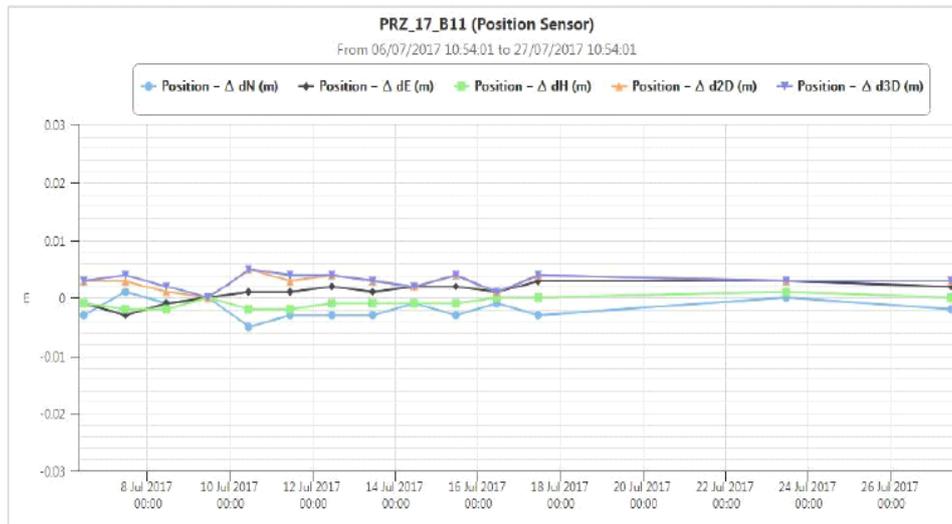
Figure 14: The observed position differences between the days 06.07.2017- 27.07.2017 on north (dN), east (dE), elevation (dH), 2D (d2D) and 3D (d3D) of monitoring prism No: 17 placed on building No: 11.

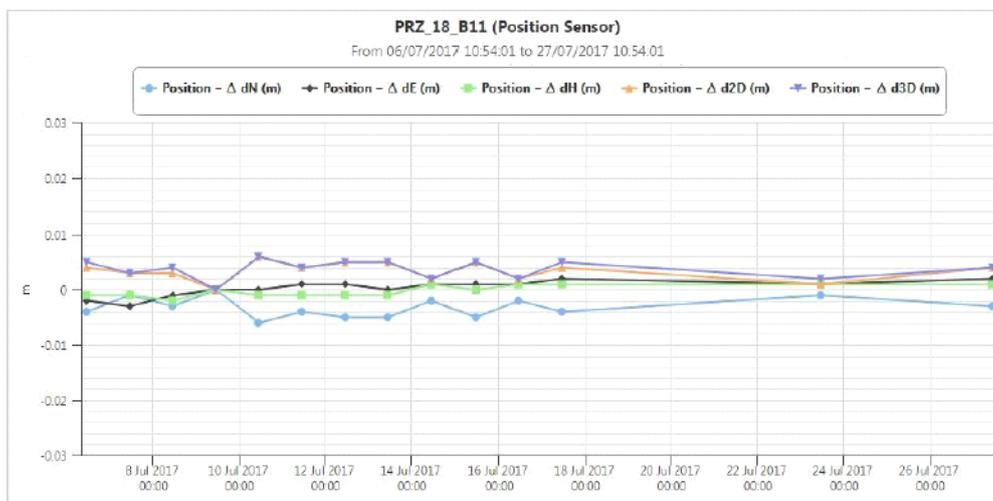
Figure 15: The observed position differences between the days 06.07.2017- 27.07.2017 on north (dN), east (dE), elevation (dH), 2D (d2D) and 3D (d3D) of monitoring prism No: 18 placed on building No: 11.

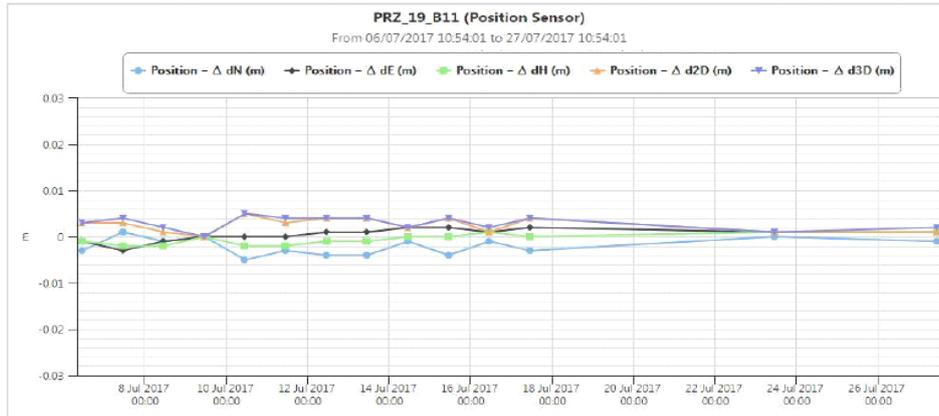
Figure 16: The observed position differences between the days 06.07.2017- 27.07.2017 on north (dN), east (dE), elevation (dH), 2D (d2D) and 3D (d3D) of monitoring prism No: 19 placed on building No: 11.

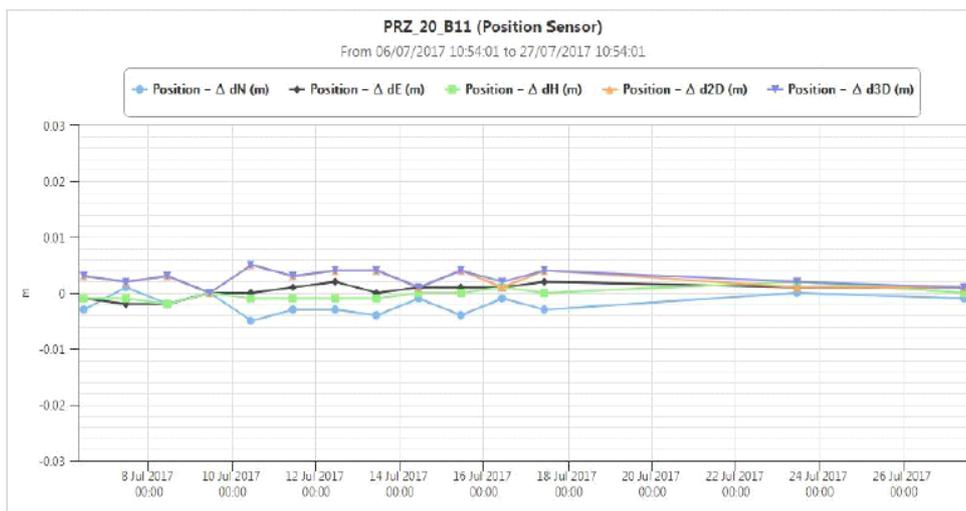
Figure 17: The observed position differences between the days 06.07.2017- 27.07.2017 on north (dN), east (dE), elevation (dH), 2D (d2D) and 3D (d3D) of monitoring prism No: 20 placed on building No: 11.

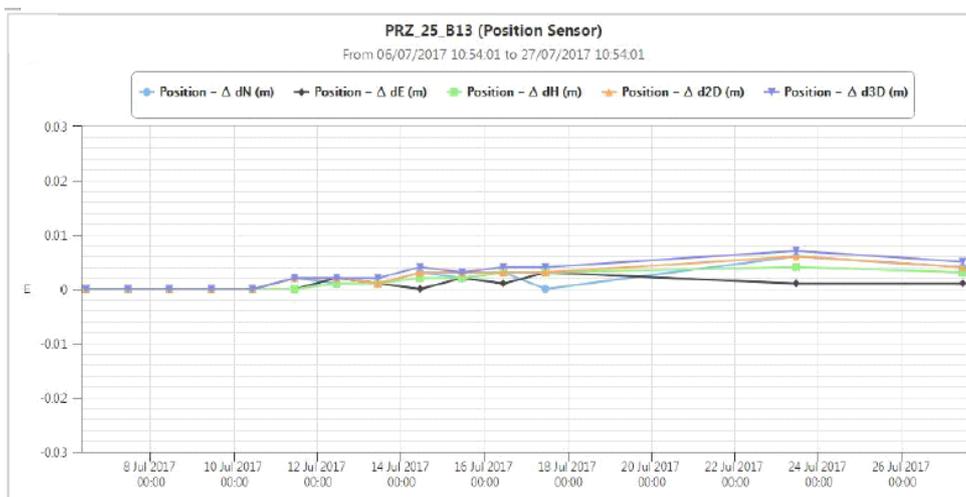
Figure 18: The observed position differences between the days 06.07.2017- 27.07.2017 on north (dN), east (dE), elevation (dH), 2D (d2D) and 3D (d3D) of monitoring prism No: 25 placed on building No: 13.

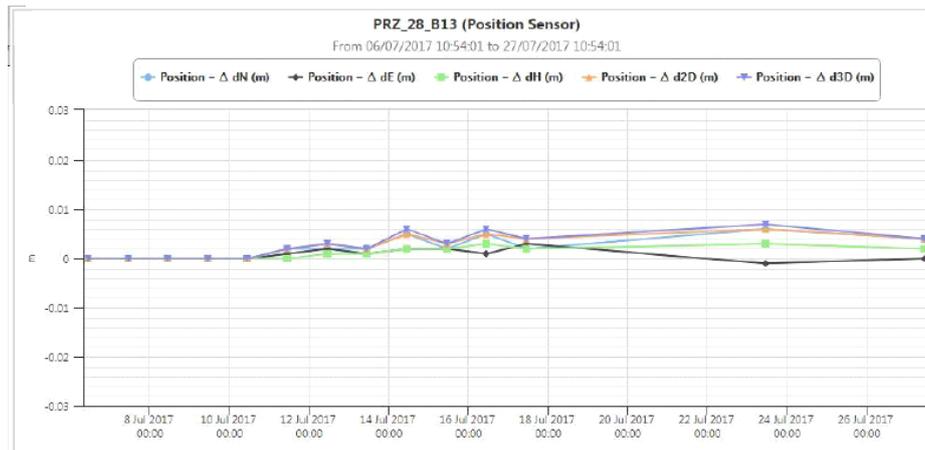
Figure 19: The observed position differences between the days 06.07.2017- 27.07.2017 on north (dN), east (dE), elevation (dH), 2D (d2D) and 3D (d3D) of monitoring prism No: 28 placed on building No: 13.

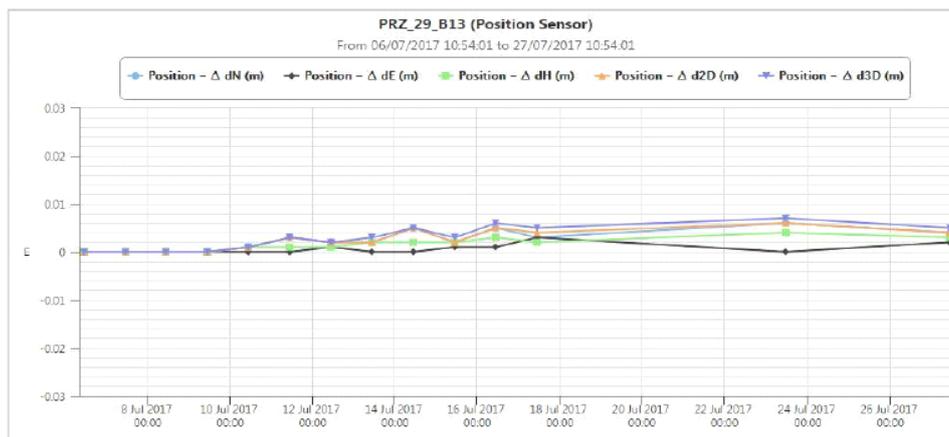
Figure 20: The observed position differences between the days 06.07.2017- 27.07.2017 on north (dN), east (dE), elevation (dH), 2D (d2D) and 3D (d3D) of monitoring prism No: 29 placed on building No: 13.
