Fracture strength of veneers using different restorative material, s and techniques. In vitro study

Aim of the study: The purpose of this study was to evaluate the fracture strength of the laminate veneers in maxillary anterior, fabricated from either composite (direct and indirect techniques) or ceramic CAD/CAM blocks.

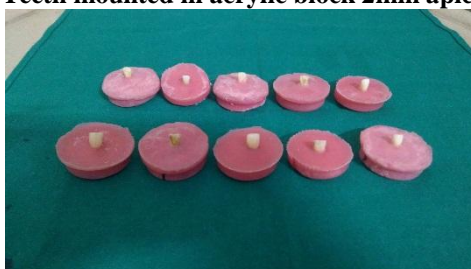
Figure 1: Teeth mounted in acrylic block 2mm apical to CEJ.

The teeth were mounted individually in specially designed, locally-manufactured rubber mold (20 mm height × 20 mm diameter) with cold cure acrylic with the long axis of the tooth parallel to center of the mold. All specimens were embedded up to 2 mm apical to the CEJ to simulate the natural biologic width as seen in (Fig.1).

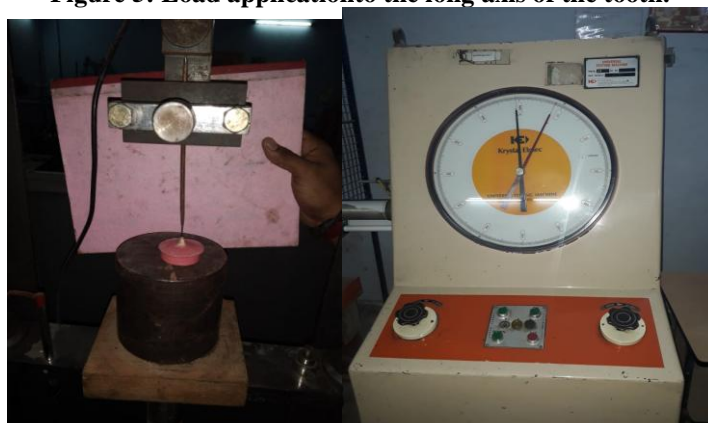
Figure 5: Load application to the long axis of the tooth.

The fracture strength test performed using a Universal Testing Machine (universal testing machine, China). Load was applied at a crosshead speed 0.5 mm/min (5) with a customized plunger (steel rod with a flat end 3.6 mm diameter) attached to the upper movable compartment of the machine (7), placed at the incisor part of the laminate veneer (16). The load was applied to the long axis of the tooth. This orientation was standardized with a specially designed, locally manufactured, mounting jig (Fig. 5). The maximum load to produce fracture for each sample was automatically recorded in Newton (N). Modes of failure were assessed with stereomicroscope at 20x magnification. The results of this study were analyzed with one-way ANOVA and LSD test.
