Endodontic Retreatment and Internal Bleaching of A Central Incisor Following Dental Trauma - Case Report

Abstract

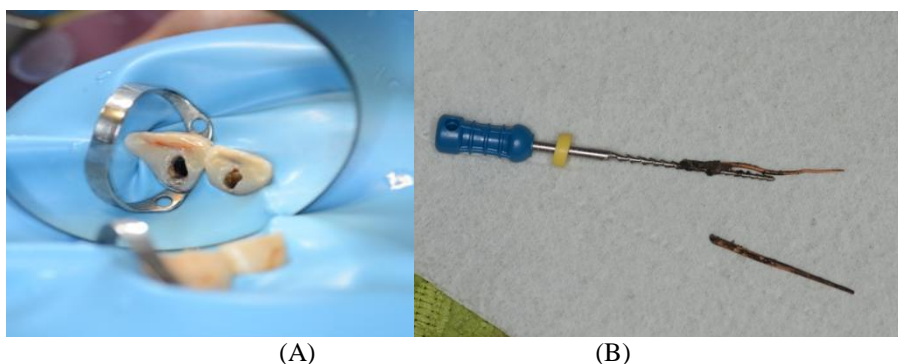
Figure 2 A. Access cavity preparation B. The gutta percha was removed using a hedstrom file

Root canal treatment was performed on tooth 11 and 12. First, the teeth were isolated using rubber dam, then access cavity preparation was performed. The gutta percha was removed using a hedstrom file in the central incisor (Figure 2). An apex locator was used to assess the working length and it was radiographically confirmed (Figure 3).

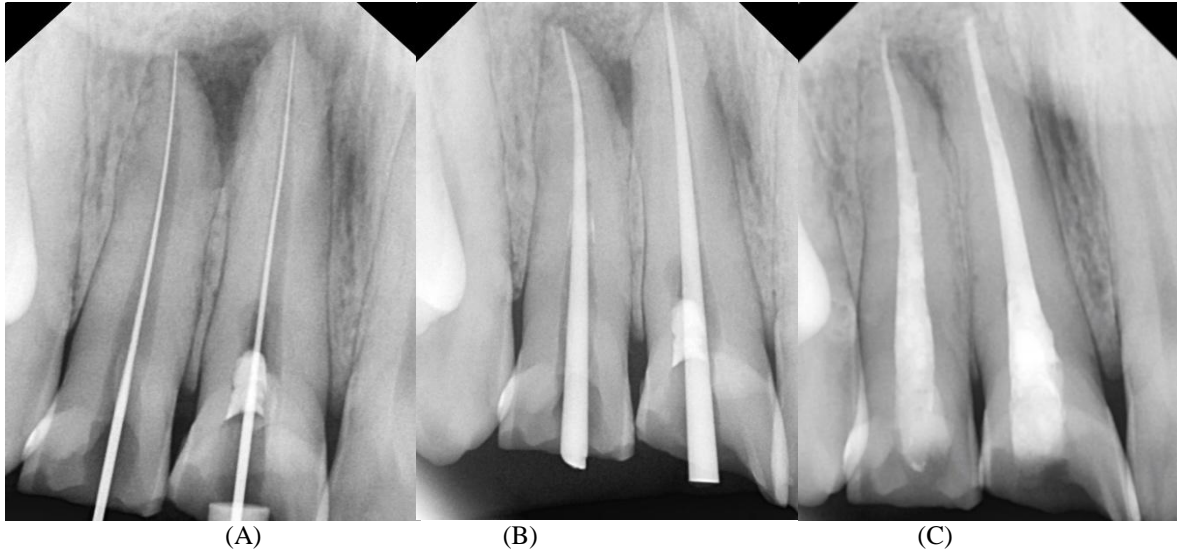
Figure 3. A. Working length confirmation with radiograph B. Gutta percha trial C. Obturation was confirmed radiographically

The biomechanical preparation of the root canal was performed using the crown-down pressure less technique. The canal was activated by a sonic activator (Endo Activator, Dentsply) with 5.25 percent sodium hypochlorite (NaOCl) irrigation between the instrumentations. Trial gutta point was performed, and radiographically confirmed (Figure 3). Next, the canal was obtured using gutta percha. Obturation was confirmed radiographically (figure 3) and temporary fillings were placed.

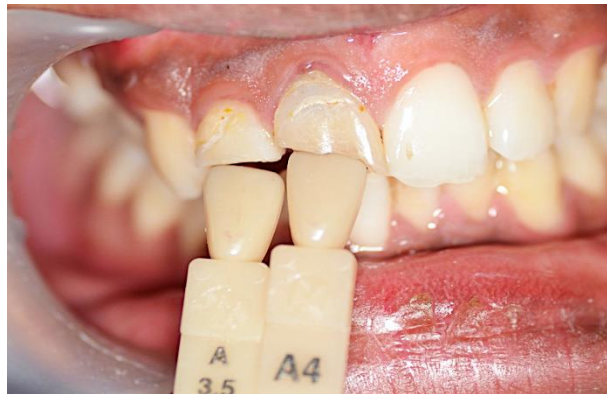
Figure 4. The color of the tooth was measured with a Vita 3D shade guide.

At the 1-week follow up, the extraoral and intra- oral revealed no symptoms or signs. The color of the tooth (Figure 4) was measured under regular daylight with a Vita 3D shade guide. The tooth was isolated using a rubber dam and removed the temporary fillings. Then, reduction 2mm of gutta percha in above the cemento-enamel junction (CEJ), and flowable composite as a cervical barrier was applied which used ski slope and bobsled tunnel appearance design. Bleaching agents (35% Hydrogen Peroxide) applied into the pulp chamber and light cured temporary fillings were placed.

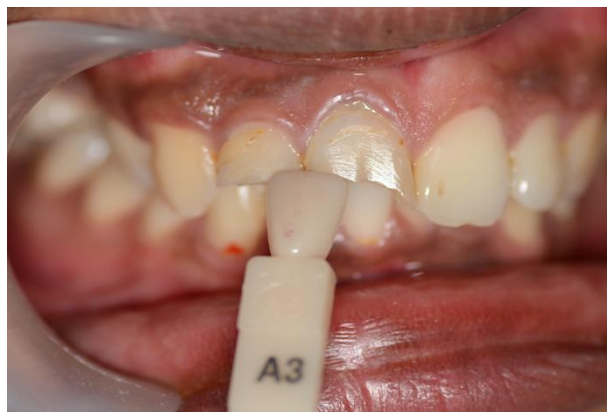
Figure 5. After 7-days follow up, the discolored tooth had similar color to the adjacent tooth

At the 7-days follow up, the discolored tooth had similar color to the adjacent tooth, checked with Vita shade guide (Figure 5). Temporary fillings were removed. The saline was rinsed and dried in the pulp chamber, calcium hydroxide was added, and placed in the dental chamber for a week until final restoration.

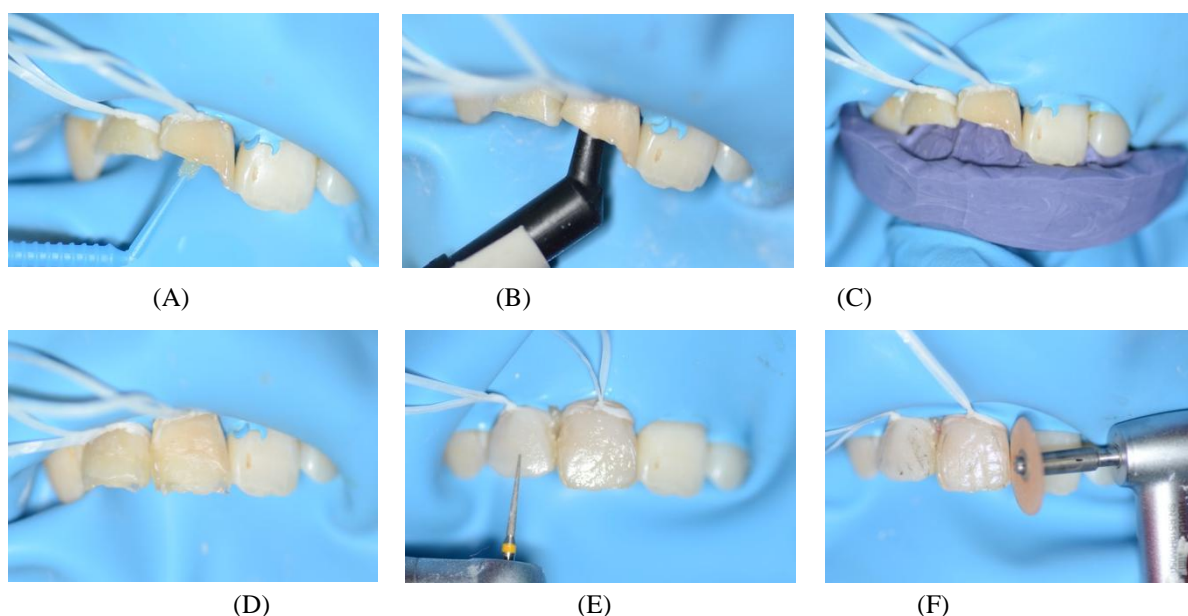
Figure 6. A. Bonding was applied B. Fiber reinforced composite applied as a core C. Palatal guidance D. Composite resin was applied E. Finishing using fine diamond bur F. Polishing using soflex disc

At the 1-week follow up, composite restoration was performed. The tooth was isolated using a rubber dam, 37% phosphoric acid was performed for 30 sec. Then, rinsed with water and dried. Bonding was applied in total etch system and light cured. Fiber reinforced composite applied as a core and permanent restoration was applied using light cured composite. Finishing and contouring done by using soflex disc and polishing done by using soflex disc (Figure 6). Patient satisfied with the result and were asked to come for follow up 1,2, and 12 months.

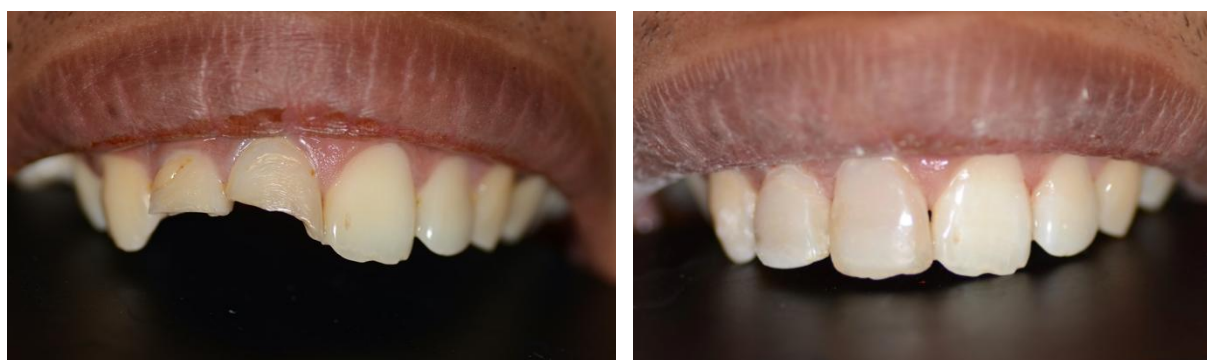
Figure 7. Labial view of before and after treatment
