Esthetic Management of Malpositioned Maxillary Anterior Implant by using Patient Specific Abutment: A Clinical Case Report

Dr Nikhil Verma, et. al. “Esthetic Management of Malpositioned Maxillary Anterior Implant by using Patient Specific Abutment: A Clinical Case Report.” *IOSR Journal of Dental and Medical Sciences (IOSR-JDMS)*, 22(3), 2023, pp. 39-42.

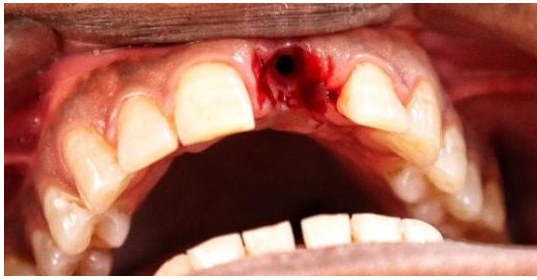
On the day of surgery, extraction of maxillary left central incisor was done followed by placement of endosseous implant, as the buccal cortical plate was found insufficient, implant has to be placed more labially inclined. Medications were prescribed for 5 days. Post-operative healing is uneventful.

Straight abutment was tried and found excessively in labial position that would not allow proper crown placement. However, even angulated abutment was not able to eliminate the labial emergence.

Fig. 1: Intraoral view showing labially oriented implant

So only treatment possible was to use custom abutment & hexed UCLA type plastic burnout pattern sleeve (Adin) in this case. Hence, patient was educated about the case and suitable treatment plan. Model was sent to lab with instruction to achieve ideal prosthetic position. The angulation of the sleeve was adjusted by molding and trimming. Incremental addition of inlay casting wax was done to obtain a framework similar to central incisor. Casting so obtained was tried on implant in patient mouth and checked for angulation, fit and clearance from adjacent tooth (Fig-2).

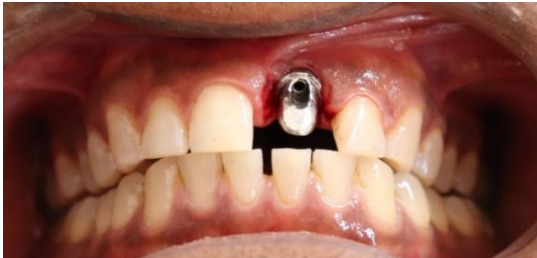
Fig. 2: Intraoral View showing improved emergence profile with custom abutment

Abutment were attached to the implant, screwed into them and tightened to 35 Nm using ratchet and motorized hex driver.

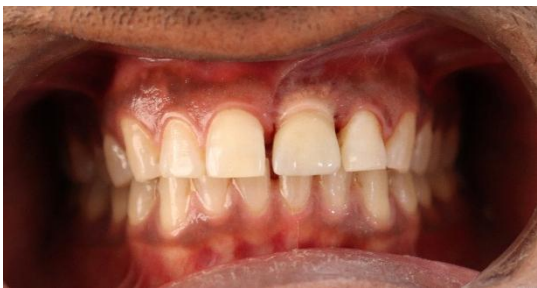
Fig. 3: Intraoral view of final prosthesis

For this patient cement retained PFM crown was chosen as final prosthesis which was shade matched properly. Trial seating of the prosthetic crown was done for verification of fit, angulation, esthetics and interferences. On conformation, final glazing was done. Then, the prosthetic PFM crown was cemented using Zinc Phosphate cement. (Fig-3)
