Investigation on Construction Techniques and the Material Usage of the Building

Abstract: Recorded structures are significant as far as both unique development methods and social legacy. In this way, material properties, development strategies and dynamic practices of these structures must be recognized so as to save them later on by reclamation contemplates. This examination is planned to fill in for instance for comparative structures in the area whose dividers were developed utilizing filled block with lime mortar and built utilizing both lumber and strengthened solid chunks. In this examination, the arrangement design, development methods and the material use of the structure were explored in detail. The mechanical and dynamic properties, for example, compressive pressure, versatile moduli, shear pressure, normal frequencies and mode states of the structure were resolved in-situ by level jack, shear and vibration tests. The limited component model of the structure was readied, and the modular investigation of the structure was performed. The alignment of the model was guaranteed by the vibration test results. The outcomes got from this examination give us that in-situ tests ar

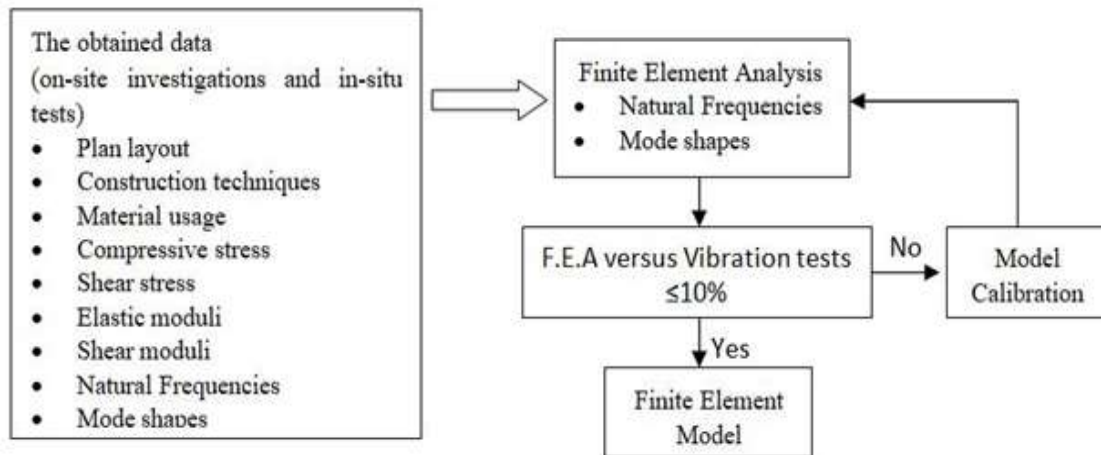
Figure 1. The flowchart of the study

In this study, the plan layout, construction techniques and material usage of the building were investigated on-site and the mechanical properties such as compressive stress, elastic moduli and shear stress of the masonry walls were investigated by using in-situ flat-jack and shear tests. The dynamic characteristics such as mode shapes and natural frequencies of the structure were analyzed by using in-situ vibration tests. The OMA test method was used for determining the dynamic characteristics of the structure. The finite element model of the structure was prepared, and the modal analysis of the structure was performed by using the ALGOR finite element program. The finite element model calibrations were done by comparing the frequencies obtained from the vibration tests and the finite element modal analysis. The process was repeated until the difference was under 10% and the finite element model was formed at the end. The flowchart of the study is presented in Figure 1.

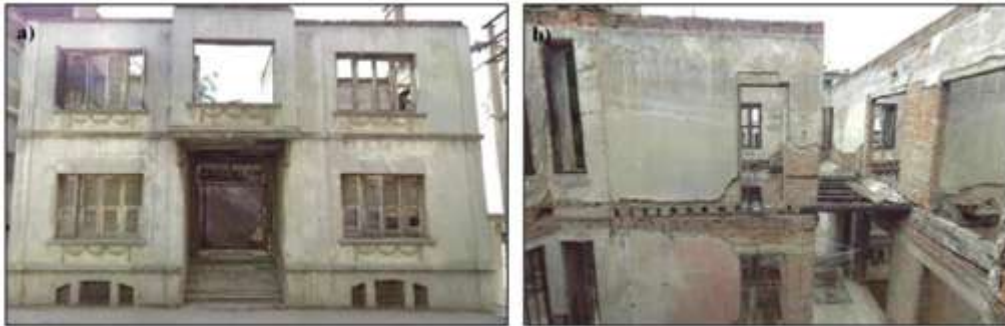
Figure 3. The studied building a) Outside view of the building b) Inside view of the building

The house gained its importance with the hosting of Mustafa Kemal Atatürk in 1934. The construction of the house began in the first quarter of the 20th century according to the architectural features. After it was exposed

to a fire in 1991, the house was unavailable for use (Figure 3). Timber beams, timber slabs and the roof of the building collapsed after the fire.

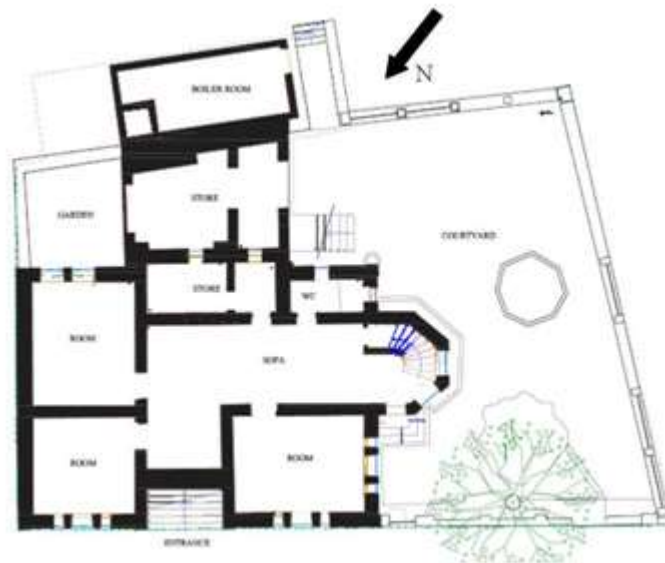
Figure 4. The basement floor plan of the building

The house has three storeys; basement, ground floor and first floor. The house has a courtyard. The basement height is 2.10 m, while the ground and first floor heights are both 3.50 m. The basement floor plan can be seen in Figure 4.

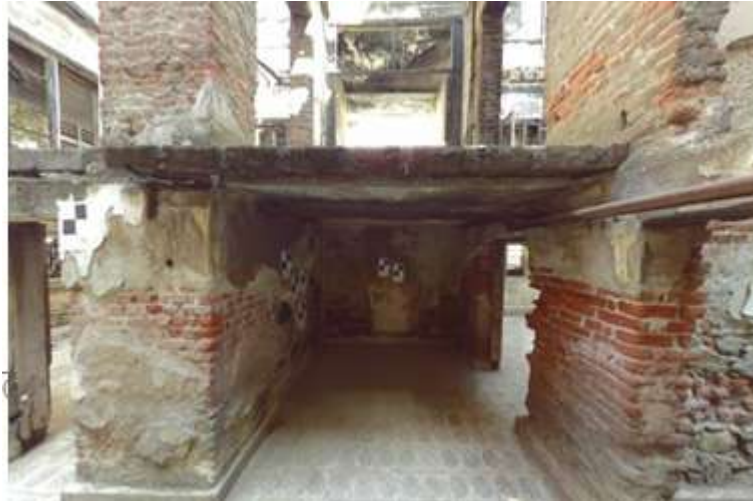
Figure 5. The reinforced concrete slab in the entrance part of the building

The walls of the building were constructed using brick material. Lime mortar was used as a binding material. Brick was used in the interior and exterior walls. The wall thicknesses are different for the exterior and interior walls. The exterior wall thicknesses are 50cm in the basement, and 40cm in the other storeys. The interior wall thicknesses are 45cm in the basement, 30cm in the ground floor and 25cm in the first floor. Two different techniques were used in the slab constructions. Timber slab was used in the living areas, while reinforced concrete slab was used in the wet areas and the entrance of the building. It is believed that these two types of slabs were constructed at the same time because there were no construction joints in the intersection of the walls, and the slab elevations are equal. Despite the fire, the reinforced concrete slabs are intact today (Figure 5).

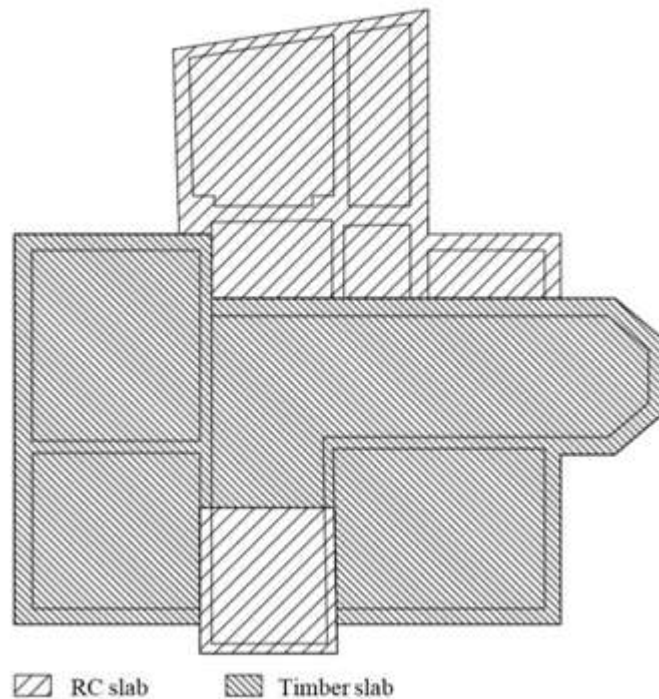
Figure 6. The reinforced concrete and timber slabs of the building

The reinforced concrete slab and timber slab usage in the construction of the building is shown in Figure 6.

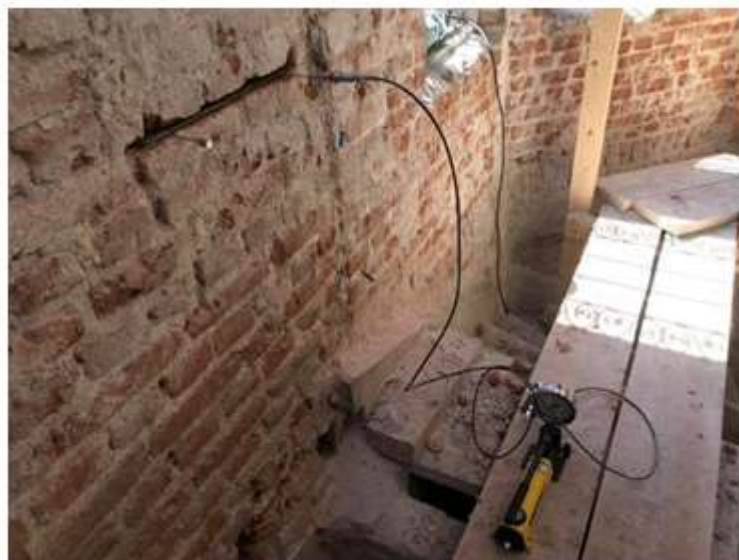
Figure 7. The mechanical tests: Single flat-jack test

The mechanical properties such as compressive stress, shear stress and elastic moduli of the walls were investigated by using in-situ flat-jack and shear tests. The single flat-jack method was used for determining the compressive stress and elastic moduli of the walls. In this method, a flatjack is inserted in a cut slot in the mortar and displacements are continuously read while hydraulic oil pressure is inflated into the flatjack (Figure 7). The tests were conducted according to ASTM C1197 and ASTM C1314 [14, 15].

Compressive stress	2.10 N/mm ²
Shear stress	0.50 N/mm ²
Elastic moduli	2750 N/mm ²

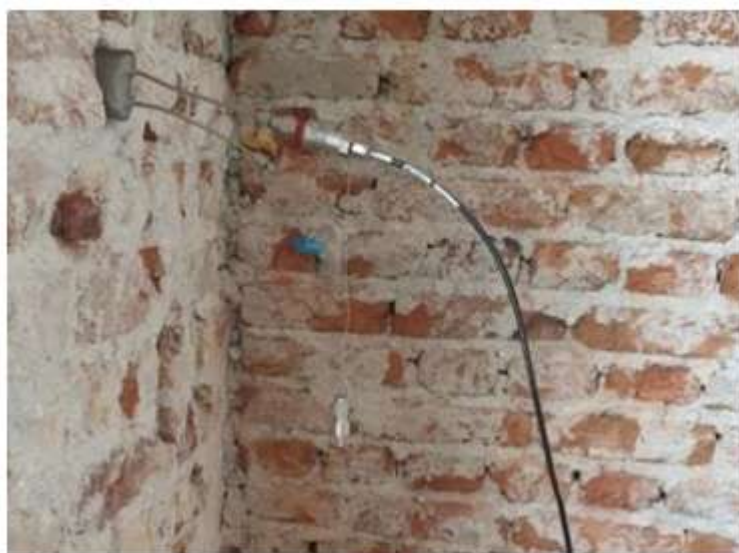
Figure 8. The mechanical tests: Shear test

The method C was used in the shear test according to ASTM C1531-09 [16]. In this method, the flatjack is horizontally inserted at one end of the test unit (Figure 8). The oil pressure is applied until the slip of the mortar occurs.

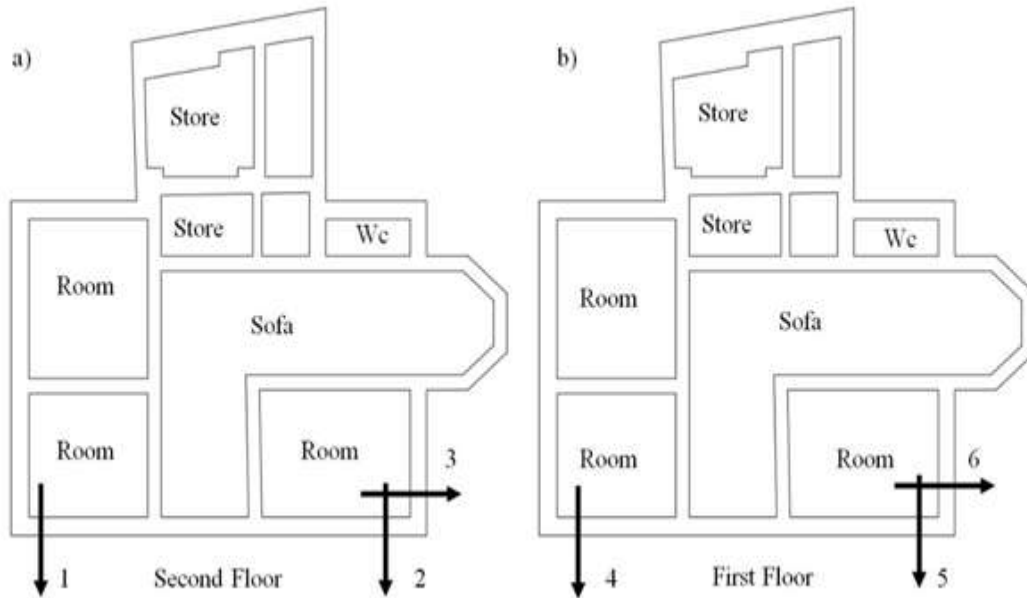
Figure 9. The sensor orientations on plan views a) Second floor b) First floor

[17]. Six uniaxial accelerometers were used and for the accuracy of the tests, 20~30 minute test periods were applied. In the sensor placements, the perpendicular orientations were carefully checked for all walls. The sensors were placed on top of the first and second floor corners. Three sensors were placed on each floor. The orientations of the sensors on the plan view are shown in Figure 9.

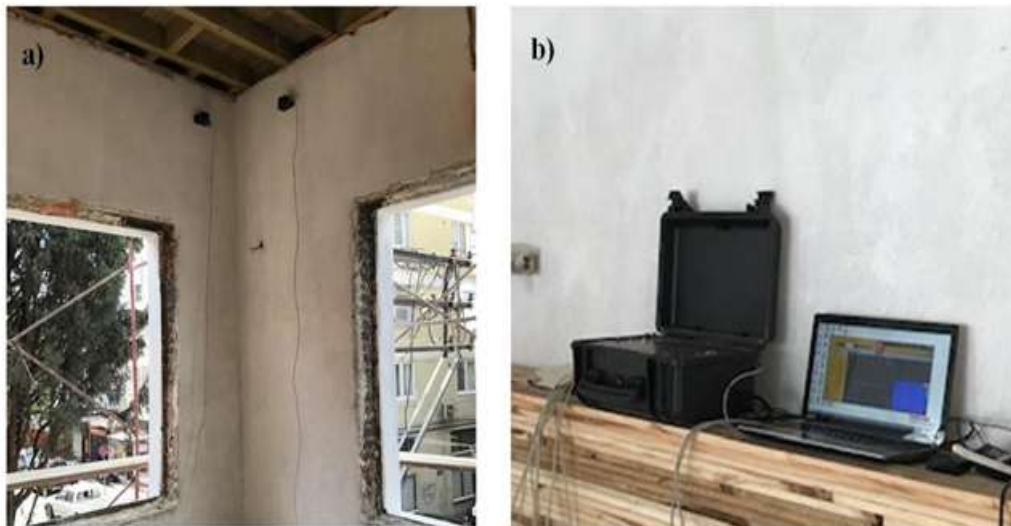
Figure 10. The sensor placements and the test equipment

The placements of sensor number 5 and sensor number 6 on the second floor and the test equipment can be seen in Figure 10.

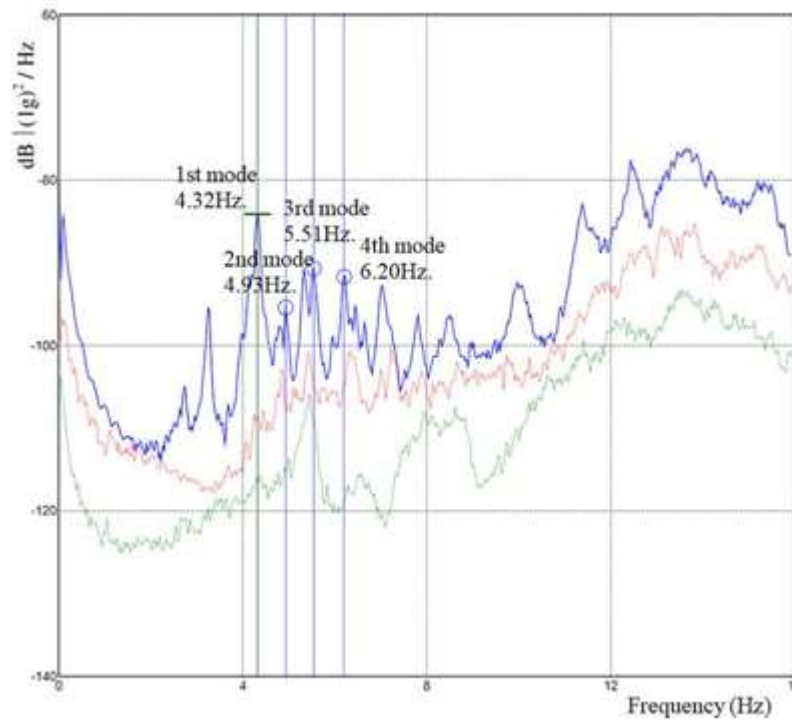
Figure 11. The singular values of the spectral densities

Frequency Domain Decomposition (FDD) was used in determination of the dynamic characteristics. The singular values of the spectral densities of the test setups are shown in Figure 11. The first mode frequencies can be seen in the figure.

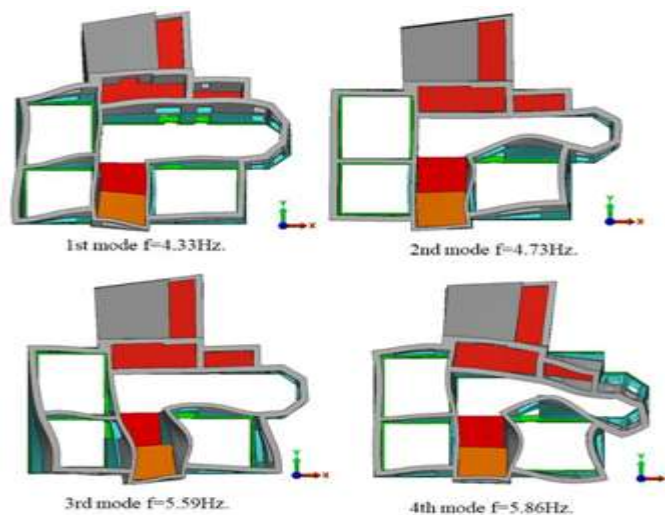
Figure 12. The first four mode shapes and frequencies

The elastic moduli of the walls were taken with an average of 2250 N/mm² after the calibrations. There is only an 18% difference between the flat-jack test results. The first four mode shapes and the frequencies are presented in figure 12. The first mode is the displacement in the y direction, the second mode is the torsion, the third mode is the displacement in the x direction and the fourth mode is the torsion.

The comparisons of the first four mode frequencies of the studied building between the vibration test results and the finite element analysis results after calibrations are presented in Table 2. It was determined that there was a maximum 5% difference between the frequency values. It can be stated that the finite element model of the structure now represents the real behavior of the structure correctly. Earthquake analysis, pushover analysis, and etc. can be done by using this model.

Mode Number	Vibration test	Finite element	Error
1	4.32	4.33	% 0.23
2	4.93	4.73	% 4
3	5.51	5.59	% 1.43
4	6.20	5.86	% 5.48
