## **The Geological – Mining and Geotechnical Opinion as a Supplement to the Geotechnical Documentation in a Region of the Past Underground Mining**

**Key words:** *geotechnical reporting, post-mining areas, mining influences*

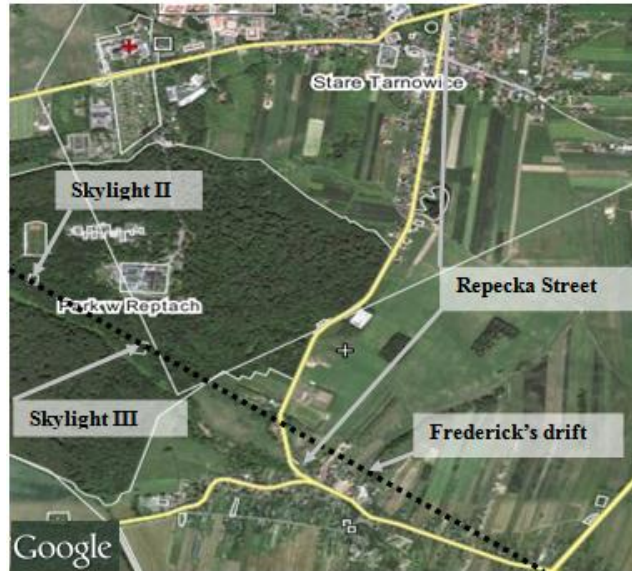
Fig. 2. Surface view of the Repecka Street in Tarnowskie Gory with the localisation of the main mining objects mentioned in the text [3]

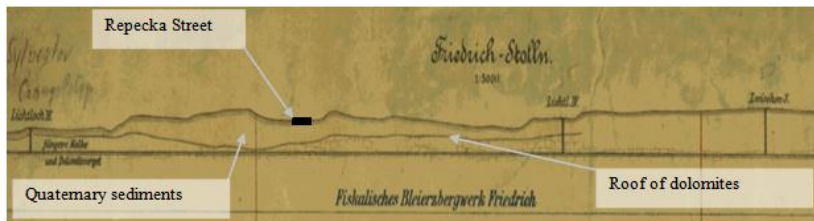
Fig.6. Cross section of the Frederick's drainage drift with the position of the roof of Triassic limestone formation and Quaternary sediments of variable thickness [1]

The only mining objects nearby the road are three small shafts (skylights) numbered as III and IV on Figures 4, 5, and 6. in the area of currently existing Natural Park and the Frederick’s drift; depth of the drift is

round 55 m below the surface. Profile of the Frederick's drift has been presented on the Fig. 6. The drift still collects water percolating from the surface to the bedrock with a daily output of 50.000 m<sup>3</sup> [8]. Nowadays, there is a possibility to take a boat trip through the drift between shafts (skylights) II and III, what belongs to the main local tourist attractions. Presence of water in the drift indicates that the working keeps its conductivity and has not been collapsed nor filled up with the quicksand.

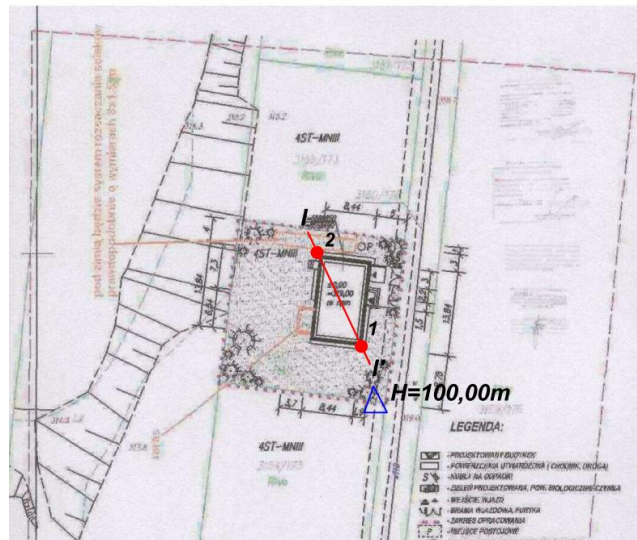
Fig.7. The schema of future investment. Location of examination boreholes, [5].

Two small diameter boreholes at the depth 4,0m (the sum equals 8 linear meters) for examination into water system and soil conditions. Macroscopic examinations and observation of water system were conducted during drilling (fig.7).

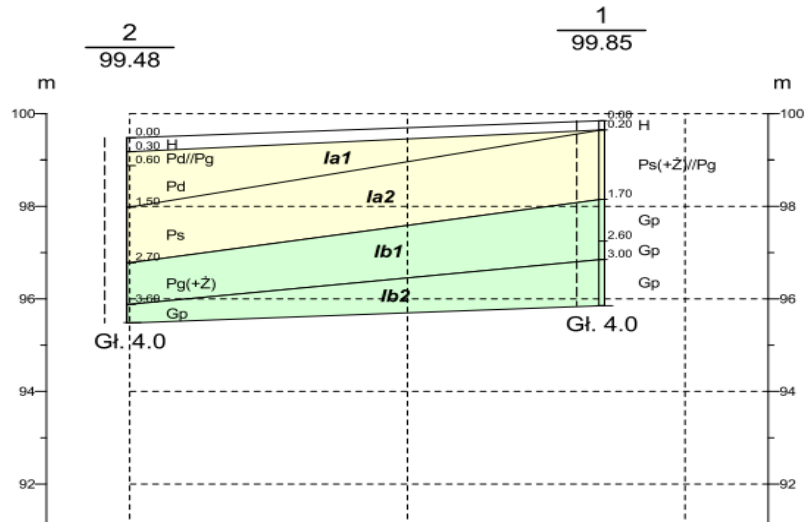
Fig.9. Geological cross-section, the holes no. 1 and 2, [5].

Supplementary information is given in documentation sheets (fig.8) and in geological cross-section (fig.9).

Basing on conducted field tests and research it can be stated that in the base of examined area – under the layer of unequally compressible ground (layer I with depth of 0,4m-1,3m) – there is low compactable and heaving bearing capacity. They are represented by middle compacted types of sand and gravel mix (layers IIa1-IIa3, fig.9).
