3D Laser Scanning and Close-Range Photogrammetry for Observation and Measuring the Reinforced Concrete (RC) Structural Cracks & Deflection

Magda Farhan, Hossam Eldin Fawzy and Reham Kandeel

Department of Civil Engineering, Faculty of Engineering, Kafr El-Sheikh University, Kafr El-Sheikh, Egypt.

Magda Farhan. "3D Laser Scanning and Close-Range Photogrammetry for Observation and Measuring the Reinforced Concrete (RC) Structural Cracks & Deflection". *IOSR Journal of Mechanical and Civil Engineering (IOSR-JMCE)*, 19(4), 2022, pp. 08-23.

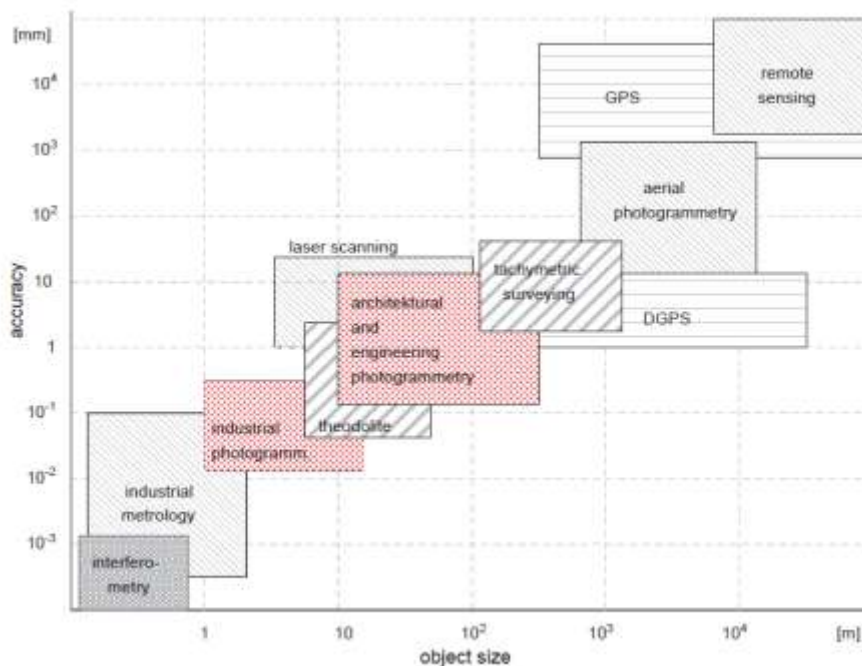
Figure 1: The relationship between target object size, accuracy and relevant technology

There exist many survey technologies that have a major function of getting the coordinates of any target under observation, such as: GPS, Total stations, remote sensing, photogrammetry, Laser scanning and others. Each of them has its own advantages and disadvantages considering cost, accuracy of measurement, distance covered and others. The following figure illustrates the relationship between target object size, accuracy and relevant technology [6].

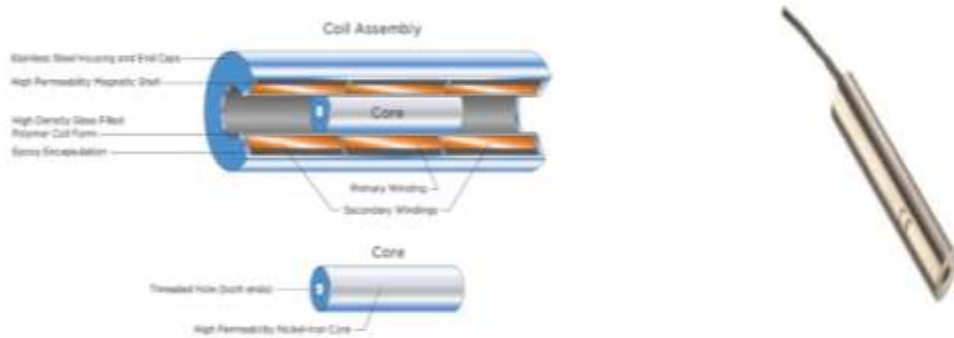
Figure 2: LVDT device

A LVDT is an electromechanical passive (not capable of generating energy) inductive position transducer that can convert linear motion (better to say, rectilinear motion), when mechanically coupled to the target object, into a corresponding electrical signal as shown in the following figure (2).

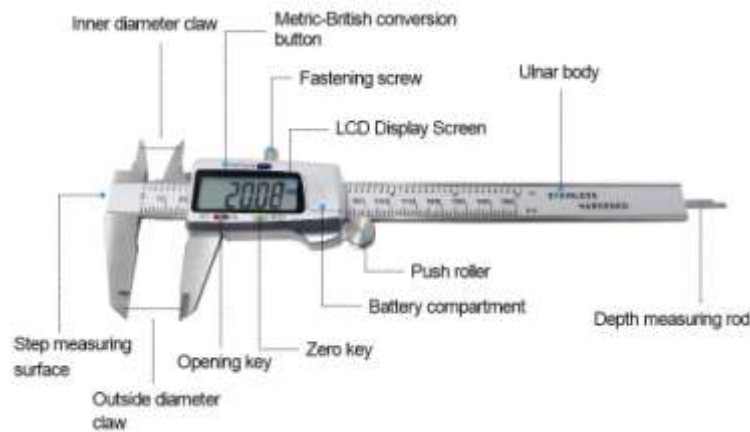
Figure 3: Digital Vernier - VINCA DCLA-0605

The digital Vernier (or calipers) is a precision instrument useful in taking accurate linear measurements like depth, diameters, lengths, etc. It is available in many sizes (150 mm, 300 mm and up to 2000 mm) and vary in the accuracy and resolution depending on the manufacturer and some Vernier devices can reach resolution of 0.01 mm. It also available with digital display to obtain the reading of the caliper instead of manually reading the measurement.

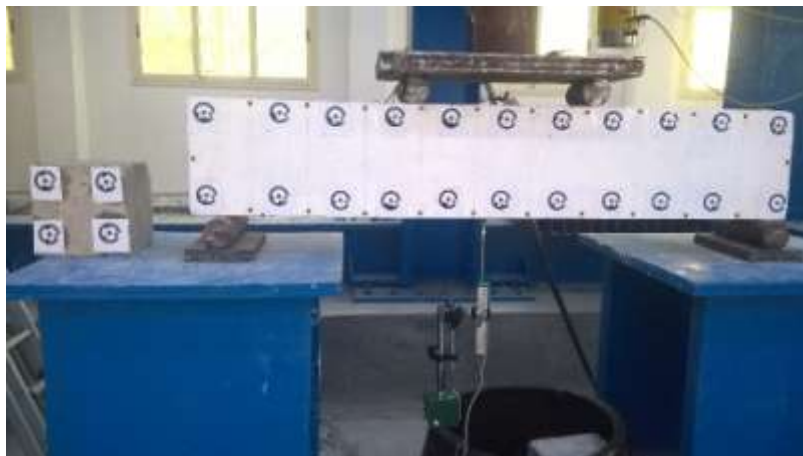
Figure 4: Test beam – No Loading case

The experiment performed under this research aims to investigate and compare the methodologies mentioned in this study in monitoring and detecting cracks and deflection in a loaded reinforced concrete beam. The beam was loaded in a 4-point load test as shown in the following figures. The test lab is composed of a steel frame, two movable I-beam girders functioning as a support for test beams, a double acting hydraulic cylinder (to apply the desired load) of 150-ton capacity and 150 mm maximum stroke connected to a hydraulic pump, a load cell of 225-ton capacity to measure the applied load.

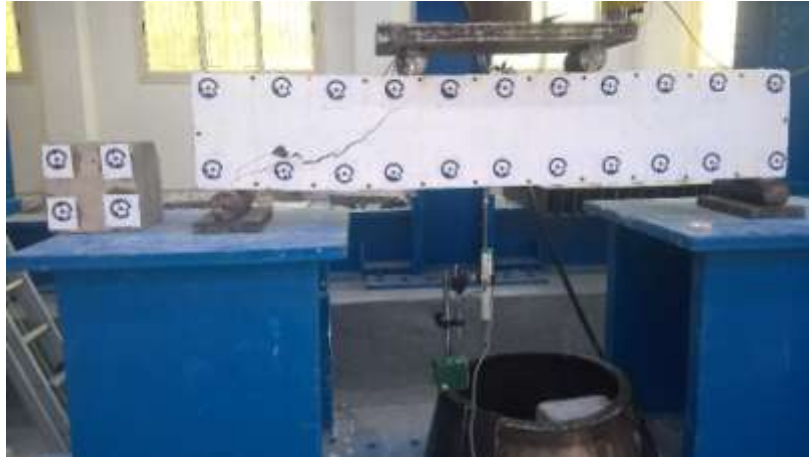
Figure 5: Test beam under loading

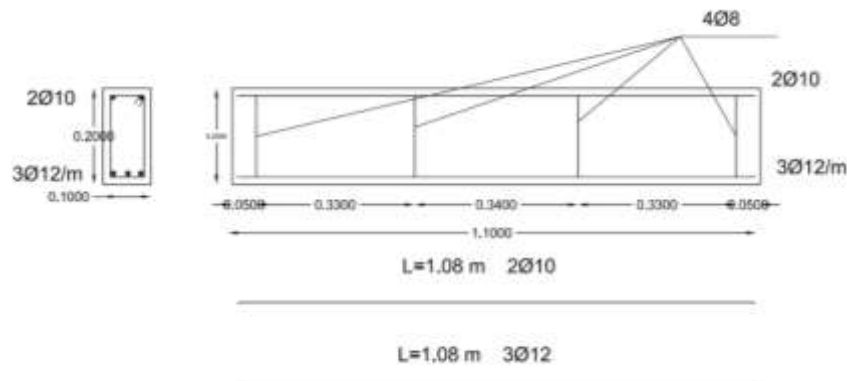
The reinforced concrete test beam has dimensions of 1100 mm length \times 200 mm depth \times 100 mm width. Steel reinforcement details were 3 ϕ 12 mm (lower bars), 2 ϕ 10 mm (upper bars), with 4 ϕ 8 mm (see figure below).

Figure 6: Reinforcement of test beam

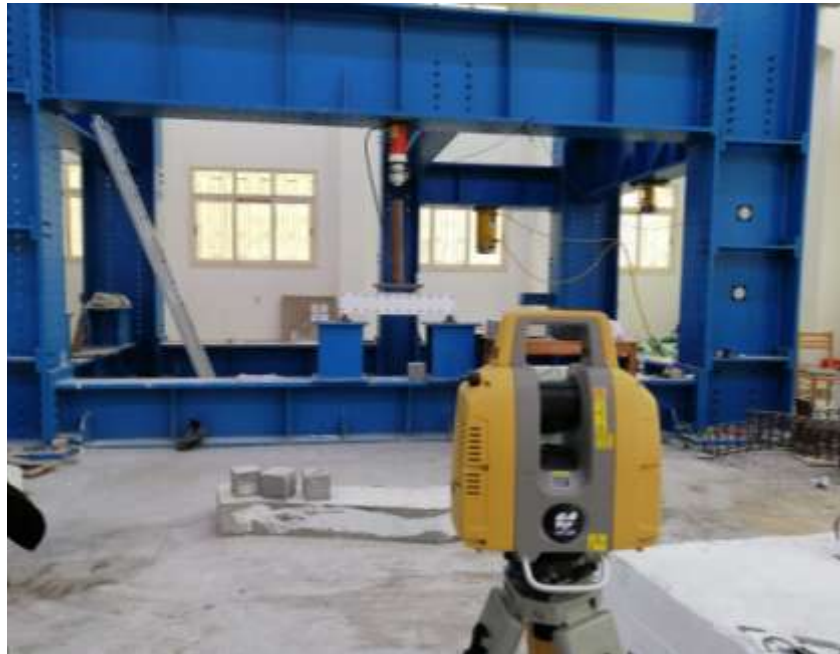
Figure 7: View of the experiment

Three loading cases have been applied to the test beam, which are: Ultimate case, Crack case & Failure case. For the photogrammetric system to function properly, 22 code targets were attached to the side surface of the test beam as shown in the previous figures. These targets were observed by the different methods under considerations of this study (Total station, Photogrammetry & Laser scanner) and the results were collected for each of them.

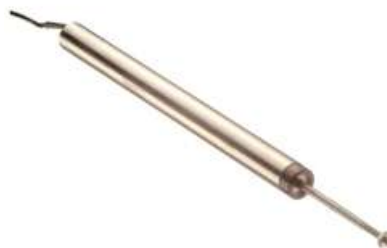
- up to 75 mm travel
- <0.2% Linearity
- Rugged 19 mm Dia. Stainless Steel Body
- Rigid Stainless Steel Carrier
- IP67 Protection
- Guided Core for Easy Installation

Figure 8: LVDT – LD320-25

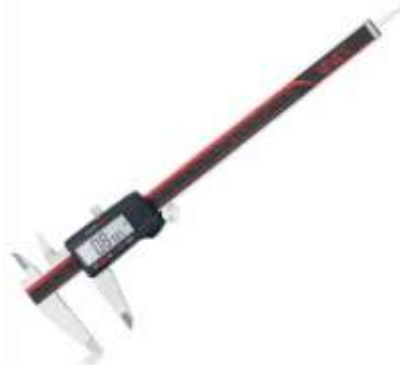
- Material is stainless steel.
- Total length is 6-in/150-mm.
- Accuracy of 0.001 in (0.02mm)
- Resolution of 0.0005 in (0.01 mm).

Figure 9: Digital Vernier - VINCA DCLA-0605

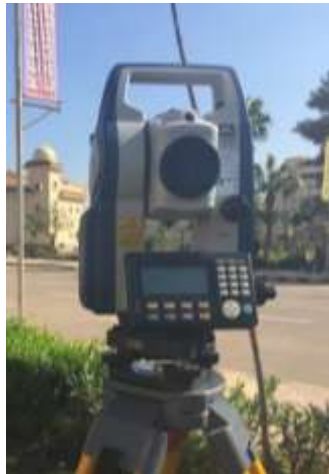
A total station SOKKIA CX-105 shown in the following figure was used in this study. The technical specifications of the total station is listed in Table 1 [29] [30].

Figure 10: SOKKIA CX105 total station

Resolution of display	1/5 in. 0.005/0.02 mil
Accuracy	5 in.
Laser beam (mode of Reflector-less)	Class 3R/Prism/sheet mode: Class 1
Range of reflector-less mode	Up to 0.5 km
Range of prism mode	1.3-4000 m/Under good conditions: to 5000 m
Resolution Display	Fine/Rapid: 0.001 m/0.01 ft./1/8 in
Tracking	0.01 m/0.1 ft./1/2 in
Accuracy Reflector-less	(3+2 ppm x D) mm
Prism Mode	(2+2 ppm x D) mm
Zooming in	30 x
Data Storage	10,000 points Internal storage
Communications	USB memory
Temperature of Operating	-20 to + 50 C
Operating Time	Approx. 36 h

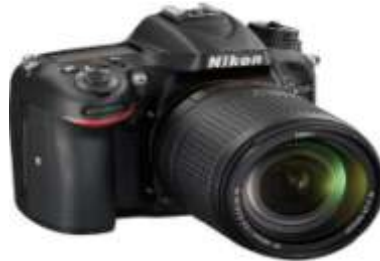
- 24.2 MP CMOS sensor
- 2016 pixel RGB metering sensor
- 1/8000 sec maximum shutter speed
- 3.2", 1.2M dot RGBW LCD display
- Dual SD card slots
- Wi-Fi with NFC

Figure 11: Nikon D7200 Photogrammetric Camera

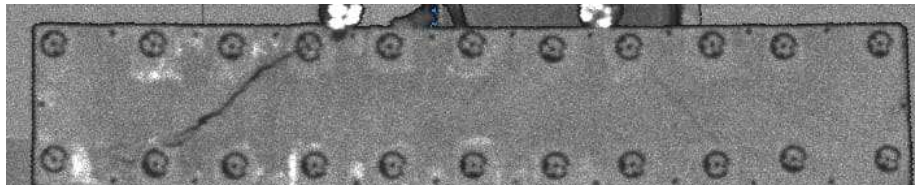
Figure 14: View of the test beam observed from TLS

As stated before, the deflection of the test beam was measured by the LVDT located at the middle of the concrete beam using, at each of the three loading cases (ultimate, crack, and failure). The total station SOKKIA CX105 was also used to observe and monitor the 22 coded control sites and the crack width was measured using the digital Vernier. This is shown in figures (13 & 14). The following is a table with the results:

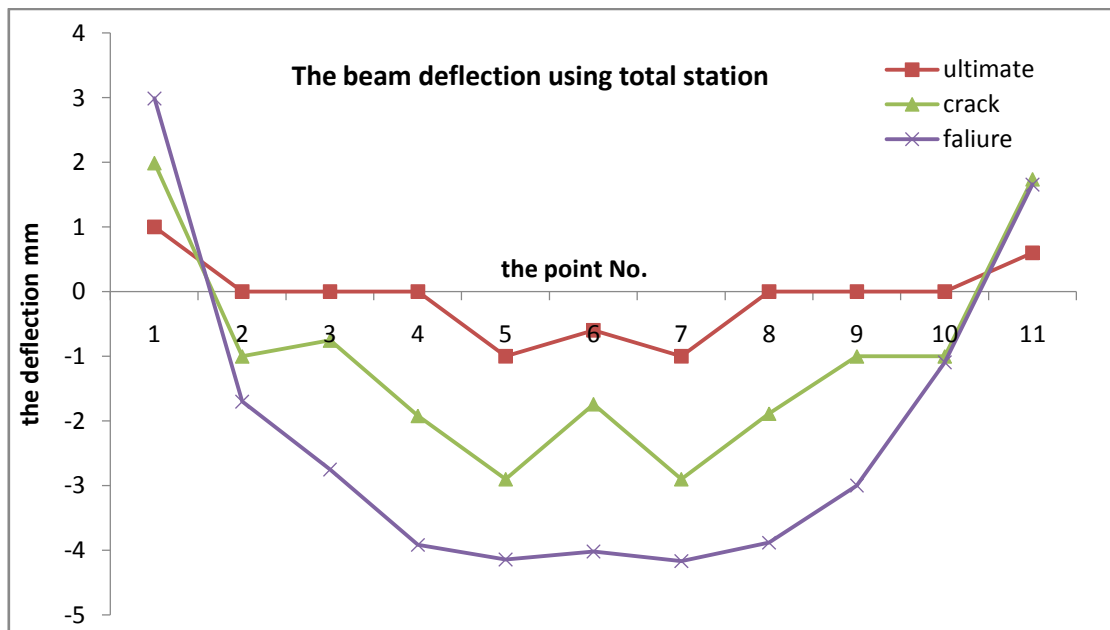
Figure 15: The beam deflection using total station in 3 cases (ultimate, crack, failure)

1) For beam deflection: The Root Mean Square Error (RMSE) was calculated for each technique in reference to LVDT readings. RMSE of total station results is 0.28, RMSE of photogrammetry is 0.46 and RMSE of laser scanner is 0.47. That means total station has provided the closest results to LVDT then follows photogrammetry then finally Laser scanner.

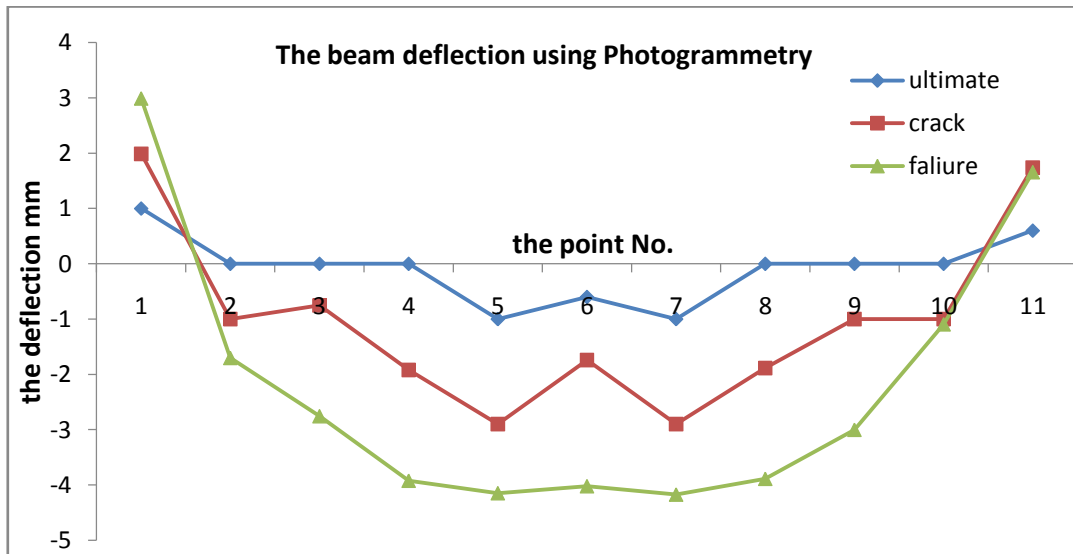
Figure 16: The beam deflection using Photogrammetry in 3 cases (ultimate, crack, failure)

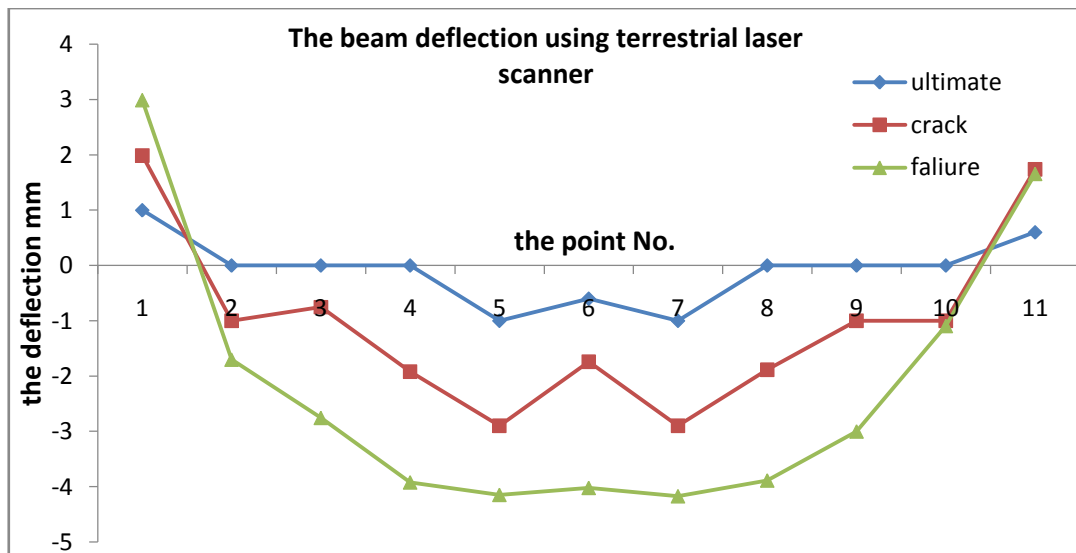
Figure 17: The beam deflection using Laser scanner in 3 cases (ultimate, crack, failure)
