## Non-Destructive Ultrasonic Testings on a Monumental Structure of The Historical Center of Cagliari (Italy)

**Abstract:** *The Municipal Center for Art and Culture Exmà is an excellent result of the transformation of a mono-functional structure (the old abattoir of Cagliari) into a polyfunctional pole dedicated to art that has hosted major events since nineties. In order to monitor the conservation state of the building materials of this monument, mostly carbonate rocks, non-destructive ultrasonic analyses have been carried out since 2007. Ultrasonic data have been related to the physical and mineralogical-petrographic features of the investigated building materials, in order to correlate the elastic properties with their intrinsic ones. In situ ultrasonic investigations were performed on the outer walls of the main building of the monumental complex, subjected to various restoration works. The methodology used in this study proved useful to evaluate and monitor the weathering process, verify the effectiveness of the old restoration works and check the thickness of the weathered shallow part of the masonry by means of refraction techniques.*

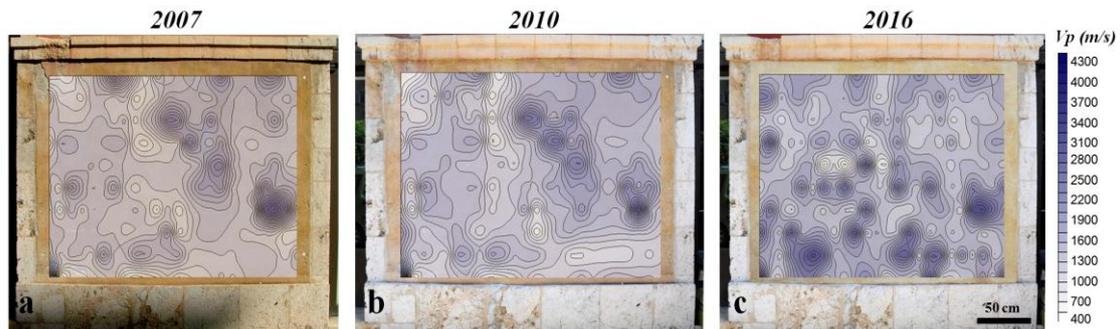
**Figure 4:** Ultrasonic in time monitoring on an external panel of *Sala delle Volte* (Exmà): a) ultrasonic survey carried out in 2007; b) ultrasonic survey carried out in 2010; ultrasonic survey carried out in 2016 (after the restoration works of 2014).

specific graphic software in order to achieve a bidimensional map of the distribution of the longitudinal ultrasonic velocity pulses. In order to facilitate the data interpretation, the map was overlaid in transparency on the digital image of the investigated panel. As deduced from different tests carried out in different conditions, the velocity values on the maps must be interpreted as relative. One possible tool to monitor the evolution of the weathering of the panel building materials is by in time ultrasonic monitoring. To determine the feasibility of the method, over a period of many years we acquired separate relative ultrasonic surveys that observed the distribution of the longitudinal velocity in time and in the same environmental conditions. As an example in Fig. 4, a,b, we show the 2007 and 2010 ultrasonic surveys.

The differences between the first (2007) and the second (2010) map is evident. An increase in low velocity areas can be observed in time. This is a consequence of the increase in weathering which affects the propagation of the longitudinal velocity through the materials.

The low velocity areas in the maps mainly represent degradation of the building materials and weakness zones. The analyzed masonry is predominantly made up of *Pietra Cantone* blocks, as can be deduced both by comparing the *in situ* velocity measurements with the laboratory results and by considering the information deduced from the petrographical study. The lower velocity values are in correspondence of the areas where the plaster detached. These sectors, which are more exposed to water infiltration and rising damp, are subject to an intense circulation of water and to a higher retention of it in the areas under the plaster, where the *Pietra Cantone* blocks are found.

Thanks to ultrasonic in time monitoring of the investigated structures, it was possible to make interesting deductions on the evolution in time of the conservation status of the heterogeneous wall materials. After the restoration works in 2014 (Fig. 4c), the elastic-mechanical conditions of the shallow part of the building materials improved slightly, which leads to the conclusion that the restoration was mostly aesthetic.
