Stability analysis and simulated hydrologic response of some vulnerable slopes in Nigeria implications for rainfall-induced landslides

O. Igwe¹

¹Department of Geology, University of Nigeria, Nsukka, Enugu State, Nigeria

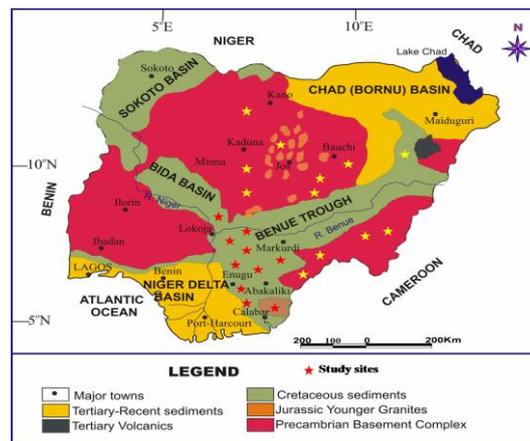
Figure 1: Study sites underlain by the different geologic units

Field survey and aerial photographs were used in the mapping and identification of landslides (using Crozier 1984, 1986 as standard) in several locations covering the northern and southern parts of Nigeria (Fig. 1). The geologic and stratigraphic setting of the study locations are discussed in detail in Caby (1989), Ephraim (2012), Igwe et al. (2013) and Igwe (2014). On the basis of their location, size, age, freshness, morphology and materials displaced, some landslides were selected for detailed mapping and documentation. Structural conditions of the slopes, nature of the old and new landslides, possible failure mechanisms and processes were studied. Failures that are typical to different areas were identified and classified using Cruden and Varnes (1996), and Hungr et al. (2001).

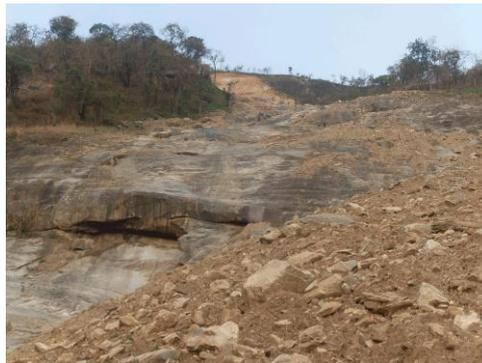
Figure 2: A translational slide on one of the slopes on the Benue mountain range in the North (photo by Igwe)

182 landslides and scars were identified by field survey and aerial photographs out of which 36 were selected for detailed mapping and documentation. Most landslides occurred on slopes $> 40^\circ$ in the north and $> 30^\circ$ in the south. The landslides in the north were predominantly shallow translational slides (> 300 m in length on average) which failure did not appear to significantly alter the steepness of the hard rock terrains (Fig. 2). Curiously, the steepness of the slopes adjacent to some of the failures tended to be inversely proportional to the runout length. On the contrary, some mass movements in the south tended to make the local slope steeper because of the nature of failure (shallow movements < 10 m on average) on the loose sandstone terrains that often defy remedial measures (Fig. 3). Landslide inventory of the study areas showed that landslides in the north consisted of mainly falls, debris flow and occasional debris avalanche. In the south the landslides were mainly slumps, short runout slides and occasional debris flow.

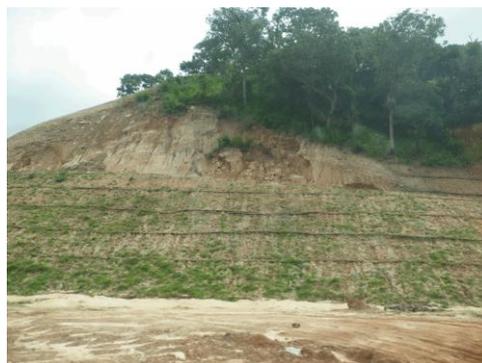
Figure 3: A slope near Nsukka Southeast Nigeria revealing failure on a remediated portion (photo by Fukuoka)

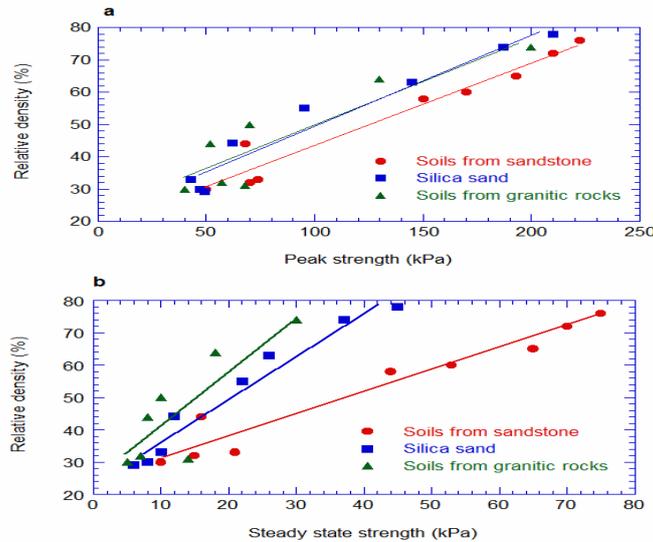
Figures 4a and b: The peak and steady state strength characteristics of the different slope soils

The frequency of events also showed that landslides were relatively less frequent in the north. Owing to these differences in frequency and failure mode, landslide volume in the north tended to be greater (averaging $615,000 \text{ m}^3$) than those in the south (with an average of 5021 m^3). The average value of the geotechnical and hydraulic properties of the samples are shown in Table 1, while the variation of factor of safety with B_D value is summarized in Table 2. The strength characteristics of the materials are presented in Fig. 4.

At all density, the peak and steady-state strength of the specimens from the sedimentary terrain are higher than those from the hard rock region. The peak strength of the silica sands used as control is almost the same with those of specimens from hard rock terrains. The compressibility characteristics of materials affect their shearing resistance (Igwe 2014). Highly compressible soils experience more severe reduction in sample height and permeability (Fortin et al 2007) which results in higher excess pore pressure and lower strength. It is remarkable that the steady-state strength of the silica sands is noticeably different from that of the hard rock

locality (Fig. 4b). This appears to confirm the validity and reliability of the use of the steady-state parameters in the stability models. At steady-state, all particle rearrangement and restructuring cease and pore pressure, effective stress and shear resistance remain constant (Poulos 1981). The most remarkable find however, is that whereas the gradient of the peak and steady-state strength of the soils derived from sandstones are nearly the same, the gradient of the steady-state strength of silica sand and soils derived from granitic rocks tend to be steeper than their peak strength (Fig. 4a,b). The result shows that at large shear displacements, the steady-state strength of more compressible materials are not significantly affected by changes in density, which may be a reason for the longer travel distances of landslides involving such soils. In the stability model, the factor of safety varied from 4.5 to 0.98 for soils from the sedimentary locations (Fig. 5a).

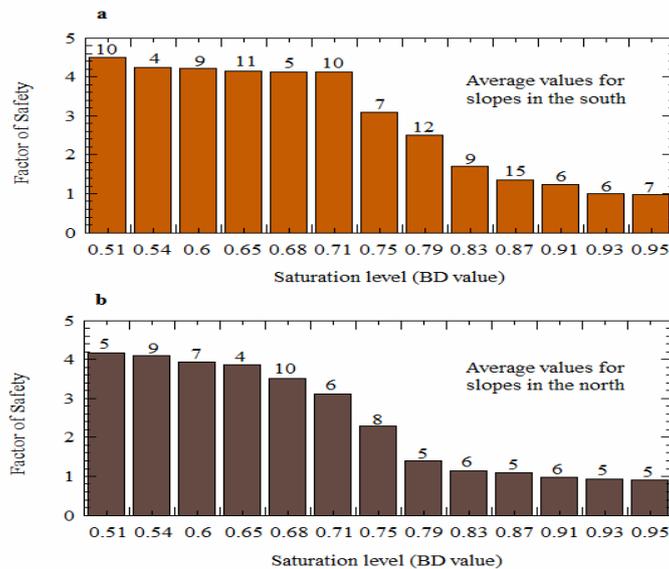
Figures 5a and b: The variation of factor of safety with changing saturation level

For soils from the igneous and metamorphic terrain, FS varied from 4.1 to 0.94 (Fig. 5b). In both cases, the onset of instability began at B_D value < 0.80 . In the infinite slope model, similar results were obtained as the factor of safety decreased with increasing moisture content m and slope angle α for all the slopes (Figs. 6 and 7).

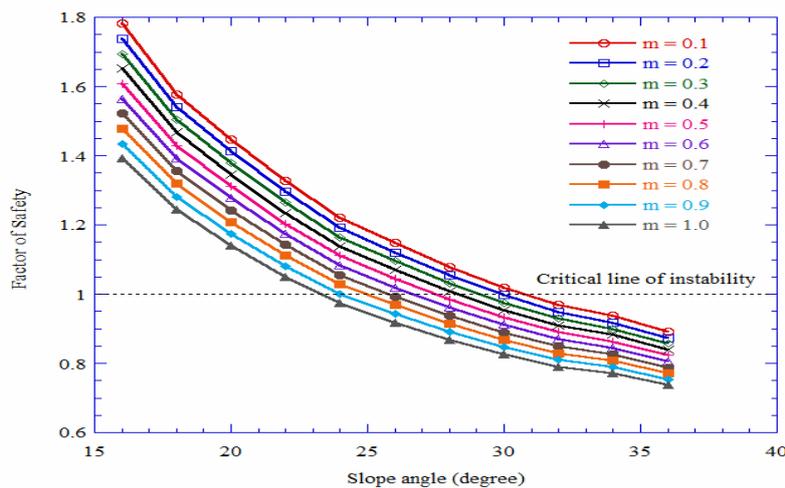
Figure 6: The effect of saturation and slope angle on the factor of safety for slopes on sedimentary rocks

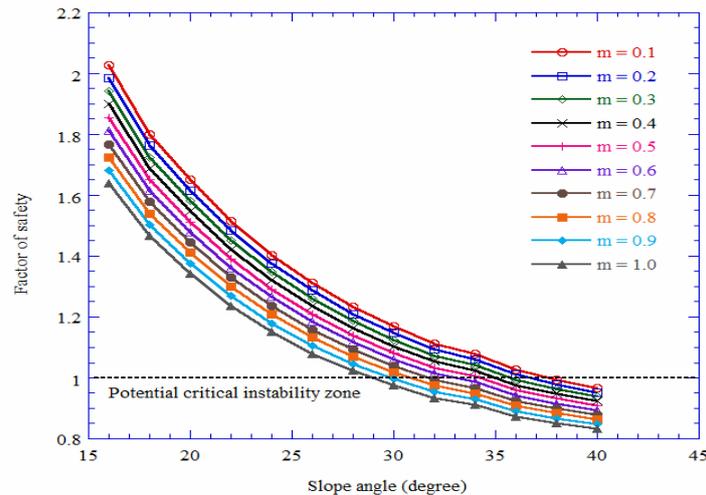
Figure 7: The relationship between factor of safety and slope angle for slopes on igneous and metamorphic rocks

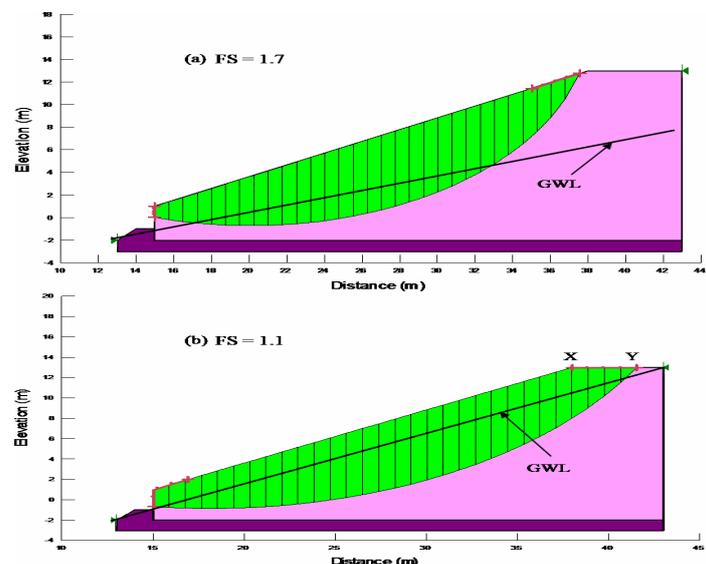
Figures 8a and b: Stability analysis using actual ground water levels of the study area

Investigation using actual groundwater levels of the two regions showed that at deeper groundwater level in the South FS was 1.7 Fig. 8a, but became 1.1 at shallower groundwater table in the North Fig. 8b, showing there was significant drop in FS with increasing saturation. The extension XY (Fig. 8b) may indicate additional instability on the landscape. Similar responses of residual soils to changes in hydrologic conditions have been reported by Reid et al. (1988), Onda et al. (2004) and Rahardjo et al. (2005). It also shows that where appropriate drainage is undertaken, there would be drastic improvement of FS.
