## Esthetic Rehabilitation For Mutilated Anterior Teeth – A Case Report

**Abstract:** The practical and esthetic reinstatement of severely mutilated anterior teeth is a challenge to clinicians in their daily practice. An endodontically treated anterior tooth requires extra coronal restoration when the tooth structure is weakened or lost due to caries, endodontic treatment, placement of previous restoration and/or is discoloured. The reduced tooth structure makes retention of extra coronal restorations difficult. This article describes a case report on restoration of mutilated maxillary anterior teeth using cast post and core, followed by layered zirconia restoration.

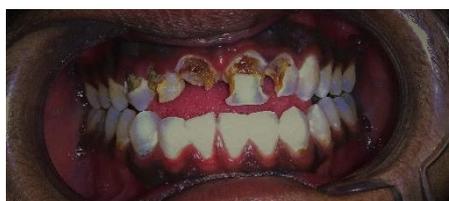
Fig. 1: Pre-operative frontal view

A 23-year-old male patient reported to the Department of Prosthodontics, at D.Y. Patil University, School of Dentistry, Nerul, Navi Mumbai with a chief complaint of poor appearance of his front teeth. The patient had undergone endodontic treatment for his five anterior teeth five months ago, due to caries (Fig.1).

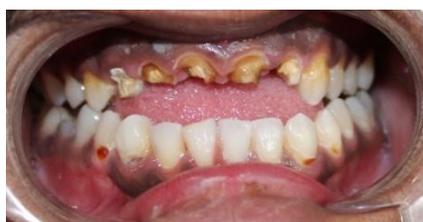
**Fig. 3:** Pre-operative frontal view

Initial treatment sequence started with removal of unsupported enamel and caries (Fig. 3). Followed by crown lengthening procedure for 11,12,13,21 and 22 (Fig. 4) with osseous reduction with the help of a stent, as it is of paramount importance to the longevity of restored endodontically treated tooth the presence of adequate height (1.5-2mm) of sound tooth structure or ferrule, between the core and the crown margin (Fig. 5).<sup>[3]</sup>
