## **Geotechnical Evaluation of Kalijhora Landslide on Sevok – Teesta Bazaar Road, Along NH 10, Kalimpong District, West Bengal.**

**Pranatosh DasMondal\***

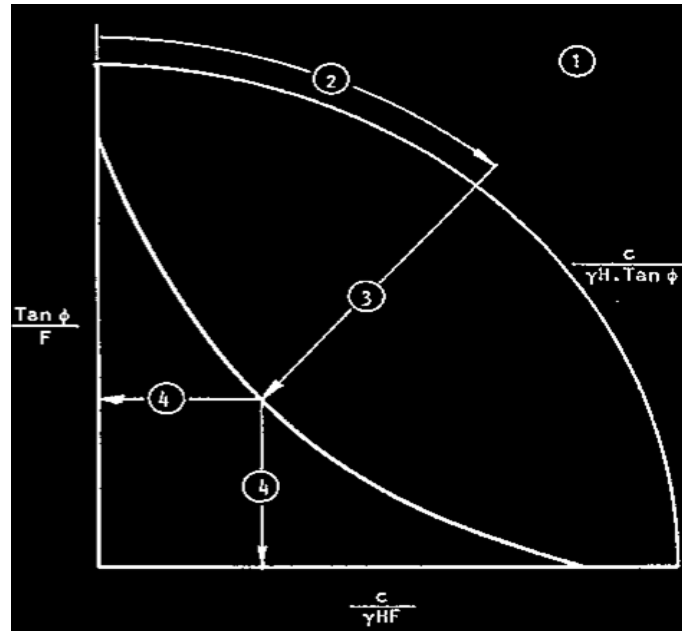
Figure 5. Calculation of Factor of safety from Circular Failure Chart (Hoek & Bray,)

The value of dimensionless ratio ( $C/\gamma.H.\tan \phi$ ) from the data obtained from field observations and tests conducted is calculated. (Fig.5)

The corresponding value of  $\tan \phi/F$  (Y-intercept) and  $C/\gamma. H.$  (X-intercept) is found out by projecting horizontally and vertically on two axes of the chart. Hence the F value is calculated as average of the above two F values (obtained from X & Y intercepts)
