## **A Geophysical Investigation for Subsurface Characterization and Structural failure at the Site of a Building, Southwestern Nigeria**

**Abstract :** This study reports a geophysical survey involving the electrical resistivity method utilizing the Vertical Electrical Sounding (VES) and Electrical Imaging techniques conducted around the distressed walls of a School building with the aim of studying the causes of distress in the walls and characterizing the soil conditions of the area. A total of 20 Vertical Electrical Sounding (VES) stations were occupied using Schlumberger Configuration with AB/2 varying from 1 to 65 m. In the electrical imaging, dipole-dipole array was adopted and the two traverses were occupied in the S-N and E-W directions close to where the wall cracks were manifested. Four geoelectric sequences were delineated within the study area. These include the topsoil, weathered layer, partially weathered/fractured basement and fresh basement. Two linear features (suspected fault) were identified by the electrical imaging on bedrock along the S-N direction. Results identified differential settlement resulting from incompetent subsoil materials and faulted bedrock as

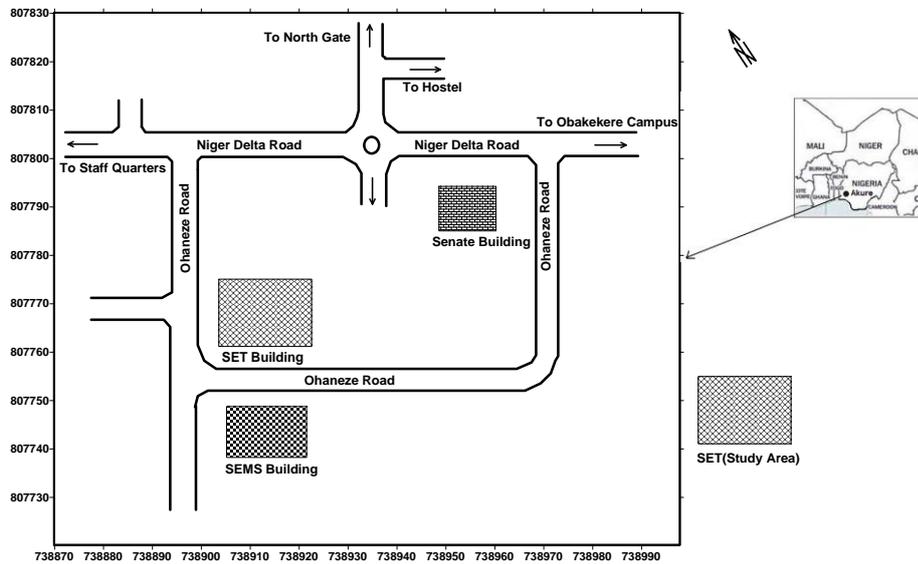
In order to ascertain the causes of such failure, which manifests as ground subsidence, major cracks and dislocation of the walls of a school building in south-western Nigeria (Fig. 1), a geophysical investigation involving the electrical resistivity method was therefore carried out with the aim of delineating geoelectric layer and their geoelectric parameters, mapping the soil corrosivity and identifying possible geologic structures such as fractures and faults that may be responsible for the structural failure of the building.

**Figure 1: Surface expression of the bedrock and effects on a major pillar**
