Geophysical Investigations of a Pavement Failure Along Akure-Ijare Road, Southwestern Nigeria

Abstract: Geophysical investigations were carried out along two failed segments of Akure-Ijare road, named locality 1 and locality 2, with the aim of establishing the cause(s) of the incessant pavement failure along the road. The geophysical investigations involved the Very Low Frequency Electromagnetic (VLF-EM) and Electrical Resistivity Methods. The VLF-EM measurements were taken at intervals of 10 m along traverses parallel to road pavements. Two techniques were adopted for the electrical resistivity method namely: the vertical electrical sounding (VES) and a combination of horizontal profiling and sounding using dipole-dipole configuration with inter stations separation (a) of 5 m and an expansion factor (n) that varies from 1 to 5. The Schlumberger configuration was used for the VES with $AB/2$ varying from 1 to 65 m. Nine (9) and twelve (12) VES were carried out at localities 1 and 2 respectively. The VLF-EM method revealed that the road pavement is founded on a weakly conductive material devoid of major geological structure. The Vertical electrical sounding curves range from A, H t

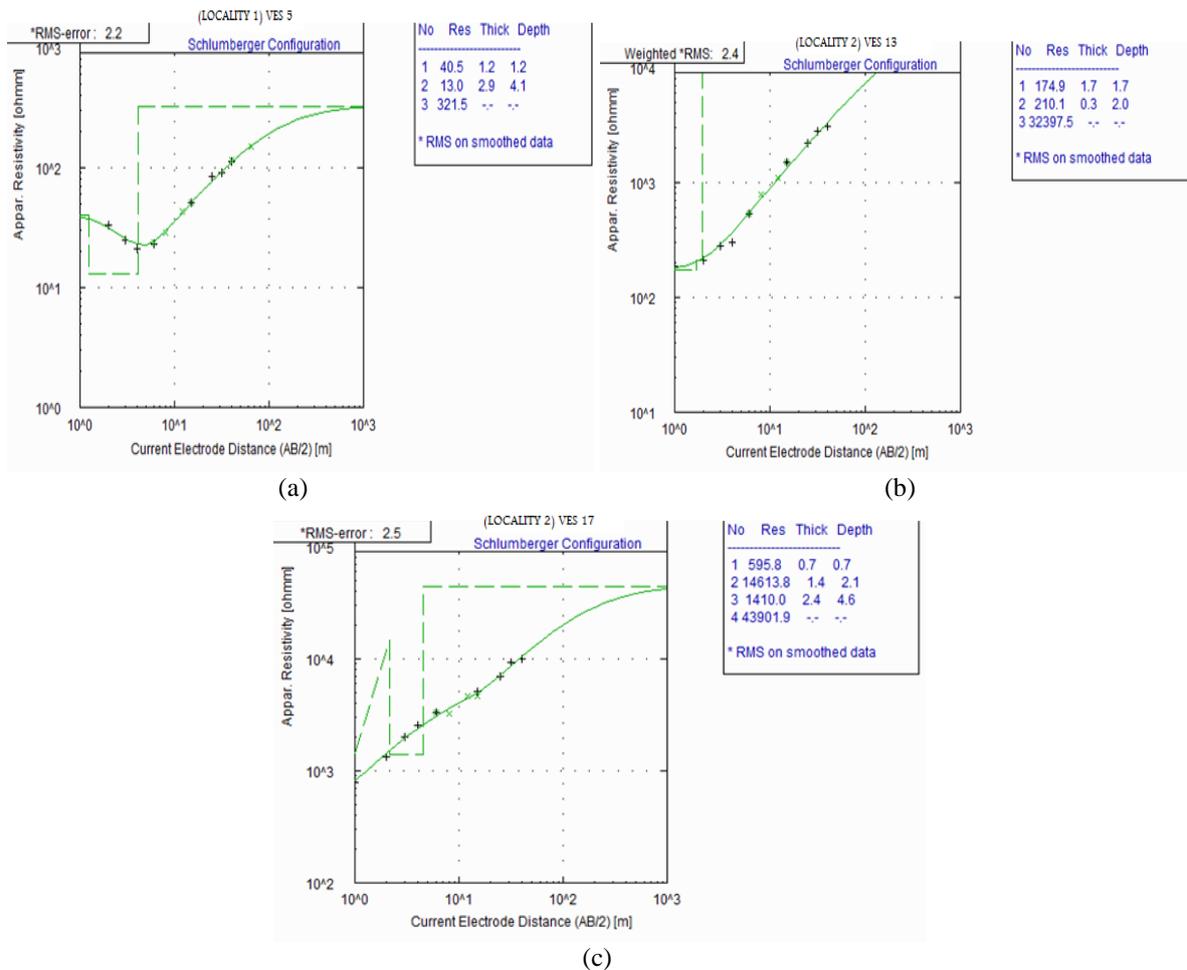
Figure 6: Typical curve types obtained in the Study Area (a) H curve (b) A curve (c) KH curve

The summary of the interpreted VES curves is presented in Table 1 – 2. The curve types identified in the studied area are H, A and KH “Fig. 6”. The most occurring curve types are H-curve and A-type; with each having 43 % and KH-curve type has 14 % of the entire curve types identified “Fig. 7”. All the curve types in locality 1 are H-curve type. The curve shows that the lithologic sequence delineated are mainly 3 layers and 4 layers.
