## **Geoelectrical Investigation of a Failed Portion of Ajaokuta-Itobe Road, North-Central Nigeria.**

**Abstract:** A Geoelectrical investigation was carried out along a segment of the Ajaokuta- Itobe highway in Kogi State, North-Central Nigeria with the aim of establishing the cause(s) of the failure of that portion of the road. Vertical Electrical Sounding (VES) involving the Schlumberger array and 2-D imaging using the dipole-dipole configuration were both utilized along a 200m traverse established parallel to the road covering both the stable and failed portions. Four subsurface geologic layers were inferred from the result of the 2D imagine. A topsoil with resistivity values ranging from 42Ωm to 84.4Ωm, weathered layer with very low resistivity values from 14.7Ωm to 38Ωm, fractured basement (Resistivity varying between 92.1Ωm to 227Ωm) and the fresh basement with resistivity value as high as 2440Ωm. The curve types identified from the interpretation of the Vertical electrical Sounding were HA, AA, HA, and A type, with the number of layers delineated by the geoelectric section being four (4). The topsoil (sandy clay) for the first three (3) VES points have resistivity values o

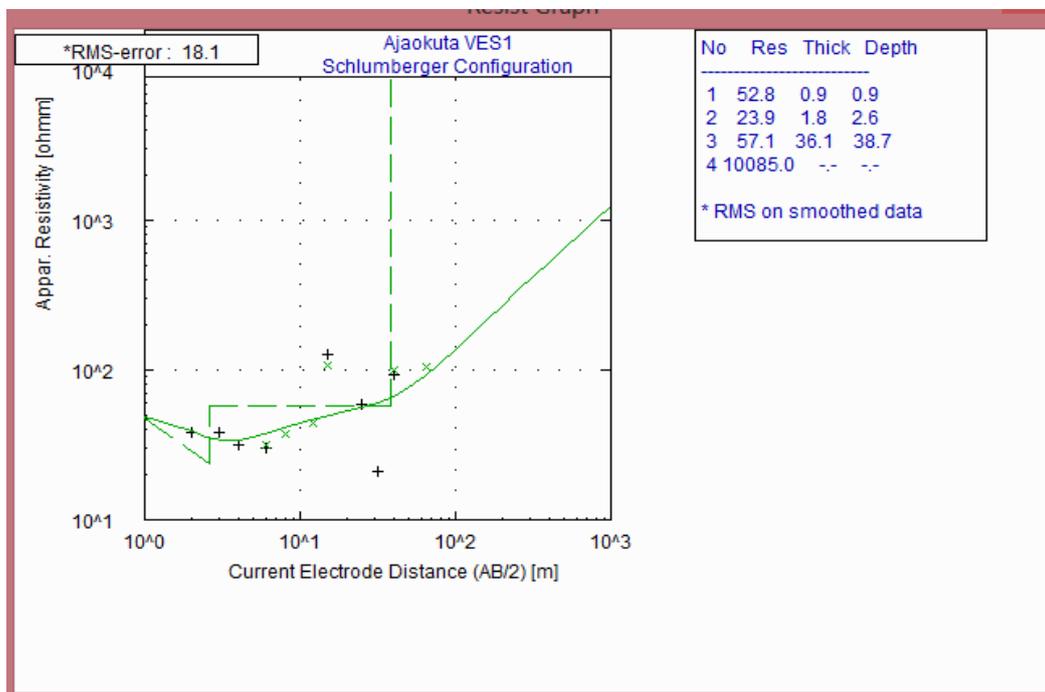
Figure 5.0: Typical Vertical Electrical Sounding Curve and Model Parameters

The interpreted VES curves obtained from the study area is summarized as shown in table 1.0. The curve types identified include HA, AA, HA, and A type, with the number of layers delineated by the geoelectric section being four (4) (Fig 6.0). The topsoil (sandy clay) for the first three (3) VES points have resistivity values of  $54\Omega\text{m}$ ,  $27\Omega\text{m}$  and  $50\Omega\text{m}$  with thickness of 0.9m, 0.9m and 0.7m respectively. For the fourth VES point, the topsoil has been replaced by the weathered layer with resistivity value of  $42\Omega\text{m}$  and thickness of 6.7m. The second layer (clay) has resistivity values ranging from  $10\Omega\text{m}$  to  $45\Omega\text{m}$  and its thickness is in the range of 2 to 7m. The third layer delineated with resistivity values of  $57\Omega\text{m}$ ,  $182\Omega\text{m}$ ,  $74\Omega\text{m}$  and  $406\Omega\text{m}$  (which is the weathered basement) is very thick at VES point 1(36m) but almost disappears at VES point 3. Its thickness at VES points 2 and 4 are 10m and 4.4m respectively. The fourth layer having resistivity values between  $406\Omega\text{m}$  and infinity represents the fresh basement rock.
