Evaluation of Beam Alignment Collimation, Reproducibility and Accuracy of Diagnostic X-Ray Machines at Public and Private Hospitals in Sokoto Metropolis

Abstract: Quality control on diagnostic X-ray machine in Radiological units of two public Hospital and two private diagnostic centers in Sokoto metropolis designated UDUTH, SHS, MDC, CDC was carried out using Beam Alignment and collimator test tool, KVP Reproducibility and Accuracy meter. The study was based on Technical standards for Radiological Protection and Quality control in medical diagnosis. The collimator and Bean alignment tests were used to measure the degree of misalignment of the target points while the kVp Accuracy and Reproducibility were also ascertained at different sets kVps. The techniques employed in measuring the percentage of misalignment was based on congruence of x-ray field and light to ascertain whether the light field accurately define the x-ray field, the value of percentage of misalignment calculated were then compared with minimum accepted value of not less than 2% as recommended by International Commission on Radiological Units and Measurements (ICRU). The hospitals under study shows to have percenta

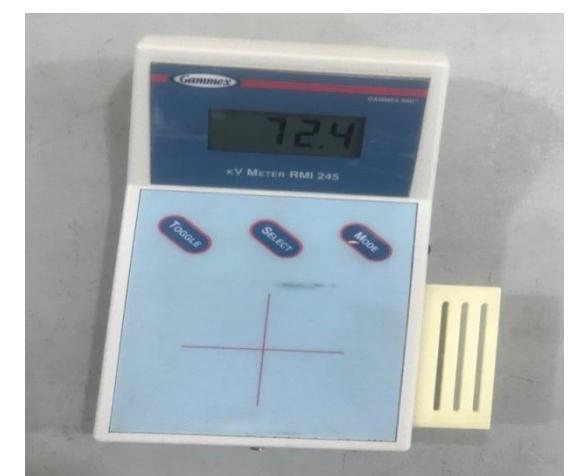
Figure 2.1: KVp Meter RMI 245 obtainable at Energy Research and Training Center Zaria.

The kVp meter RMI 245 compact was used in this study. This meter simplifies the determination of actual kVp for radiographic, fluoroscopic and mammographic x-ray systems. This highly accurate meter can be used for a wide range of energies and can store up to ten readings.

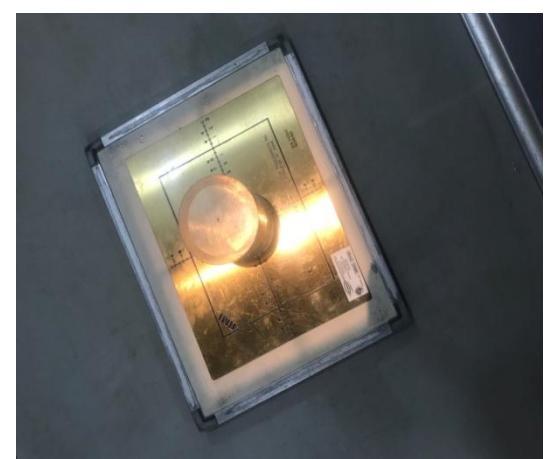
Figure 2.2: Gammex 161B x-ray beam alignment test tool with a 24 x 30cm cassette obtainable at Energy Research and Training Center Zaria.

To assure that the light field accurately defines the X-ray field, the light and X-ray field mis-alignment should not exceed 2% of the source-to-image distance (SID) in either the length or width of the film. For this test an X-ray light/beam alignment test tool (Fig.2.2), loaded with 24 x 30 cm (10 x 12 inch) cassette and measuring tape were used.

A 24 x 30 cm (10 x 12 inch) loaded cassette was placed in the Bucky and the SID was set at 100 cm (40 inches). Tape measure was used to verify. The test tool was placed over the cassette (parallel to its edges). The light beam diaphragm collimator was adjusted so that the light beam covers exactly the inner pattern of the test tool. An exposure with approximately 50 kVp and 4 mAs was performed. The film was developed and kept with the image of the test tool.

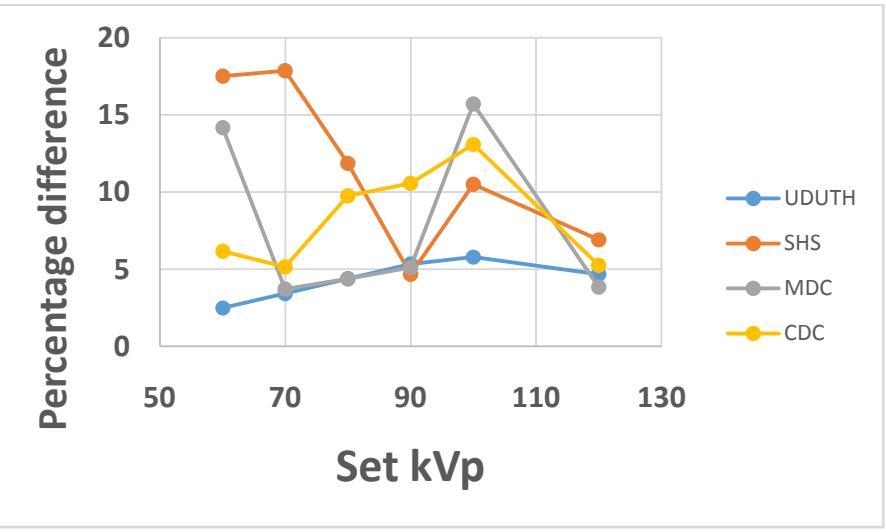
On the other hand the kVppercentage of accuracy of the tested kVp values at all study areas Table 3.6 - 3.9 shows the results. At UDUTH the percentage of the accuracy of all the tested kVp values falls within the rage of 2.50% to 5.80 %. While at SHS the percentage difference is within the range of 4.67 % to 17.86 %. At SHS only two tested kVp (90 kVp and 120 kVp) values pass the criteria. At MDC, the percentage difference of the facility unit is within the range of 3.71 % to 15.70 %. Half of the tested kVp values (60 kVp, 100 kVp and 120) fails the criteria. The facility unit at SHS and MDC has single phase generator. Most devices with single-phase generators did not have a good presentation in voltage accuracy test, which can be due to high ripple voltage (Rasuli et al, 2015). Moreover, single-phase generators hardly met linearity (mA) criteria, which was due to the high performance of filament in machine tube and the imbalance between the generated heat and outgoing electrons. Whileat CDC, the percentage difference of the facility unit is within the range of 5.14 % to 13.10 %. Only two tested kVp values (90 kVp and 100 kVp) fails the criteria.

The kVp percentage difference (accuracy) test indicates that only UDUTH facility unit meet the acceptance limit of not greater than 10 %. However at the remaining three study areas there is fluctuation of the percentage of accuracy of the tested set kVp's. The percentage accuracy of some set kVp's are below the designed limit. Specifically the accuracy of 100 kVp is above the limit at all the three areas (SHS, MDC and CDC) as depicted in Fig.3.1. For machines with high percentage difference in kVp values, there is high risk of over-exposure(Tyovenda et al, 2017).
