# Microscope-Assisted Ultrasonic Retrieval Of A Separated Endodontic Instrument In The Buccal Canal Of A Mandibular Premolar: A Case Report.

**Keywords:** Separated instrument, fractured file retrieval, mandibular premolar, ultrasonic technique, endodontic complication.

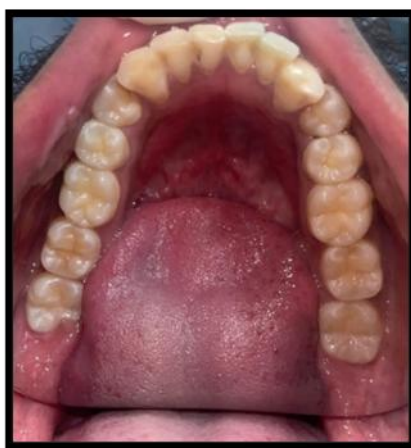
Intraoral examination revealed a deep carious lesion involving the mandibular premolar. The tooth exhibited tenderness on vertical percussion. No swelling or sinus tract was observed in the surrounding soft tissues.

*Figure 1: Intra-Oral Clinical Picture*

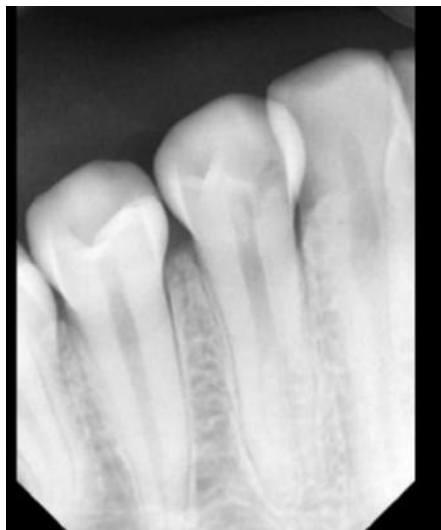
A preoperative intraoral periapical radiograph revealed a deep carious lesion approaching the pulp chamber. The tooth demonstrated two distinct roots consistent with the typical morphology of mandibular premolars.

Mild widening of the periodontal ligament space was observed around the root apex. No significant periapical radiolucency was noted.

**Figure 2: Intra-Oral Periapical Radiograph**

Based on the clinical and radiographic findings, nonsurgical root canal treatment was planned.

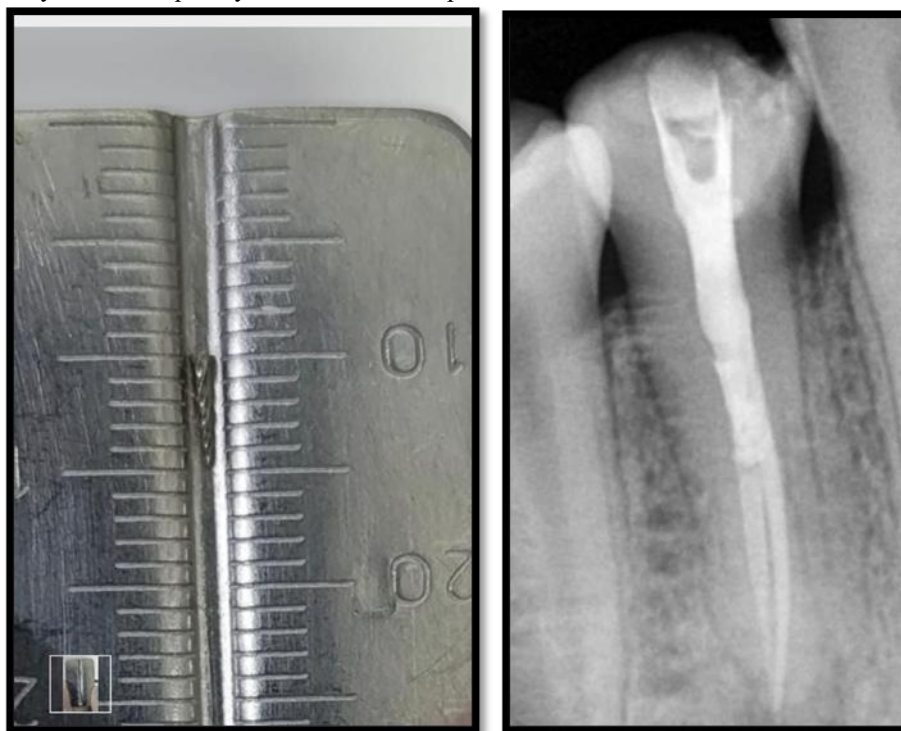
A postoperative radiograph confirmed satisfactory obturation of the canals.

**Figure 4(a): Broken Instrument Retrieved & Measured using a scale**

**4(b): Final IOPAR showing well obturated canals**

Following successful retrieval of the separated instrument, canal patency was re-established using small K-files. Biomechanical preparation was completed using rotary instrumentation while maintaining copious irrigation.

Obturation was performed using gutta-percha cones with an endodontic sealer using a suitable obturation technique to achieve three-dimensional sealing of the canal system.

The access cavity was subsequently restored with composite resin to ensure coronal seal.
